August 4, 2017

CITY OF SASKATOON

# Asbestos-Containing Building Materials Assessment Report - Pleasant Hill Substation

**Report Number: 1667963**

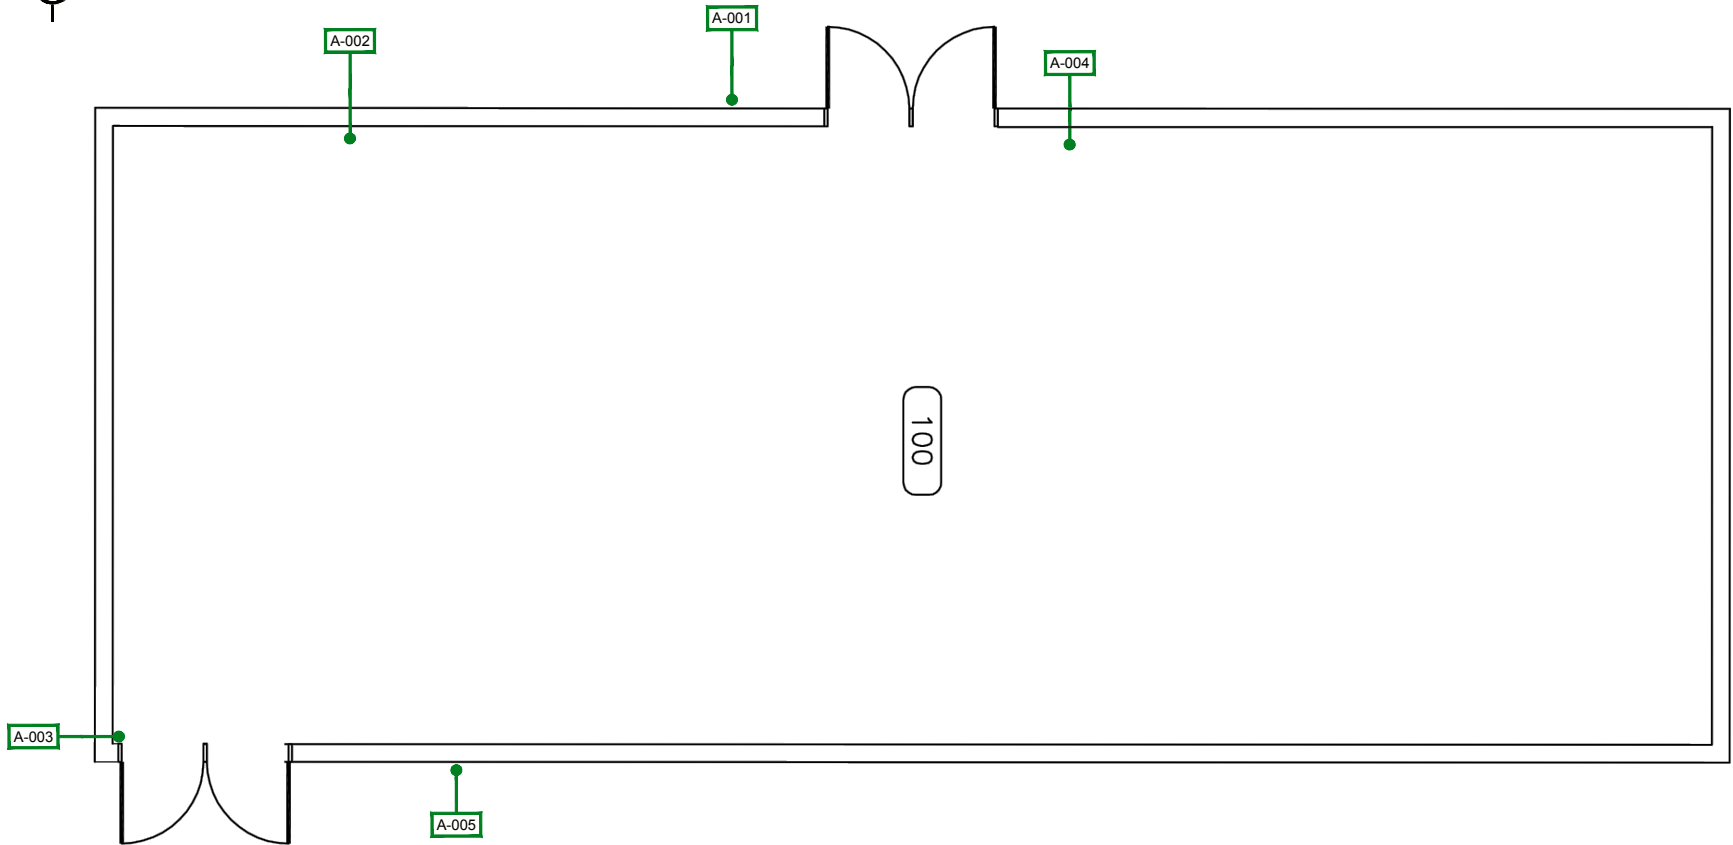
FIGURE  
1

1. ASBESTOS IS A CARCINOGEN. DO NOT BREATHE ASBESTOS DUST.
2. ASBESTOS-CONTAINING MATERIALS WERE NOT OBSERVED WITHIN THE BUILDING AT THE TIME OF THE ASSESSMENT.
