November 15, 2017

CITY OF SASKATOON

# Asbestos-Containing Building Materials Assessment Report - Powerhouse Lift Station

**Report Number: 1667963**

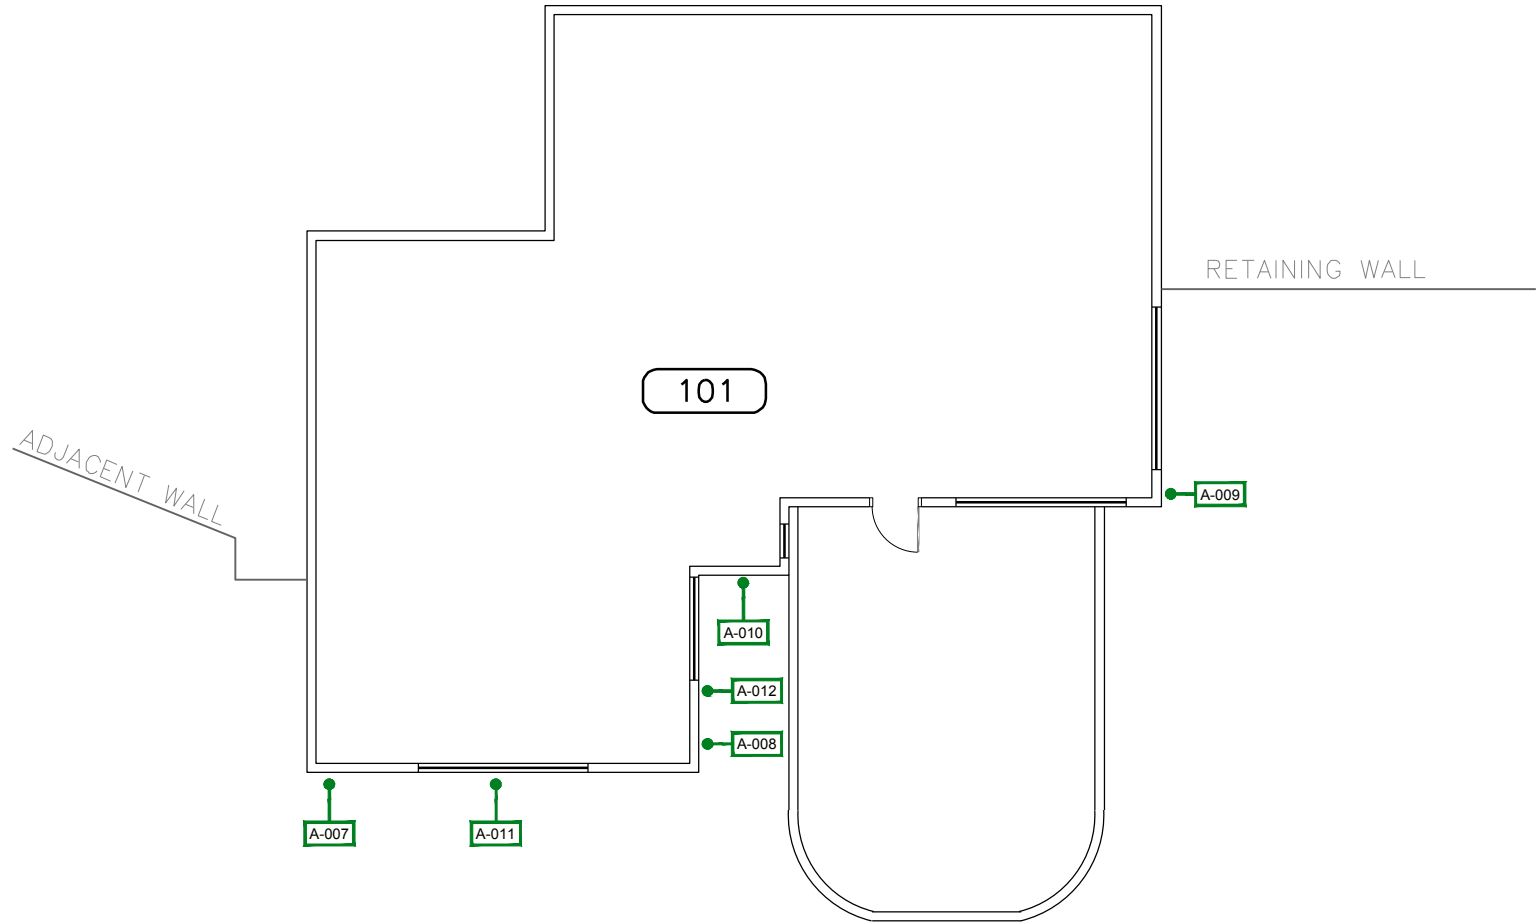
TITLE  
**MAIN FLOOR**

1. ASBESTOS IS A CARCINOGEN. DO NOT BREATHE ASBESTOS DUST.
2. SAMPLES A-001 TO A-006 WERE COLLECTED FROM ADJACENT WELL.
3. ASBESTOS-CONTAINING MATERIALS WERE NOT OBSERVED ON SITE DURING THE ASSESSMENT.
