Subject: Pre-Renovation Assessment – Forestry Farm Pump House

File Number: B67IRG16H- Saskatoon Forestry Farm

Project: Saskatoon Forestry Farm – Investigation of Maintenance Building & Pump House

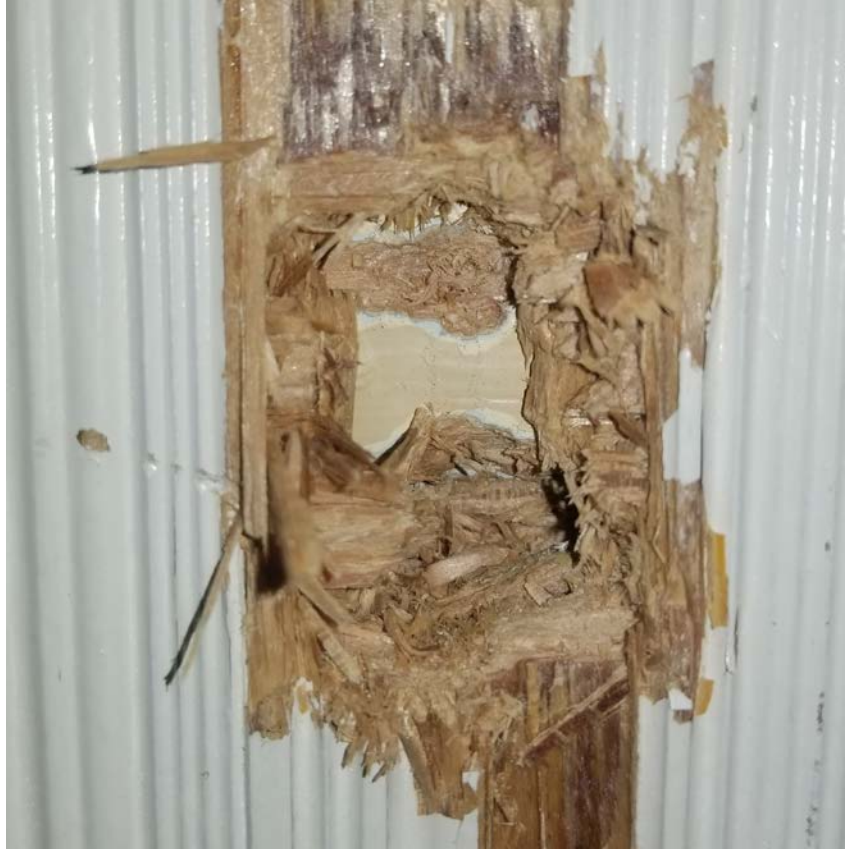
B67PRB13J - 001

The wall paneling consisted of wood panels on top of wood walls. Since the panels and wall are remaining in place there are no concerns regarding asbestos within these materials. Please reference to **Appendix I** for the **Site Photos**.

Wall panel cored into wood wall behind.

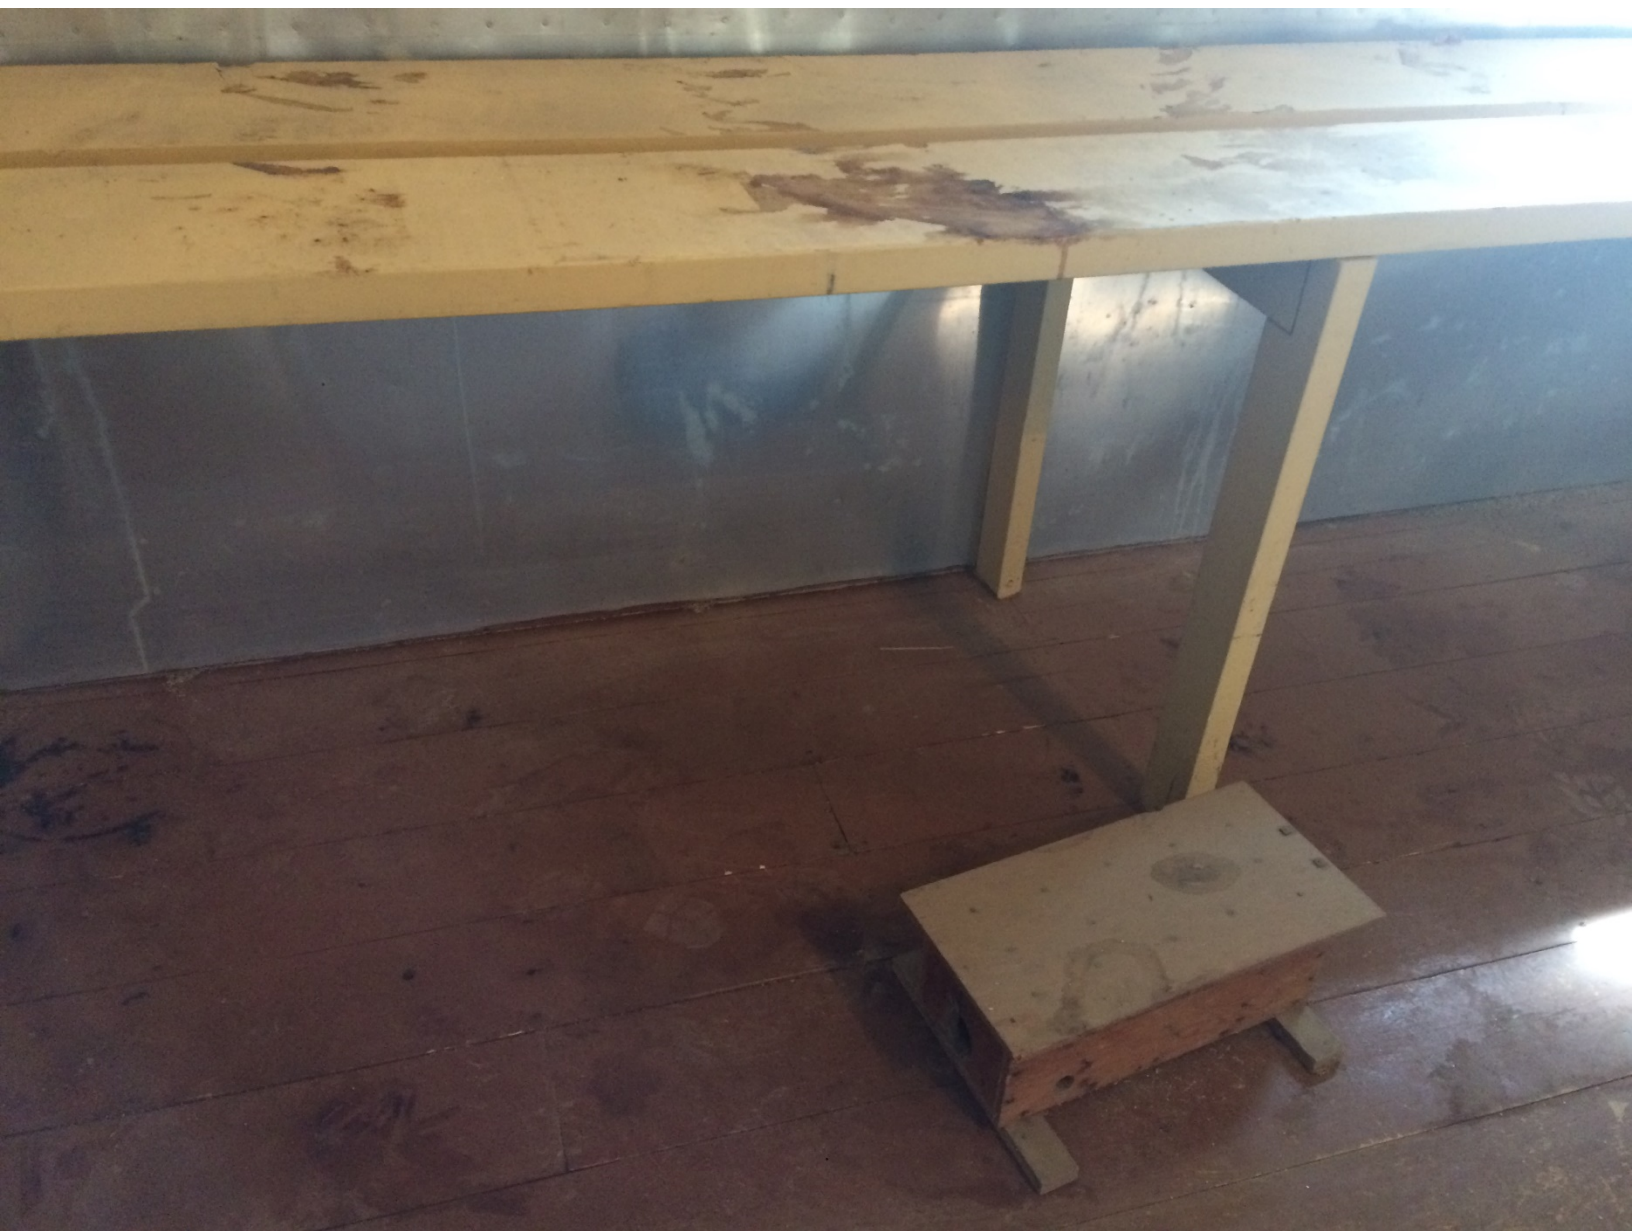
Photo 001- Seed Storage Room

The scope of this investigation included the Maintenance Building and Old Pump House on the Saskatoon Forestry Farm site. Vermiculite was identified within the seed storage room in the northwest corner of the Maintenance Building, the second-floor loft and “Burlap and Twine Storage Room”. Vermiculite in the seed storage room is leaking from the east and west wall cavities onto the floor in minor amounts. In the second-floor loft vermiculite is leaking from a penetration in the north wall. In the “Burlap and Twine Storage Room” vermiculite is leaking through joints in the ceiling tin in the north half of the room. Vermiculite was not identified in any other areas of the Maintenance Building or Pump House.

The vermiculite may be cleaned under following low-risk procedures by HEPA vacuuming and caulking penetrations to prevent further contamination. Following this step areas containing or suspected to contain vermiculite should be inspected regularly and staff be alerted to its presence. See **Appendix II** for site photos.
