CITY OF SASKATOON

Asbestos-Containing Building Materials Assessment Report - Victoria Park Riversdale Badminton and Tennis Club

Report Number: 1667963

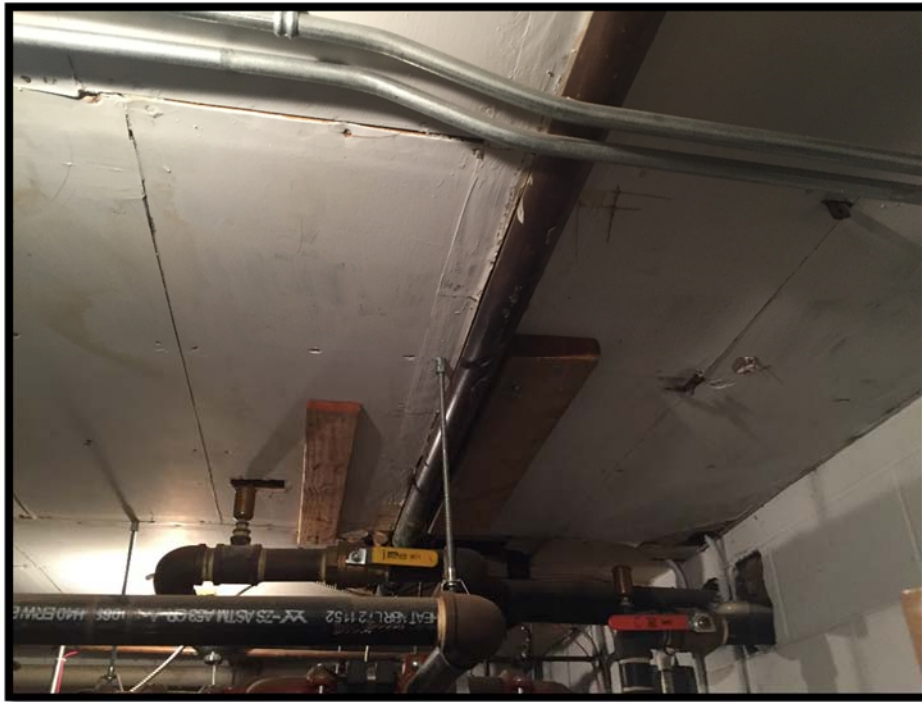
Seven (7) samples of drywall joint compound were collected during the assessment. Three of the samples collected were found to contain 2.1% to 2.8% Chrysotile asbestos. Asbestos-containing drywall joint compound (see Photograph 1 in Appendix B) was observed in the following location:

- Room 102 (approximately 250 ft²);
- Room 103 (approximately 65 ft²);
- Room 104 (approximately 275 ft²);
- Room 105 (approximately 475 ft²);
- Room 106 (approximately 270 ft²);
- Room 107 (approximately 900 ft²);
- Room 108 (approximately 300 ft²);
- Room 110 (approximately 175 ft²);

- Room 111 (approximately 500 ft²);
- Room 112 (approximately 500 ft²);
- Room 201 (approximately 50 ft²);
- Room 202 (approximately 375 ft²);
- Room 203 (approximately 1,175 ft²);
- Room 204 (approximately 450 ft²);
- Room 205 (approximately 500 ft²);
- Room 206 (approximately 225 ft²);
- Room 206 Washroom (approximately 225 ft²);
- Room 207 (approximately 325 ft²);
- Room 208 (approximately 500 ft²);
- Room 209/210 (approximately 475 ft²); and
- Men's Lower Level Change Room (approximately 1,250 ft²).

Additional asbestos-containing drywall joint compound may be located behind ceramic tiles, lockers and texture coats and above dropped ceilings throughout the site.

Photograph 1: Asbestos-Containing Drywall Joint Compound.

If scheduled for impact, asbestos-containing drywall joint compound should be abated following low-risk abatement work procedures as outlined in the *Saskatchewan Asbestos Abatement Manual* (2017). Alternatively, as the drywall joint compound was observed in good condition, and with a priority rating of 5 (please see the room by room spreadsheet provided in Appendix C for a description of the priority ratings), it can be managed in place if not scheduled for impact.

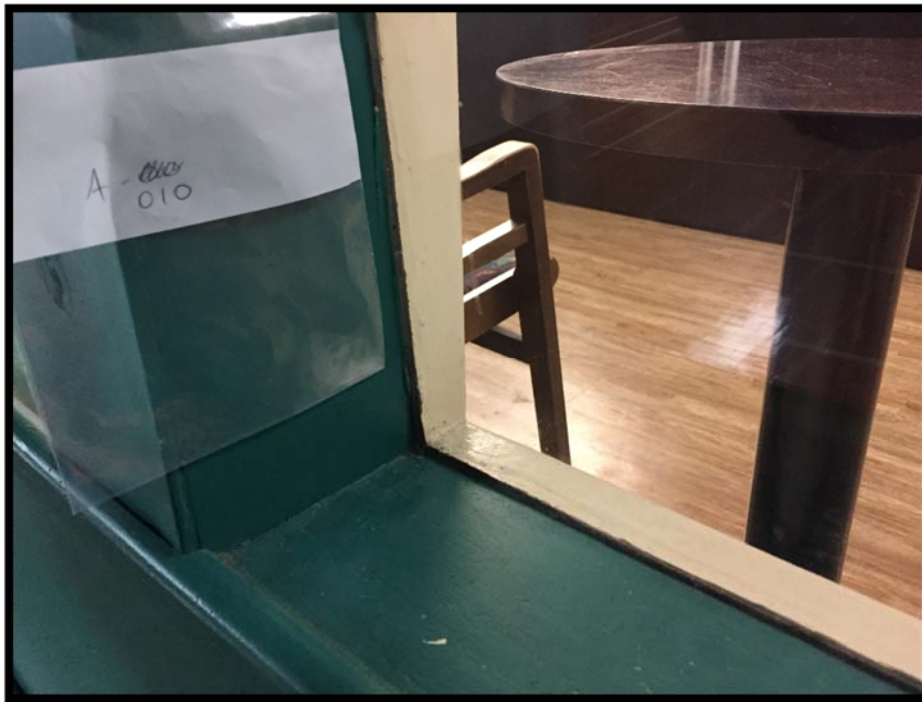
Two (2) samples of black window caulking were collected during the assessment. One of the samples collected was found to contain 1.6% Chrysotile asbestos. Asbestos-containing black window caulking (see Photograph 2 in Appendix B) was observed in the following location:

- Room 101 (approximately 10 linear ft).

Photograph 2: Asbestos-Containing Black Window Caulking.

If scheduled for impact, asbestos-containing black window caulking should be abated following low-risk abatement work procedures as outlined in the *Saskatchewan Asbestos Abatement Manual* (2017). Alternatively, as the black window caulking was observed in good condition, and with a priority rating of 5 (please see the room by room spreadsheet provided in Appendix C for a description of the priority ratings), it can be managed in place if not scheduled for impact.
