December 1, 2017

CITY OF SASKATOON

Asbestos-Containing Building Materials Assessment Report - Riversdale Pool

Report Number: 1667963

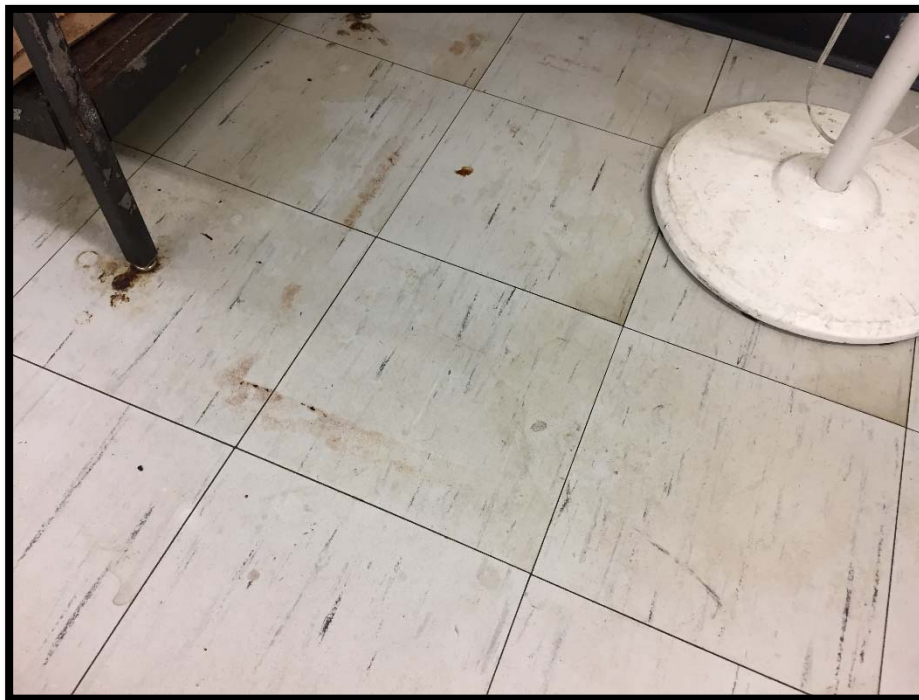
One (1) sample of 12"x12" off-white floor tile with black streaks was collected during the assessment. The sample collected was found to contain 1.3% Chrysotile asbestos. Asbestos-containing 12"x12" off-white floor tile with black streaks (see Photograph 1 in Appendix B) was observed in the following locations:

- Room 127/130 (approximately 550 ft²);
- Room 128 (approximately 90 ft²); and
- Room 129 (approximately 190 ft²).

Photograph 1: Asbestos-Containing 12"x12" Off-White Floor Tile with Black Streaks.

If scheduled for impact, asbestos-containing 12"x12" off-white floor tile with black streaks should be abated following low-risk abatement work procedures as outlined in the *Saskatchewan Asbestos Abatement Manual* (2017). Alternatively, as the 12"x12" off-white floor tile with black streaks was observed in good condition, and with a priority rating of 5 (please see the room by room spreadsheet provided in Appendix C for a description of the priority ratings), it can be managed in place if not scheduled for impact.

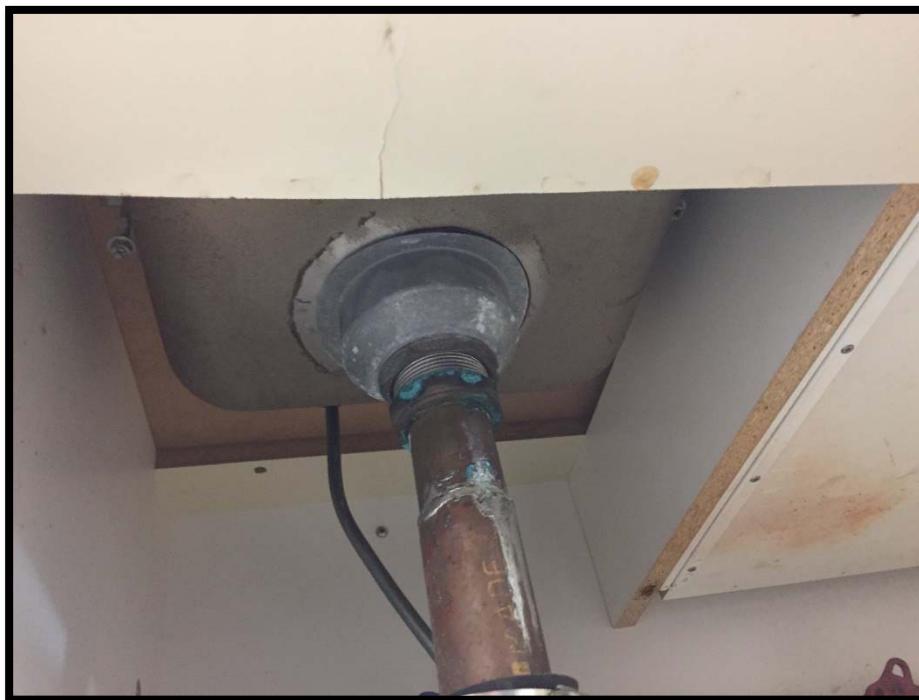
One (1) sample of gold sink undercoat was collected during the assessment. The sample collected was found to contain 12% Chrysotile asbestos. Asbestos-containing gold sink undercoat (see Photograph 2 in Appendix B) was observed in the following locations:

- Room 112 (approximately 1 sink); and
- Room 117 (approximately 2 sinks).

Photograph 2: Asbestos-Containing Gold Sink Undercoat.

If scheduled for impact, asbestos-containing gold sink undercoat should be abated following low-risk abatement work procedures as outlined in the *Saskatchewan Asbestos Abatement Manual* (2017). Alternatively, as the gold sink undercoat was observed in good condition, and with a priority rating of 5 (please see the room by room spreadsheet provided in Appendix C for a description of the priority ratings), it can be managed in place if not scheduled for impact.

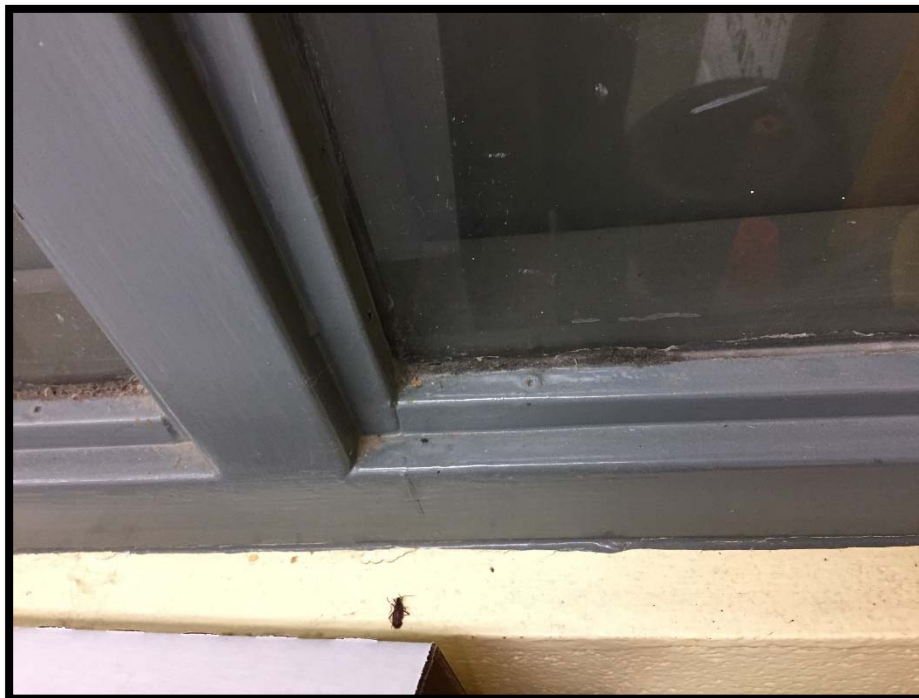
One (1) sample of grey window caulking was collected during the assessment. The sample collected was found to contain 15% Chrysotile asbestos. Asbestos-containing grey window caulking (see Photograph 3 in Appendix B) was observed in the following locations:

- Room 112 (approximately 32 linear feet); and
- Room 118 (approximately 48 linear feet).

Photograph 3: Asbestos-Containing Grey Window Caulking.

If scheduled for impact, asbestos-containing grey window caulking should be abated following low-risk abatement work procedures as outlined in the *Saskatchewan Asbestos Abatement Manual* (2017). Alternatively, as the grey window caulking was observed in good condition, and with a priority rating of 5 (please see the room by room spreadsheet provided in Appendix C for a description of the priority ratings), it can be managed in place if not scheduled for impact.

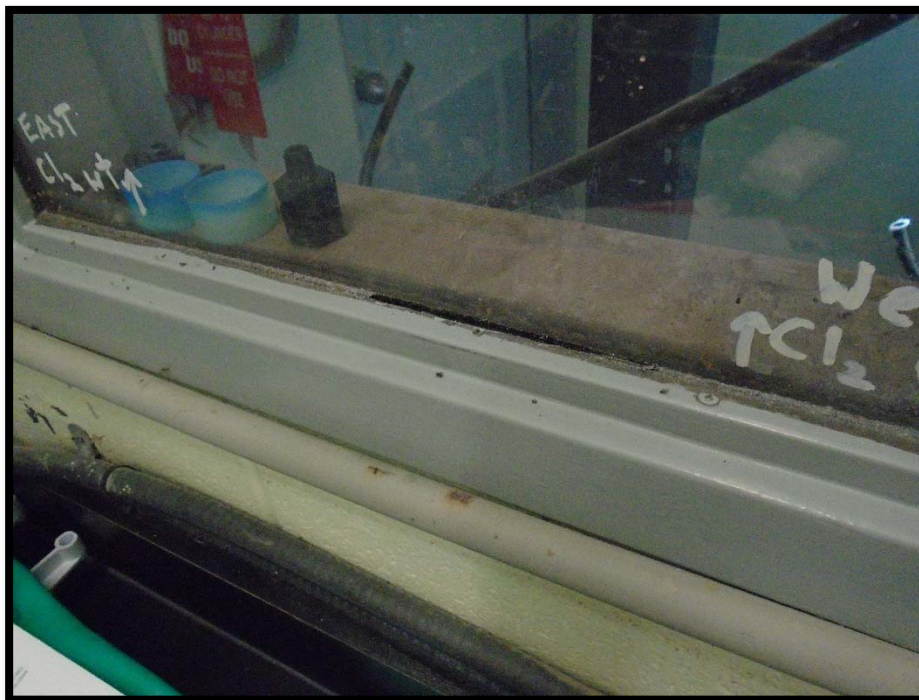
One (1) sample of black window putty was collected during the assessment. The sample collected was found to contain 15% Chrysotile asbestos. Asbestos-containing black window putty (see Photograph 4 in Appendix B) was observed in the following location:

- Room 103 (approximately 5 linear feet).

Photograph 4: Asbestos-Containing Black Window Putty.

If scheduled for impact, asbestos-containing black window putty should be abated following low-risk abatement work procedures as outlined in the *Saskatchewan Asbestos Abatement Manual* (2017). Alternatively, as the black window putty was observed in good condition, and with a priority rating of 5 (please see the room by room spreadsheet provided in Appendix C for a description of the priority ratings), it can be managed in place if not scheduled for impact.

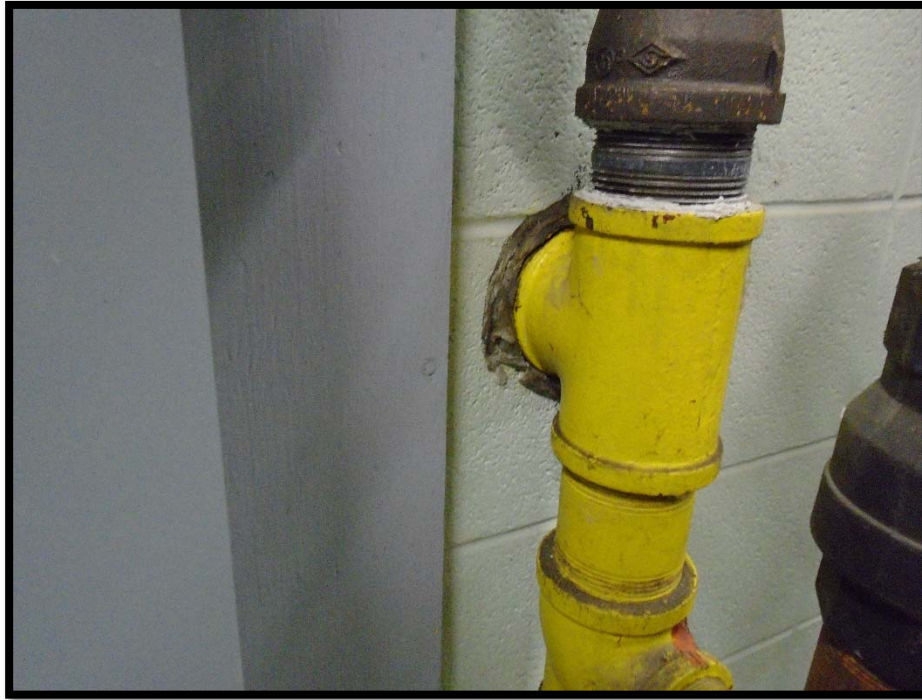
One (1) sample of light grey firestop was collected during the assessment. The sample collected was found to contain 2.2% Chrysotile asbestos. Asbestos-containing light grey firestop (see Photograph 5 in Appendix B) was observed in the following location:

- Room 104 (approximately 1 linear foot).

Photograph 5: Asbestos-Containing Light Grey Firestop.

If scheduled for impact, asbestos-containing light grey firestop should be abated following low-risk abatement work procedures as outlined in the *Saskatchewan Asbestos Abatement Manual* (2017). Alternatively, as the light grey firestop was observed in good condition, and with a priority rating of 5 (please see the room by room spreadsheet provided in Appendix C for a description of the priority ratings), it can be managed in place if not scheduled for impact.

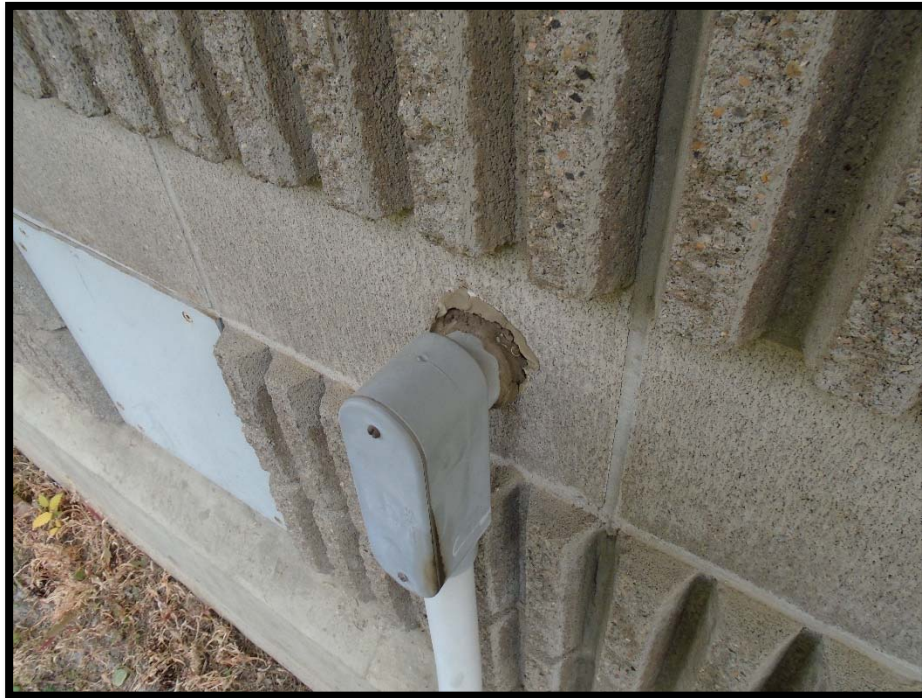
One (1) sample of light grey building caulking was collected during the assessment. The sample collected was found to contain 10% Chrysotile asbestos. Asbestos-containing light grey building caulking (see Photograph 6 in Appendix B) was observed in the following location:

- Exterior (approximately 1 linear foot).

Photograph 6: Asbestos-Containing Light Grey Building Caulking.

If scheduled for impact, asbestos-containing light grey building caulking should be abated following low-risk abatement work procedures as outlined in the *Saskatchewan Asbestos Abatement Manual* (2017). Alternatively, as the light grey building caulking was observed in good condition, and with a priority rating of 5 (please see the room by room spreadsheet provided in Appendix C for a description of the priority ratings), it can be managed in place if not scheduled for impact.

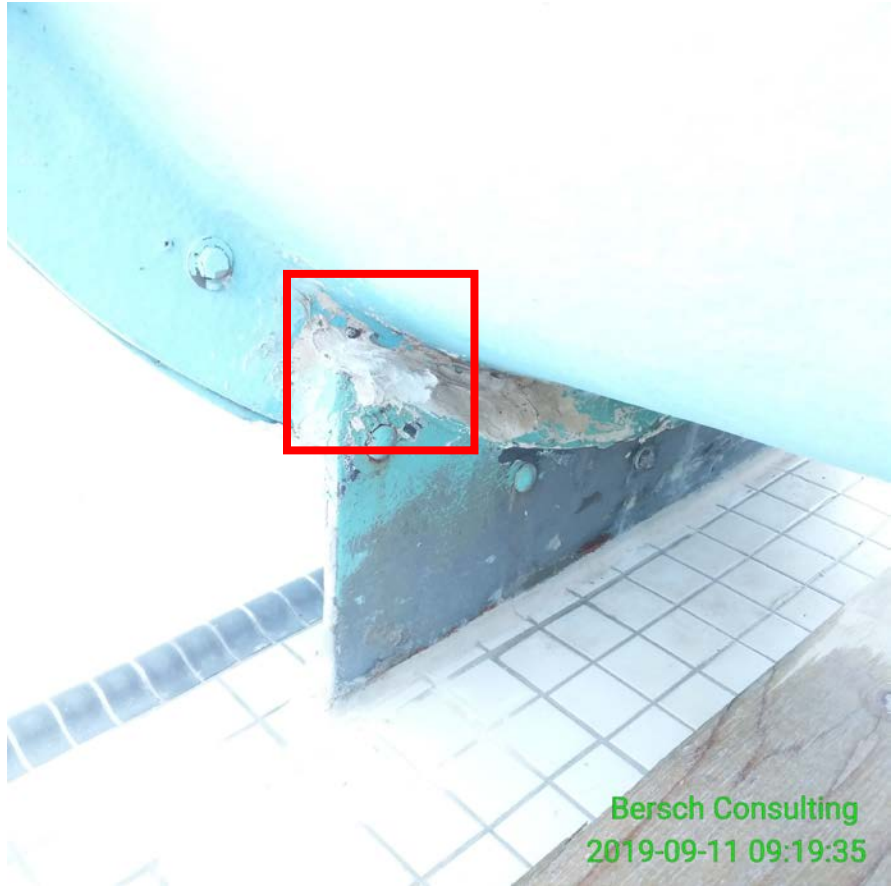
B67PRI11I - 002

White Caulking

Waterslide Section Joint

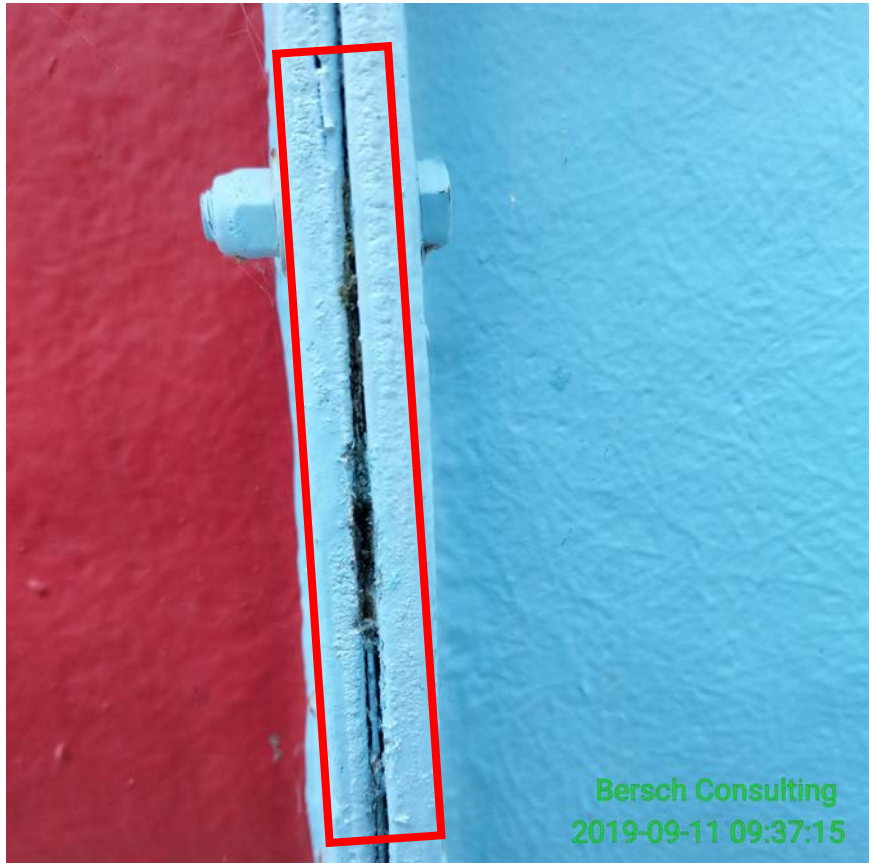
B67PRI11I - 003

Gasket Material

Waterslide Section Joint

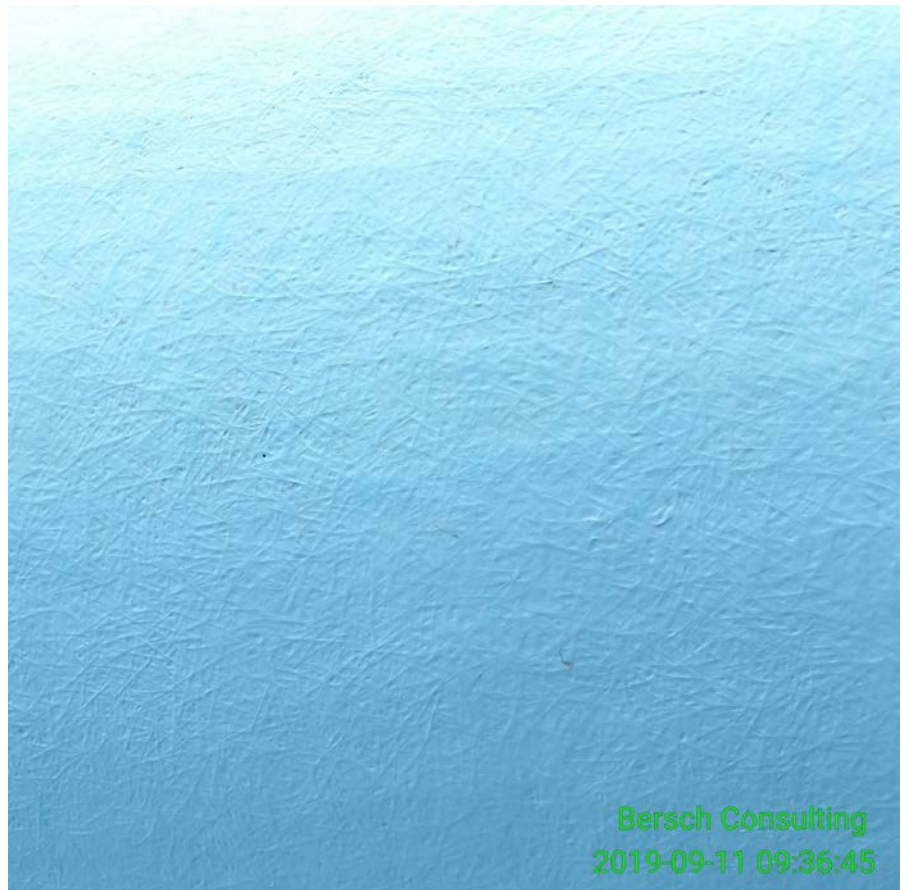
B67PRI11I - 005

Waterslide Material
