CITY OF SASKATOON

Asbestos-Containing Building Materials Assessment Report - Rotary Park Washrooms

Report Number: 1667963

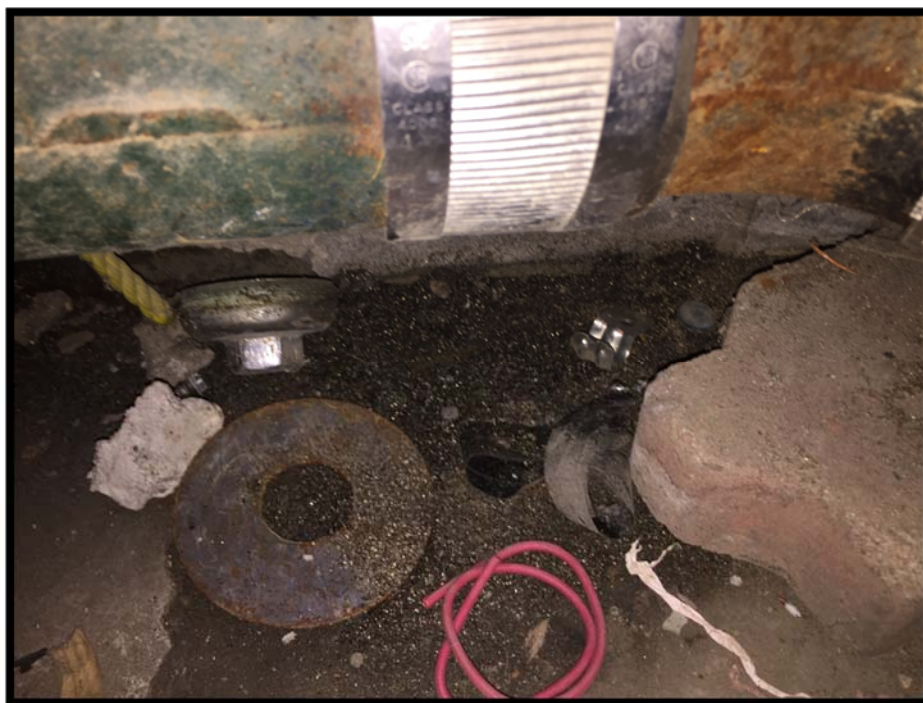
One (1) sample of vermiculite debris was collected during the assessment. The sample collected was found to contain 1.6% Actinolite asbestos. Asbestos-containing vermiculite debris (see Photograph 1 in Appendix B) was observed in the following location:

- Room 101 (approximately 30 ft²).

Based upon information provided by the Client, the vermiculite debris within Room 101 was cleaned up following its identification. Additional asbestos-containing vermiculite is suspected to be located within the block walls throughout the Site.

Photograph 1: Asbestos-Containing Vermiculite Debris.

Asbestos-containing vermiculite debris should be cleaned-up following low-risk abatement work procedures as outlined in the *Saskatchewan Asbestos Abatement Manual (2017)*. Based upon information provided by the Client, the vermiculite debris within Room 101 was cleaned up following its identification. Additional asbestos-containing vermiculite is suspected to be located within the block walls throughout the Site.
