CITY OF SASKATOON

Asbestos-Containing Building Materials Assessment Report - Ruth Street Substation

Report Number: 1667963

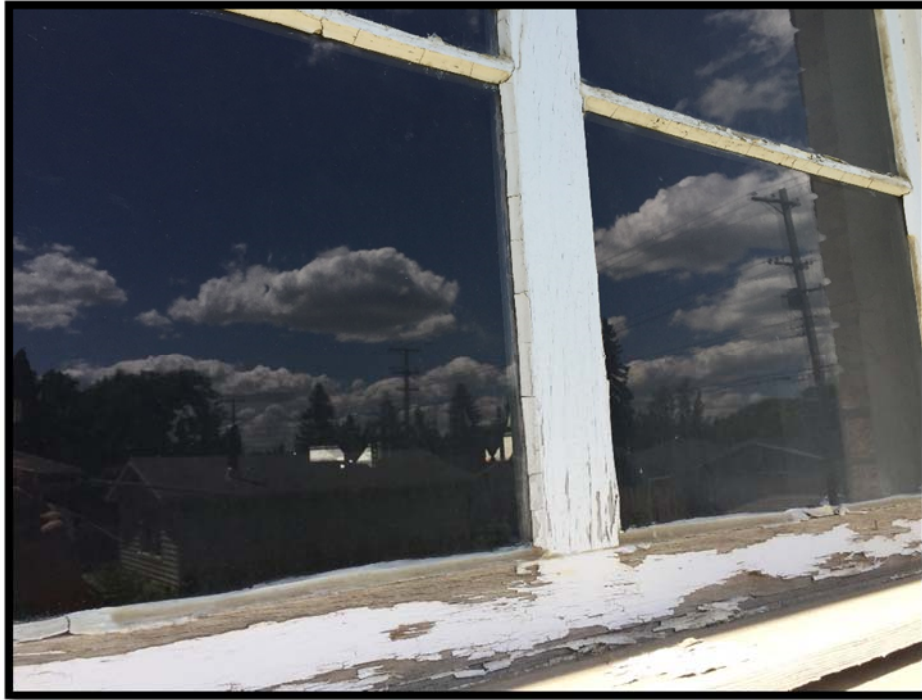
One (1) sample of white window caulking was collected during the assessment. The sample collected was found to contain 1.2% Chrysotile asbestos. Asbestos-containing white window caulking (see Photograph 1 in Appendix B) was observed in the following locations:

- Exterior (approximately 220 linear ft).

Photograph 1: Asbestos-Containing White Window Caulking.

If scheduled for impact, asbestos-containing white window caulking should be abated following the low-risk abatement work procedures as outlined in the *Saskatchewan Asbestos Abatement Manual* (2017). Alternatively, as the white window caulking was observed in good condition, and with a priority rating of 5 (please see the room by room spreadsheet provided in Appendix C for a description of the priority ratings), it can be managed in place if not scheduled for impact.

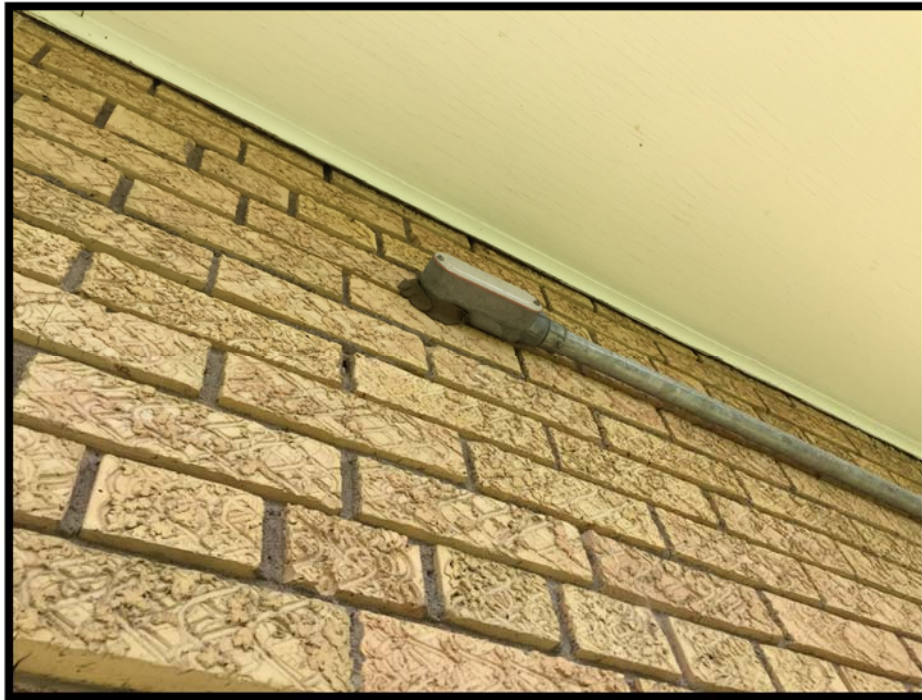
One (1) sample of black firestop was collected during the assessment. The sample collected was found to contain 2.8% Chrysotile asbestos. Asbestos-containing black firestop (see Photograph 2 in Appendix B) was observed in the following locations:

- Exterior (approximately 1 ft²).

Photograph 2: Asbestos-Containing Black Firestop.

If scheduled for impact, asbestos-containing black firestop should be abated following the low-risk abatement work procedures as outlined in the *Saskatchewan Asbestos Abatement Manual* (2017). Alternatively, as the black firestop was observed in good condition, and with a priority rating of 5 (please see the room by room spreadsheet provided in Appendix C for a description of the priority ratings), it can be managed in place if not scheduled for impact.
