**SPCA ANIMAL SHELTER  
ASBESTOS SURVEY REPORT**

**May 2013**

**Prepared For: City of Saskatoon – Infrastructure Services Department**  
1101 Avenue P North, Saskatoon SK, Canada S7L 7K6  
Attn: Brent Anderson

**Prepared By: Bersch & Associates Ltd.**  
**Project No. : B67.13**

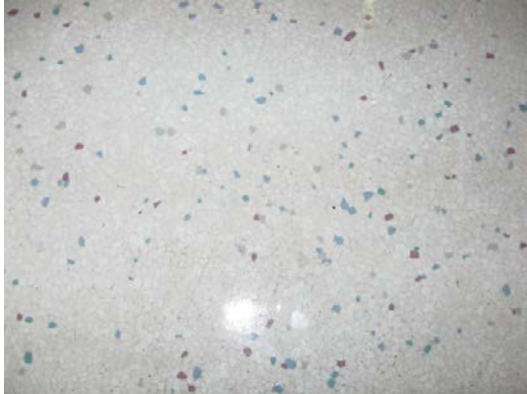
#1) Sheet Floor Covering

| <b>NO.</b> | <b>DATE</b> | <b>SAMPLE INFORMATION</b> | <b>ASBESTOS</b> | <b>%</b> | <b>ANALYST</b> |
|---|---|---|---|---|---|
| 1 | 2-May-13 | 128 - Sheet floor covering, gray stone pattern with blue, pink and green spec | None detected | | WB |

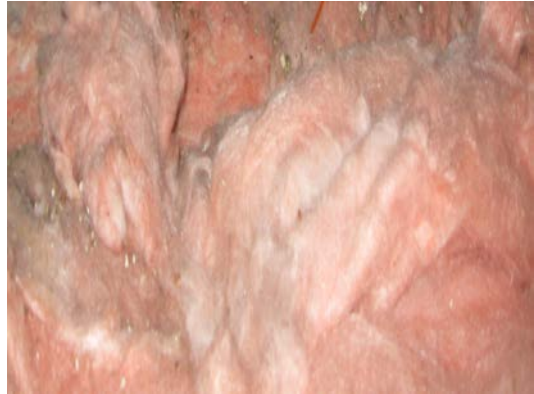
#2) Attic Insulation

| <b>NO.</b> | <b>DATE</b> | <b>SAMPLE INFORMATION</b> | <b>ASBESTOS</b> | <b>%</b> | <b>ANALYST</b> |
|---|---|---|---|---|---|
| 2 | 2-May-13 | 127 - Attic insulation | None detected | | WB |

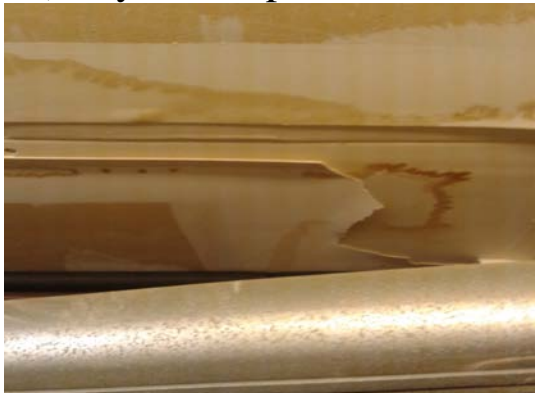
#3) Drywall Tape/ Mud

| <b>NO.</b> | <b>DATE</b> | <b>SAMPLE INFORMATION</b> | <b>ASBESTOS</b> | <b>%</b> | <b>ANALYST</b> |
|---|---|---|---|---|---|
| 3 | 2-May-13 | B100 - Drywall tape/ mud | None detected | | WB |

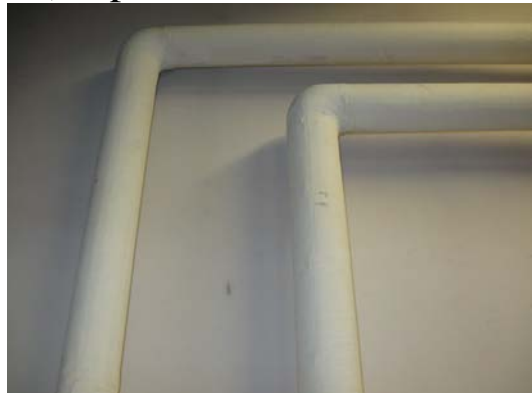
#4) Pipeline Insulation

| <b>NO.</b> | <b>DATE</b> | <b>SAMPLE INFORMATION</b> | <b>ASBESTOS</b> | <b>%</b> | <b>ANALYST</b> |
|---|---|---|---|---|---|
| 4 | 2-May-13 | B100 - Pipeline insulation | None detected | | WB |

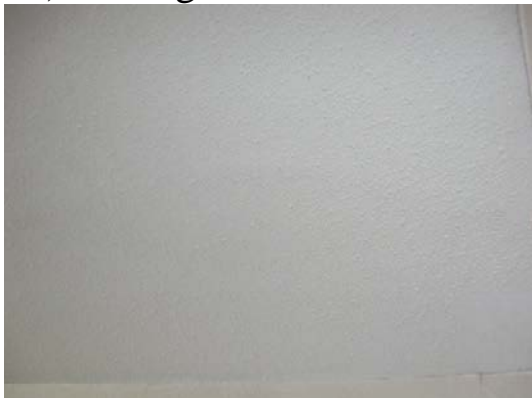
#5) Ceiling Board

| <b>NO.</b> | <b>DATE</b> | <b>SAMPLE INFORMATION</b> | <b>ASBESTOS</b> | <b>%</b> | <b>ANALYST</b> |
|---|---|---|---|---|---|
| 5 | 2-May-13 | 119 - Ceiling board | None detected | | WB |

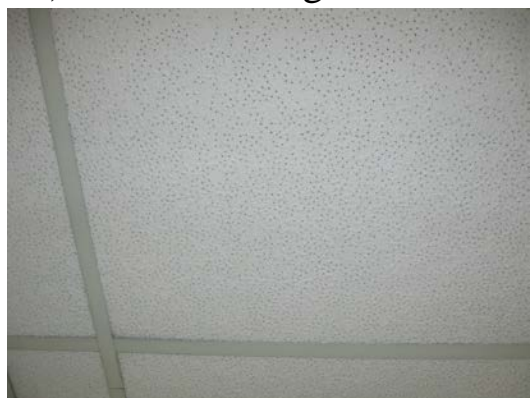
#6) 2' x 4' Ceiling Tile

| <b>NO.</b> | <b>DATE</b> | <b>SAMPLE INFORMATION</b> | <b>ASBESTOS</b> | <b>%</b> | <b>ANALYST</b> |
|---|---|---|---|---|---|
| 6 | 2-May-13 | 112 - 2' x 4' ceiling tile | None detected | | WB |

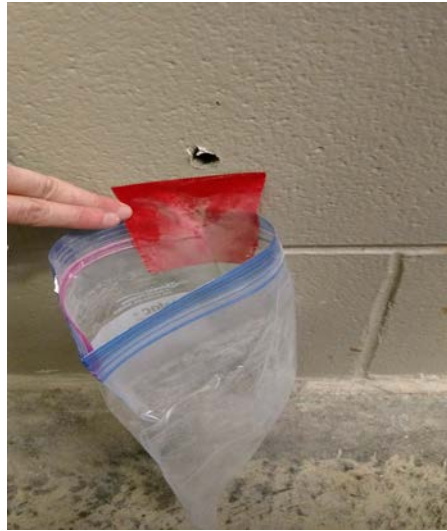
The SPCA building consists of block walls, drywall walls/ceilings and vinyl sheet flooring. The block walls were drilled into resulting in a hollow block cavity. No insulation was observed in the block wall. Please refer to *Appendix II – Site Photo's*.

**PHOTO 1 – Block Wall Cavity (Empty)**

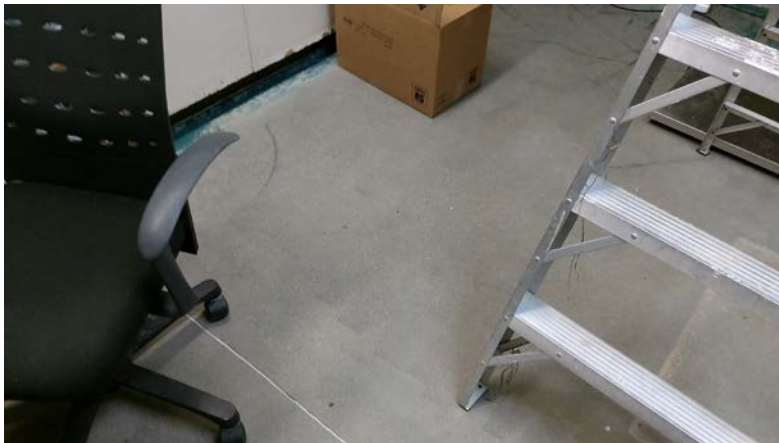
| <b>NO.</b> | <b>DATE</b> | <b>SAMPLE INFORMATION</b> | <b>ASBESTOS</b> | <b>%</b> | <b>ANALYST</b> |
|---|---|---|---|---|---|
| 3 | 23-Jan-17 | 110<br>- Concrete Flooring | No Asbestos<br>Detected | | WB |

**PHOTO 2 – Concrete Flooring**

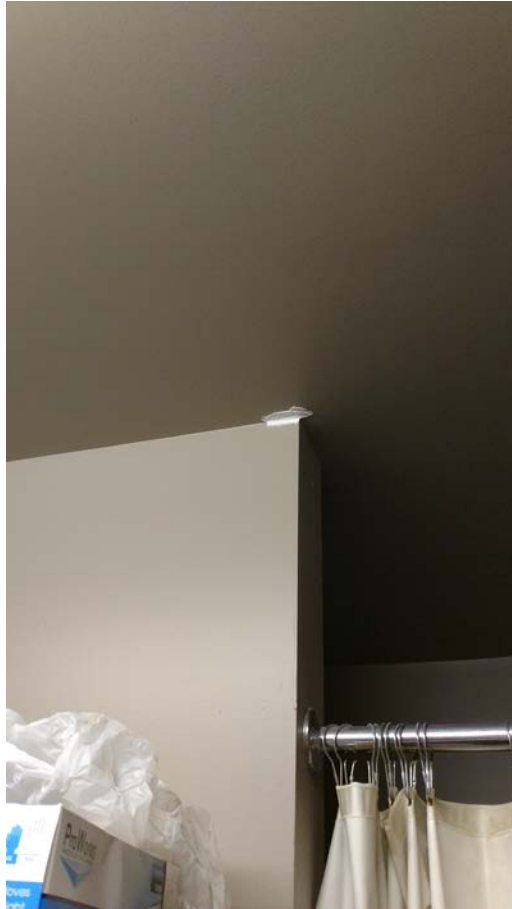
**PHOTO 3 – Drywall Walls/Ceiling**
