**Field House  
Asbestos Survey Report**

**January 2015**

**Prepared For: City of Saskatoon Infrastructure Services - Facilities Branch**  
3130 Laurier Drive, Saskatoon, SK.  
Attn: Brent Anderson

**Prepared By: Bersch & Associates Ltd.**  
**Project No. : B67SRJ08**

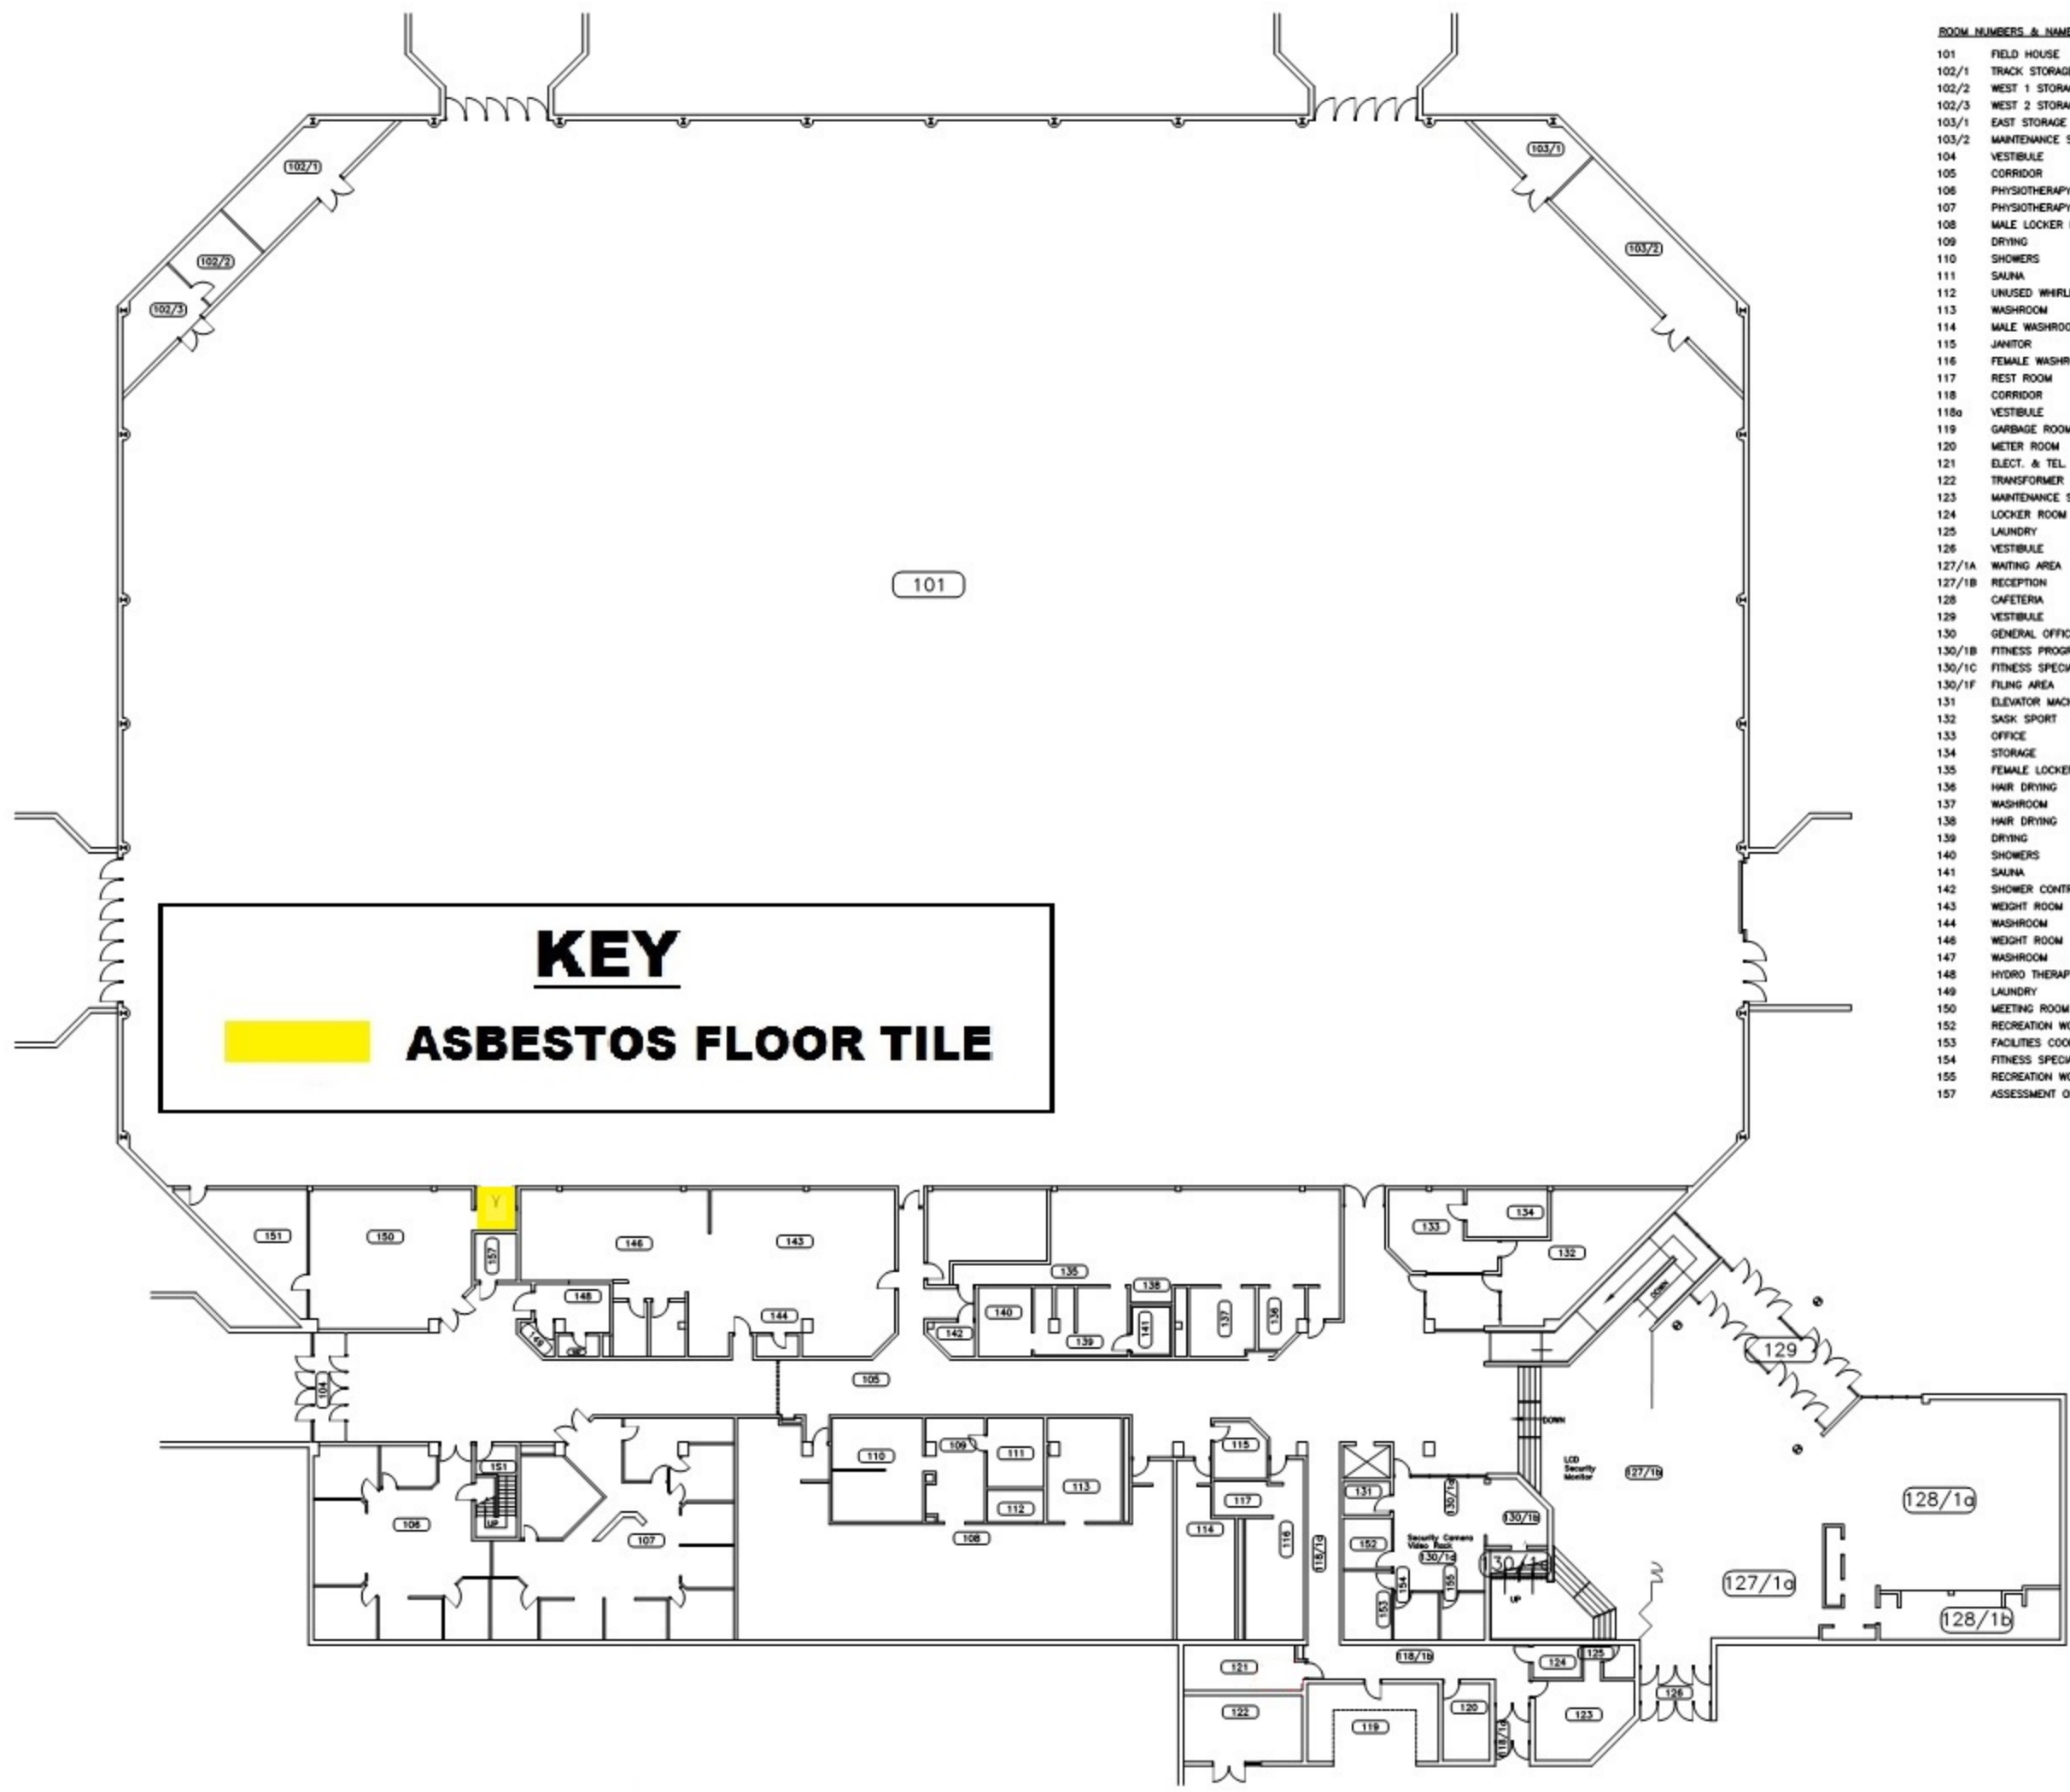
- **Vinyl Asbestos Floor Tile** is located in Meeting Room 151(walkway to track area) and Meeting Room 207. The Asbestos Floor Tile is identified on the **Floor Plans** in **Appendix III** of this report. It is suspected that the vinyl asbestos tile is present beneath the new layer of flooring throughout the facility. ***Further testing of any flooring beneath the top layer is recommended prior to renovations.***

**ASBESTOS FLOOR TILE**

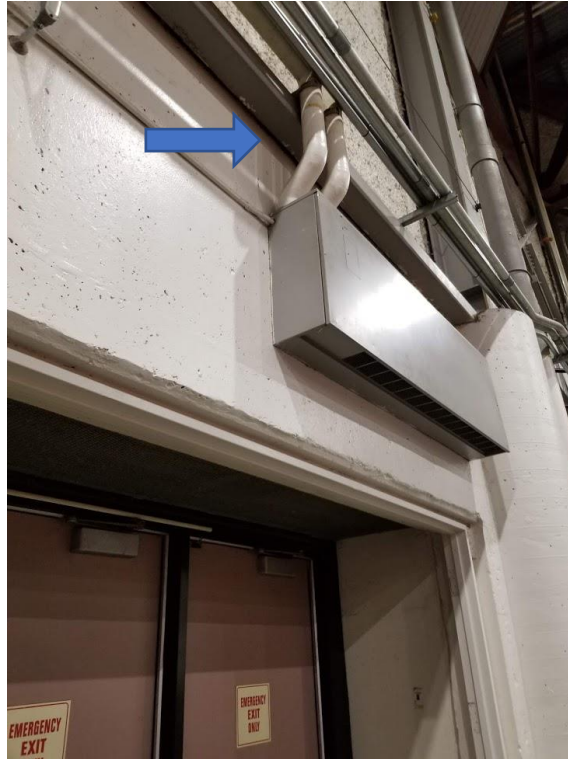
### 1) Pipeline Fittings Above Doorway (non-asbestos)

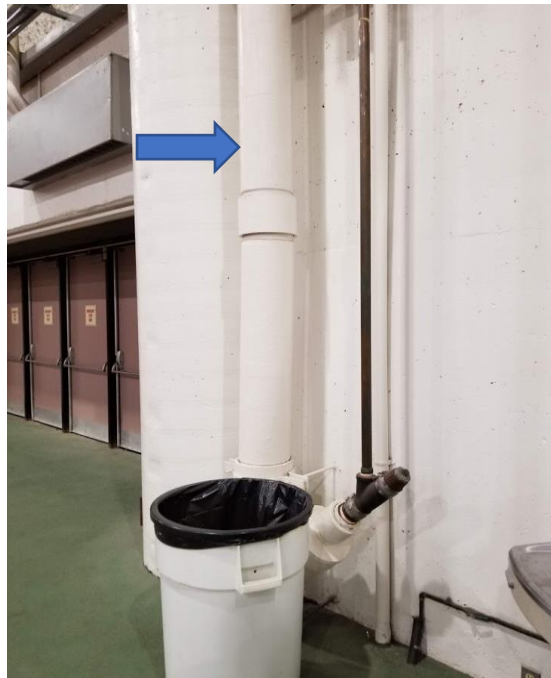
### 2) Transite Roof Drainpipe (Asbestos Containing) Adjacent Exit Doors on the North Wall

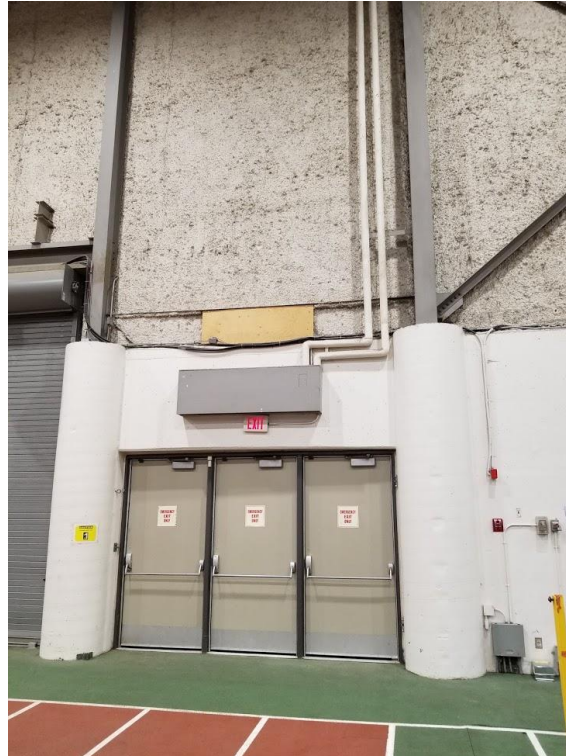
### 3) Upper East Wall Spray-Applied Insulation (non-asbestos)

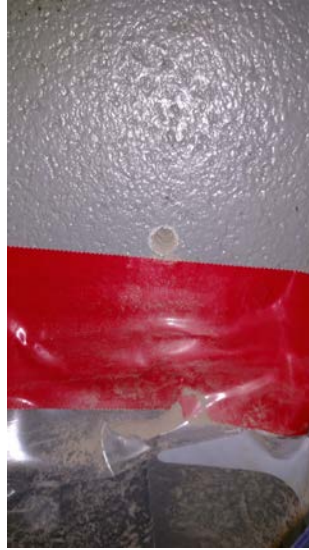
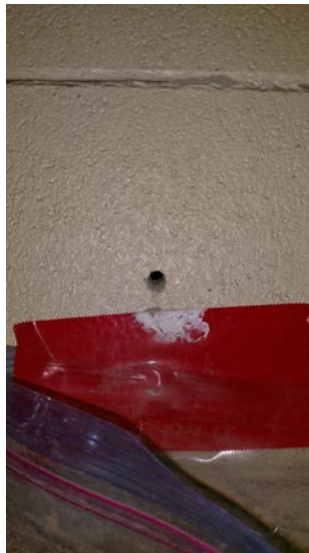
### ROOM 119 –BLOCK WALL – EMPTY CAVITIES

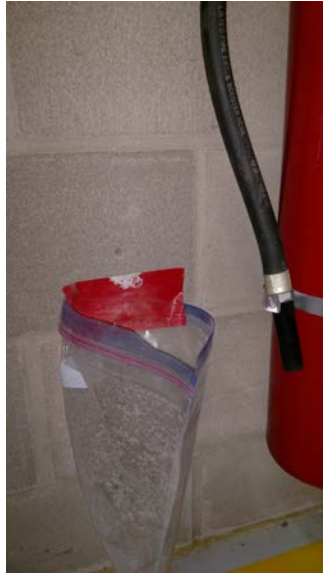
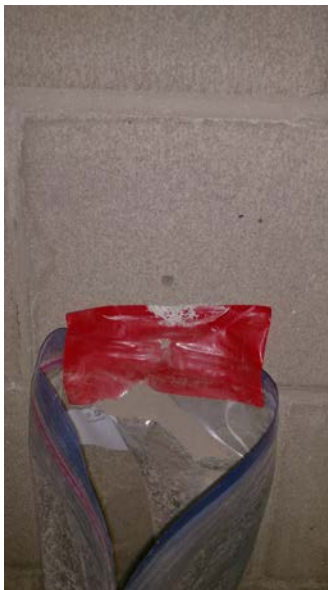
**ROOM 121 –BLOCK WALL – EMPTY CAVITIES**
