July 11, 2017

CITY OF SASKATOON

# Asbestos-Containing Building Materials Assessment Report - Sasktel Centre

**Report Number: 1667963**

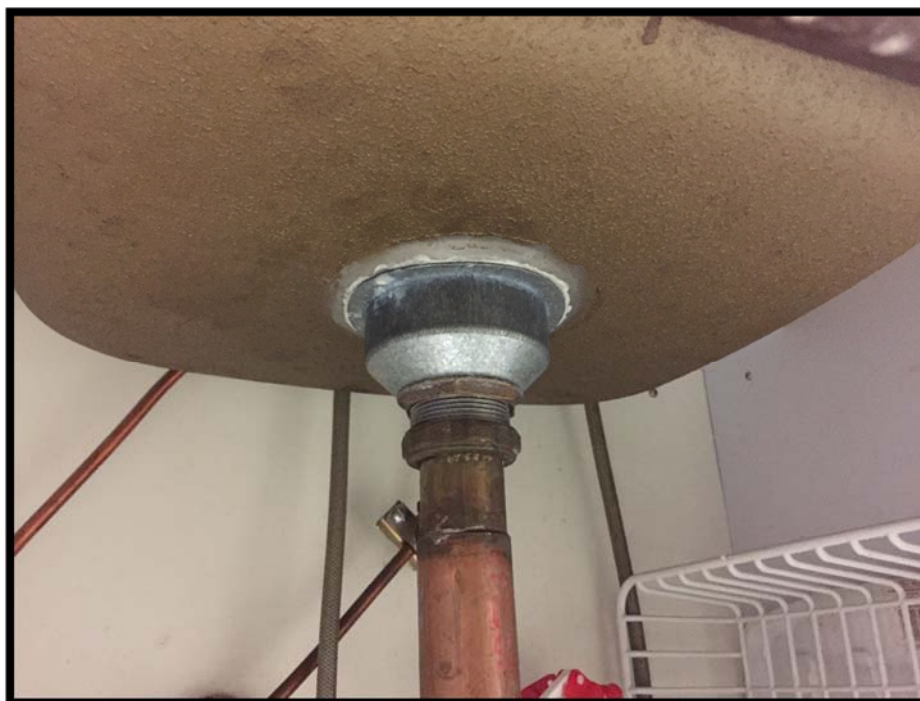
One (1) sample of gold/silver sink undercoat was collected during the assessment. The sample collected was found to contain 0.5% Chrysotile asbestos. Asbestos-containing gold/silver sink undercoat (see Photograph 1 in Appendix B) was observed in the following locations:

- Room 119 (approximately 1 sink);
- Room 122 (approximately 1 sink);
- Room 154/155/156 (approximately 1 sink);
- Room 177 (approximately 1 sink);

- Room 206 (approximately 2 sinks); and
- Room 304E (approximately 1 sink).

**Photograph 1: Asbestos-Containing Gold/Silver Sink Undercoat.**

If scheduled for impact, asbestos-containing gold/silver sink undercoat should be abated following low-risk abatement work procedures as outlined in the *Saskatchewan Asbestos Abatement Manual* (2017). Alternatively, as the gold/silver sink undercoat was observed in good condition, and with a priority rating of 5 (please see the room by room spreadsheet provided in Appendix C for a description of the priority ratings), it can be managed in place if not scheduled for impact.

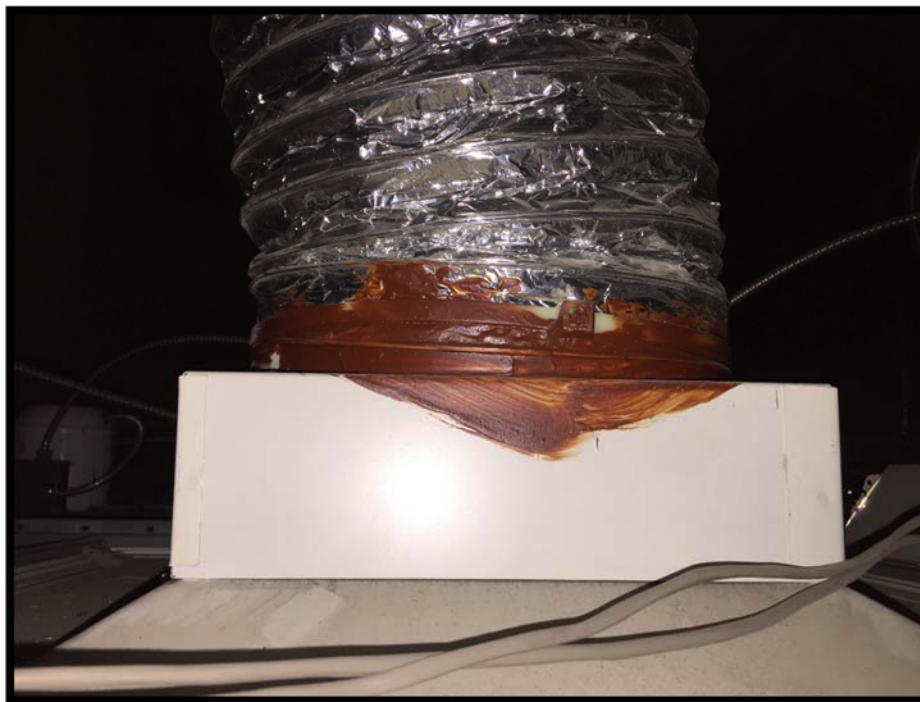
Two (2) samples of red/brown duct mastic were collected during the assessment. Both of the samples collected were found to contain 0.75% to 1.3% Chrysotile asbestos. Asbestos-containing red/brown duct mastic (see Photograph 2 in Appendix B) was observed in the following locations:

- Room 154/155/156 (approximately 15 ft);
- Room 153 (approximately 25 ft);
- Room 130 (approximately 5 ft);
- Room 125 (approximately 30 ft);
- Room 130 (approximately 5 ft);
- Arena Level Ceiling Space Mechanical Room (approximately 600 ft);
- Room 214 (approximately 5 ft);
- Room 210 (approximately 5 ft);
- Room 208 (approximately 5 ft);
- Mezzanine Level Mechanical Room Adjacent S5 (approximately 10 ft);
- Room 324 (approximately 20 ft); and
- Room 301 (approximately 50 ft).

Please note additional asbestos-containing red/brown duct mastic is suspected to be located behind fibreglass insulation and within concealed locations (wall cavities, ceiling spaces and cavities, mechanical shafts, etc.) throughout the Site.

**Photograph 2: Asbestos-Containing Red/Brown Duct Mastic.**

If scheduled for impact, asbestos-containing red/brown duct mastic should be abated following low-risk abatement work procedures as outlined in the *Saskatchewan Asbestos Abatement Manual* (2017). Alternatively, as the red/brown duct mastic was observed in good condition, and with a priority rating of 5 (please see the room by room spreadsheet provided in Appendix C for a description of the priority ratings), it can be managed in place if not scheduled for impact.
