December 1, 2017

CITY OF SASKATOON

# Asbestos-Containing Building Materials Assessment Report - Silverwood Golf Course Maintenance Storage Building

**Report Number: 1667963**

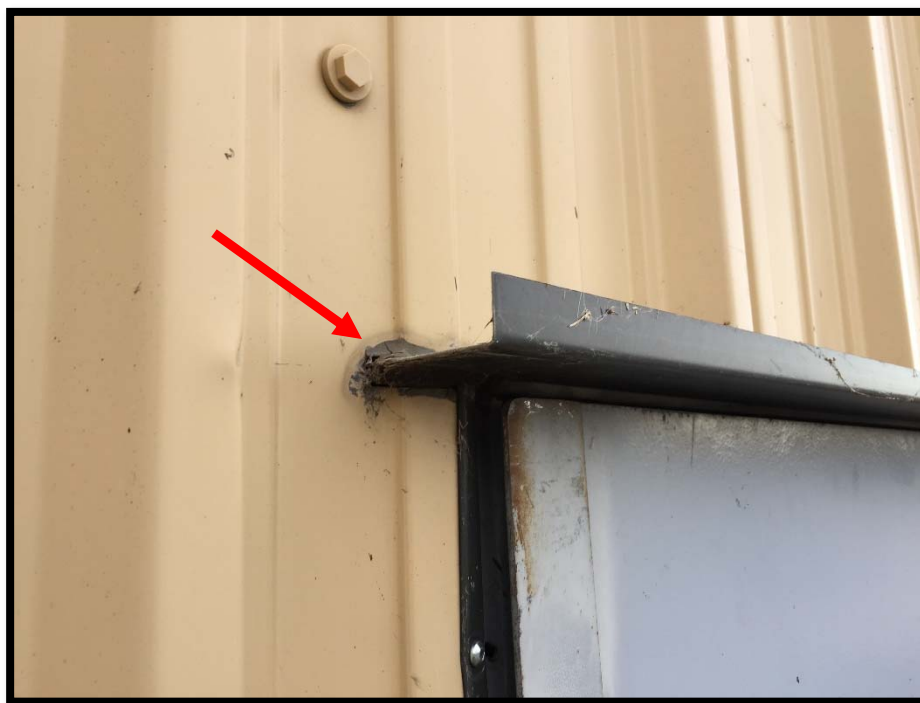
One (1) sample of black door caulking was collected during the assessment. The sample collected was found to contain 1.2% Chrysotile asbestos. Asbestos-containing black door caulking (see Photograph 1 in Appendix B) was observed in the following location:

- Exterior (approximately 40 linear feet).

**Photograph 1: Asbestos-Containing Black Door Caulking.**

If scheduled for impact, asbestos-containing black door caulking should be abated following low-risk abatement work procedures as outlined in the *Saskatchewan Asbestos Abatement Manual (2017)*. Alternatively, as the black door caulking was observed in good condition, and with a priority rating of 5 (please see the room by room spreadsheet provided in Appendix C for a description of the priority ratings), it can be managed in place if not scheduled for impact.
