November 23, 2017

CITY OF SASKATOON

Asbestos-Containing Building Materials Assessment Report - Silverwood Golf Course Pump House

Report Number: 1667963

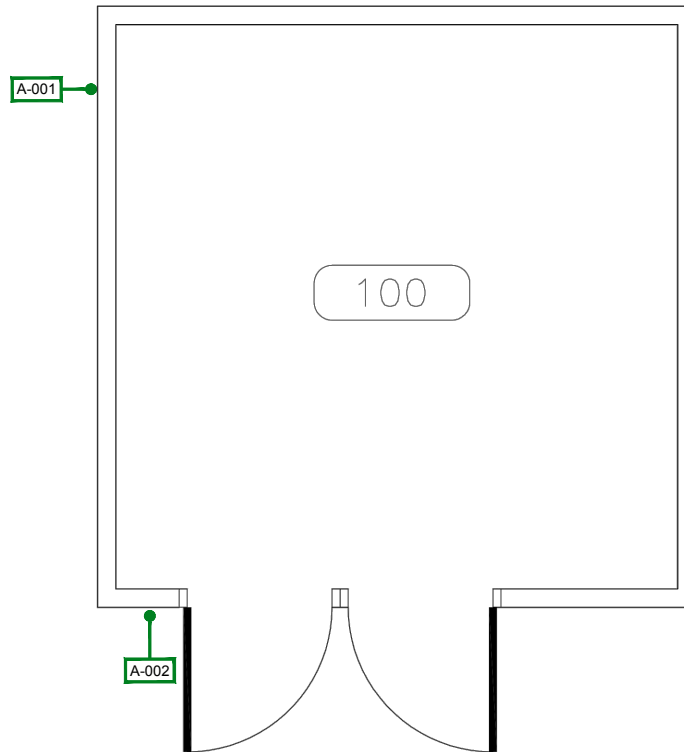
TITLE
PUMP HOUSE

1. ASBESTOS IS A CARCINOGEN. DO NOT BREATHE ASBESTOS DUST.
2. ASBESTOS-CONTAINING MATERIALS WERE NOT OBSERVED WITHIN THE BUILDING AT THE TIME OF THE ASSESSMENT.
