November 28, 2017

CITY OF SASKATOON

Asbestos-Containing Building Materials Assessment Report - Supernatant Pump Station (North 40 Sludge)

Report Number: 1667963

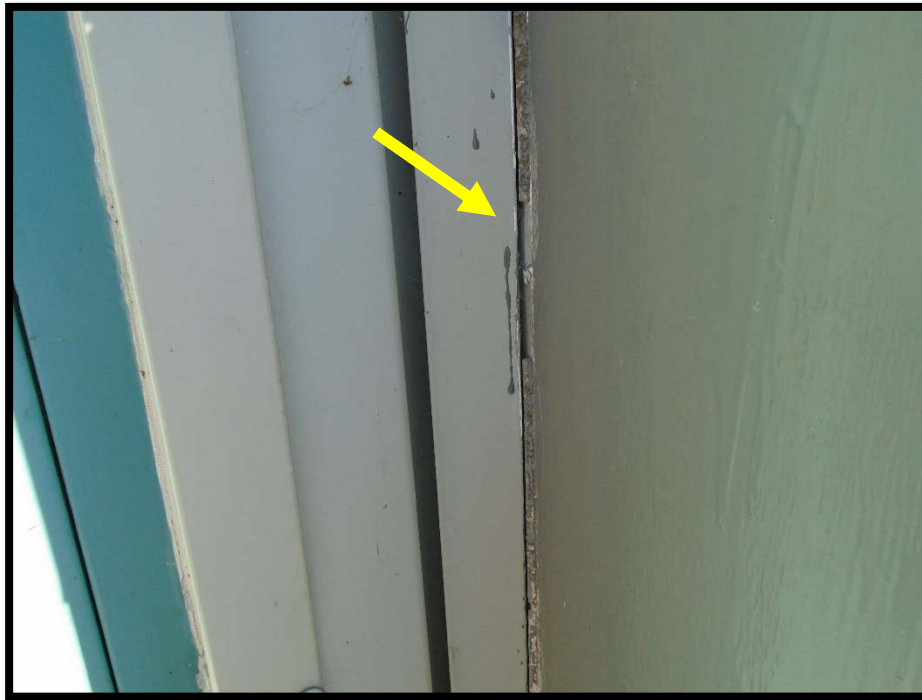
One (1) sample of grey caulking was collected during the assessment. The sample collected was found to contain 0.25% Chrysotile asbestos. Asbestos-containing grey caulking (see Photograph 1 in Appendix B) was observed in the following locations:

- Exterior (30 linear ft.)

Lab No.: 6371153 **Analyst Observation:** White/Grey Caulk **Location:** Exterior
Client No.: A-021 **Client Description:** Grey Door Frame Caulking **Facility:**
Percent Asbestos: Percent Non-Asbestos Fibrous Material: Percent Non-Fibrous Material:
PC 0.25 Chrysotile None Detected 99.75

Photograph 1: Asbestos-Containing Grey Caulking

If scheduled for impact, asbestos-containing exterior grey caulking should be abated following low-risk abatement work procedures as outlined in the *Saskatchewan Asbestos Abatement Manual (2017)*. Alternatively, as the caulking was observed in good condition, and with a priority rating of 5 (please see the room by room spreadsheet provided in Appendix C for a description of the priority ratings), the caulking can be managed in place if not scheduled for impact.
