**Sutherland Hall
Asbestos Survey Report**

February 2014

Prepared For: City Of Saskatoon- Infrastructure Services Department
1101 Avenue P North, Saskatoon, SK.
Attn: Brent Anderson

Prepared By: Bersch & Associates Ltd.
Project No. : B67SRB04

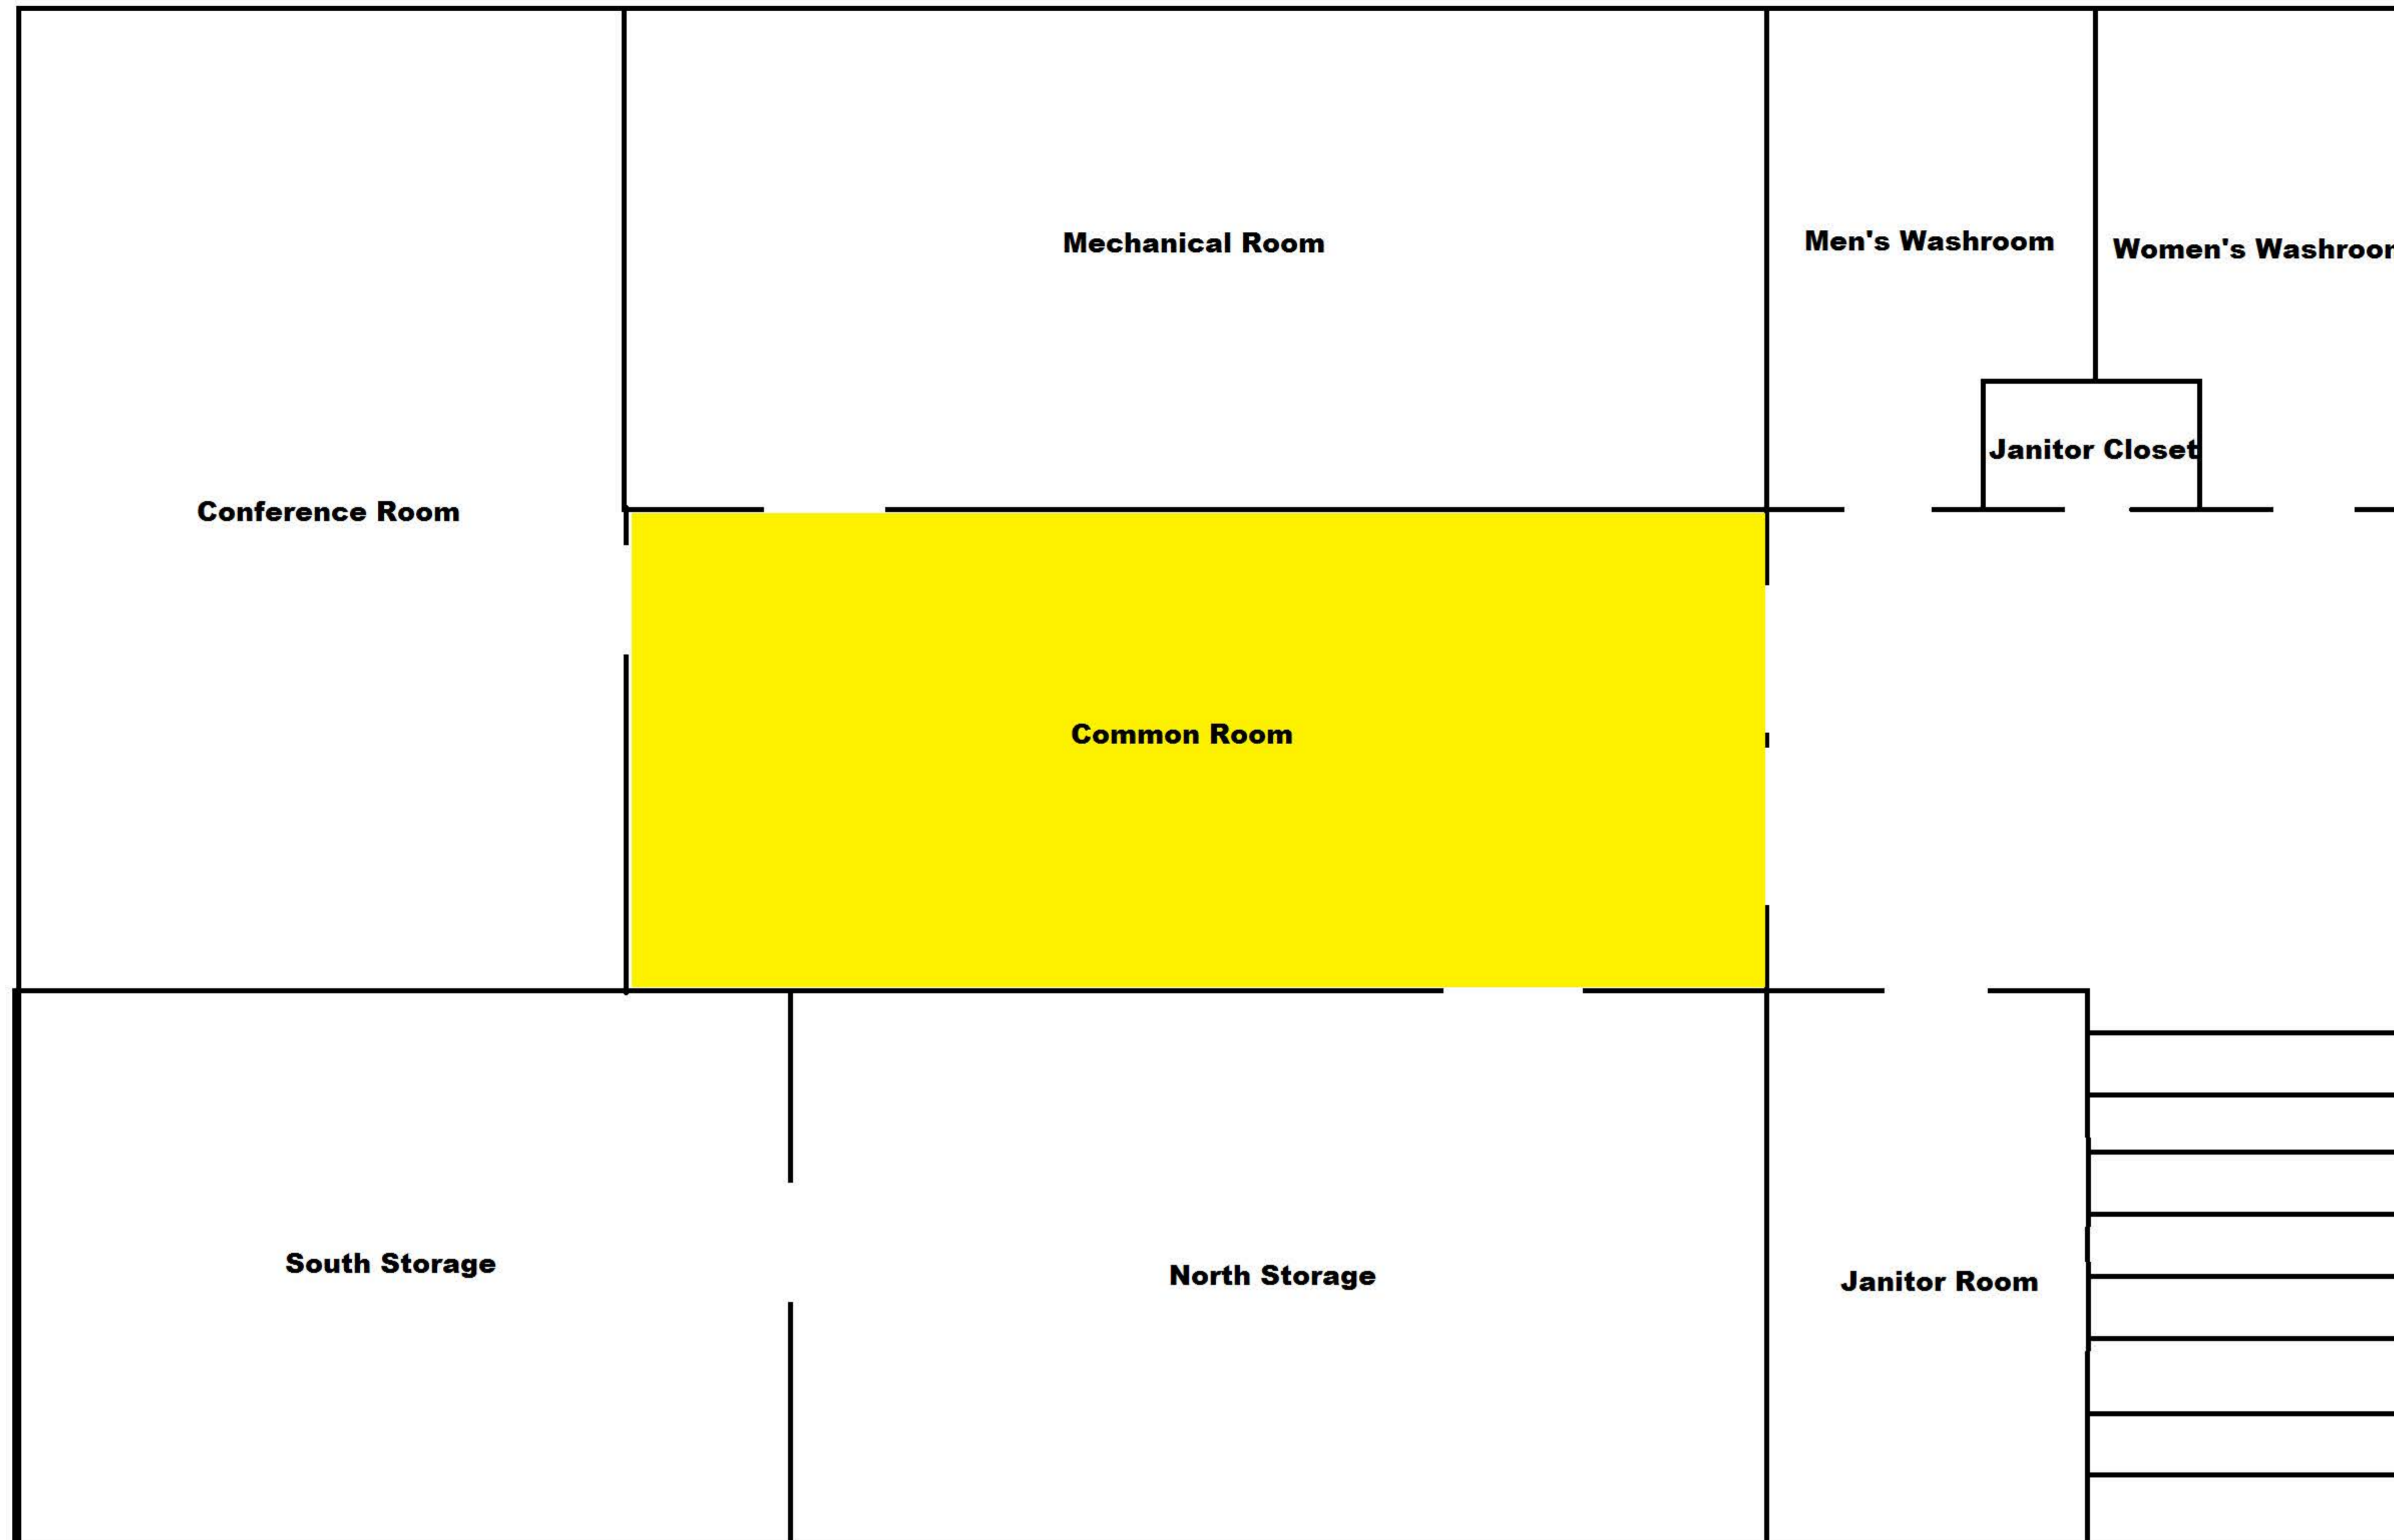
Sutherland Hall - Basement

- **Asbestos Mud Compound** is located on ducting in the Mechanical Room and Storage Rooms within the basement.
- **Asbestos Floor Tile** is located in the basement common room.
- **Heat Shield Material** is found within six light fixtures stored in the basement North Storage Room.

Vinyl Asbestos Floor Tile
