**TCU PLACE  
ASBESTOS HAZARD ASSESSMENT  
SURVEY REPORT**

**MAY 2007**

**Prepared by: Bersch & Associates Ltd.  
Prepared for: Jim Greenshields – City of Saskatoon  
Project No. B67.07**

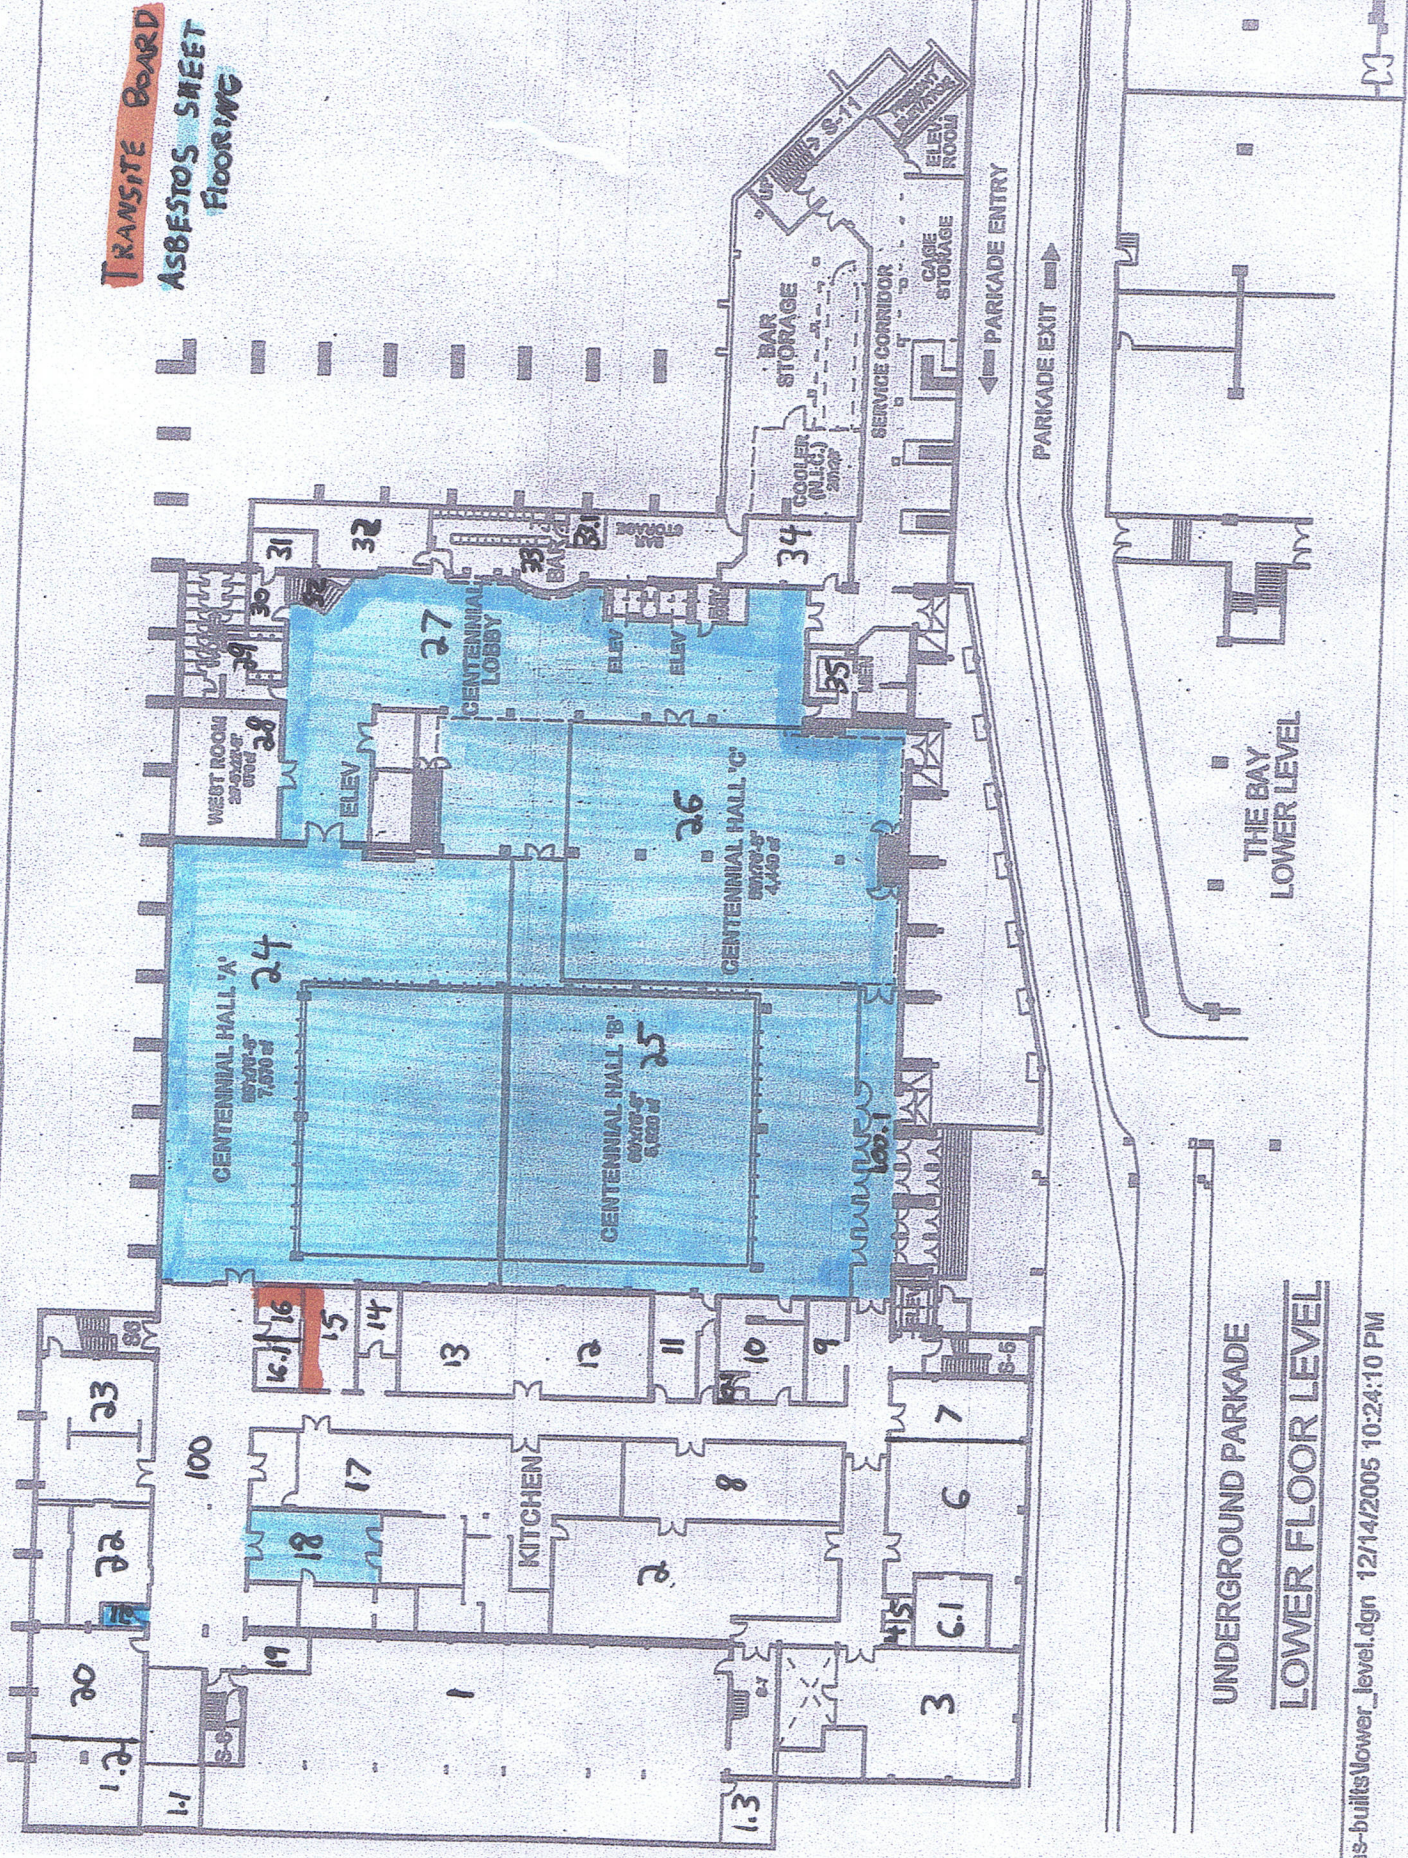
UNDERGROUND PARKADE  
LOWER FLOOR LEVEL

TRANSITE BOARD  
ASBESTOS SHEET  
Flooring

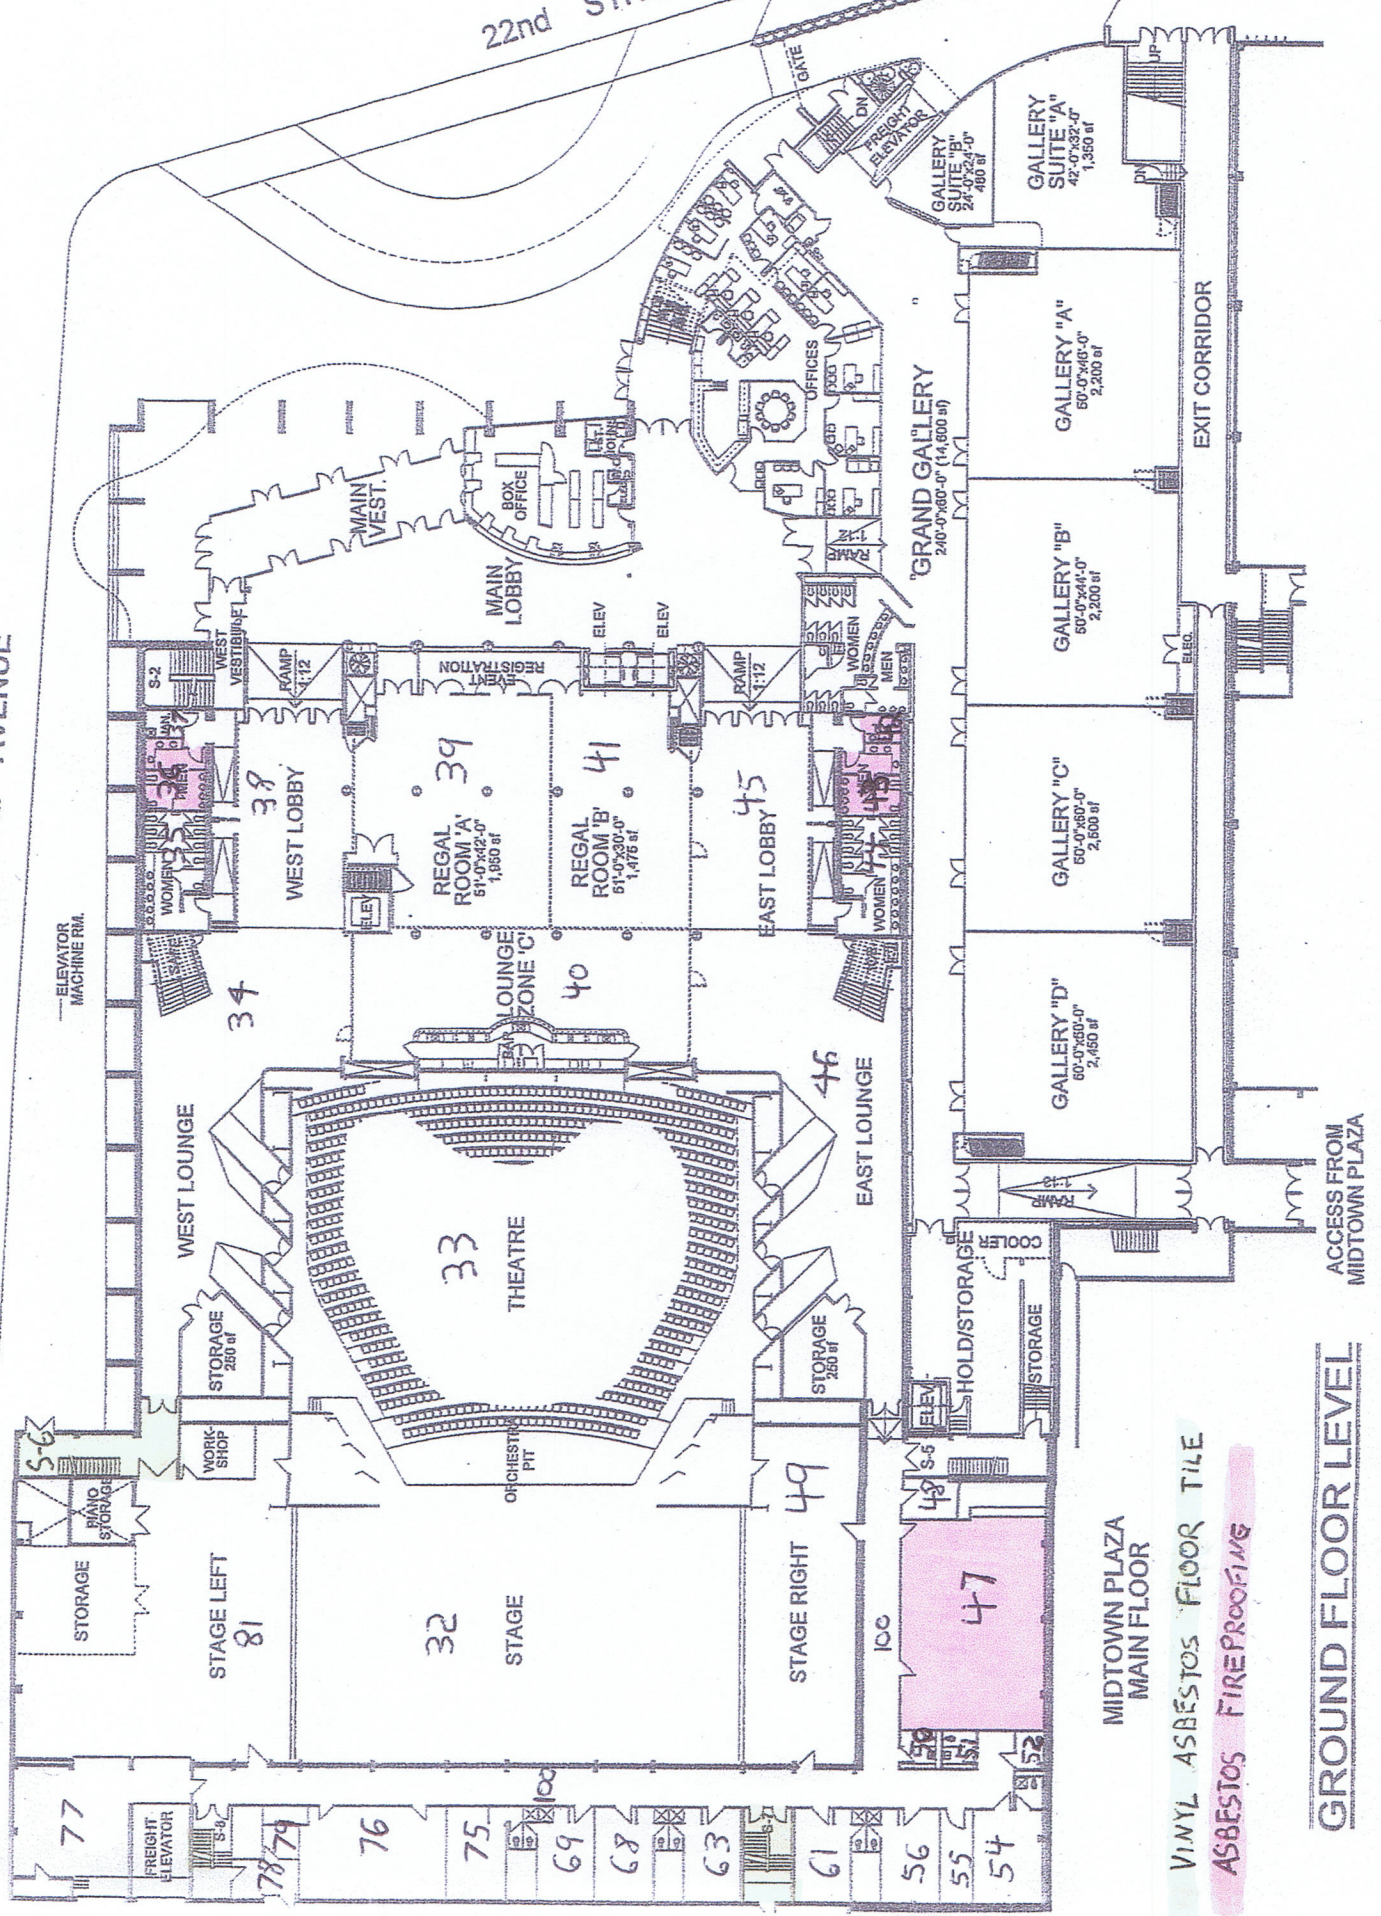
GROUND FLOOR LEVEL

VINYL ASBESTOS FLOOR TILE  
 ASBESTOS FIREPROOFING

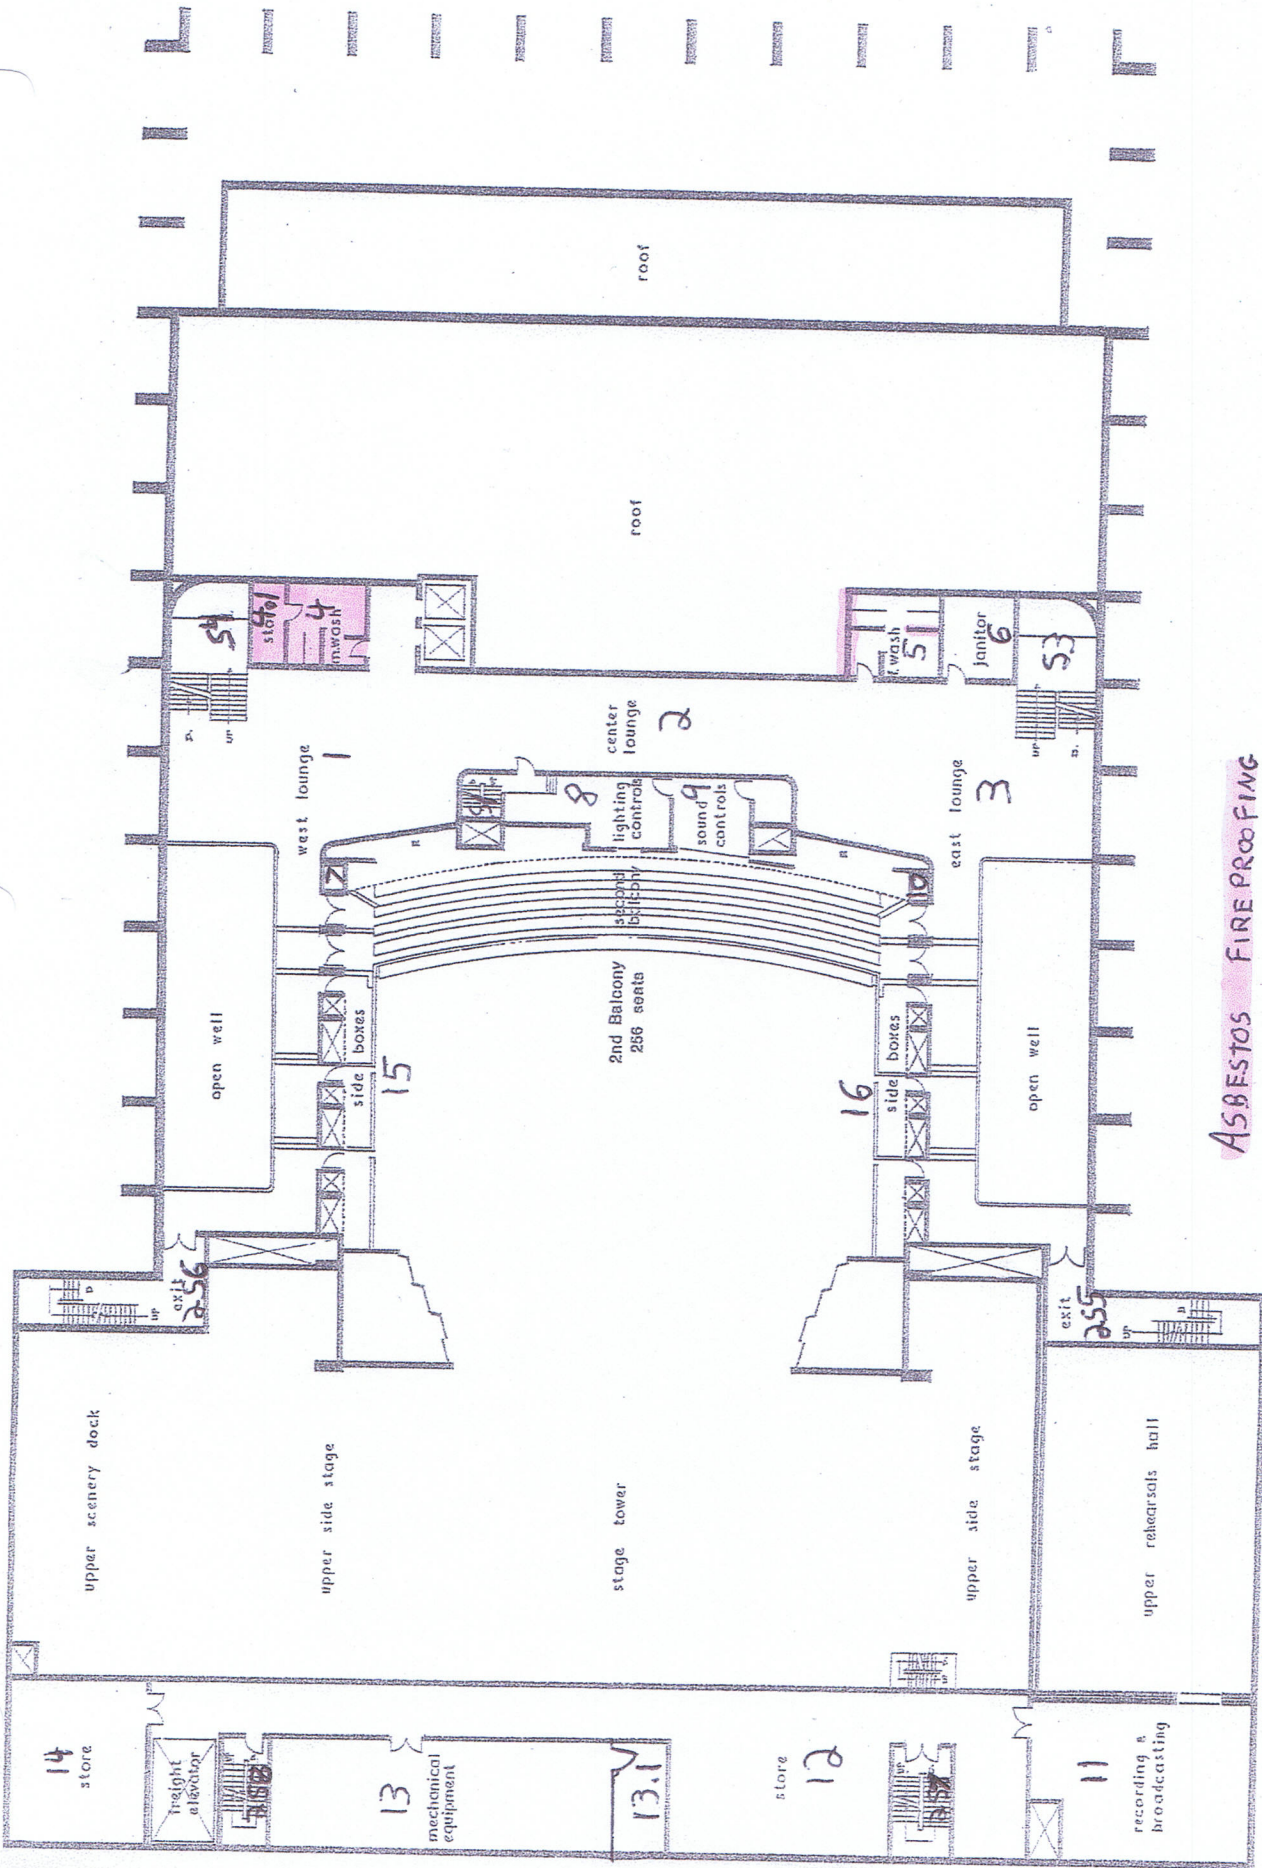
# SASKATOON CENTENNIAL AUDITORIUM SECOND FLOOR PLAN

ASBESTOS FIRE PROOFING

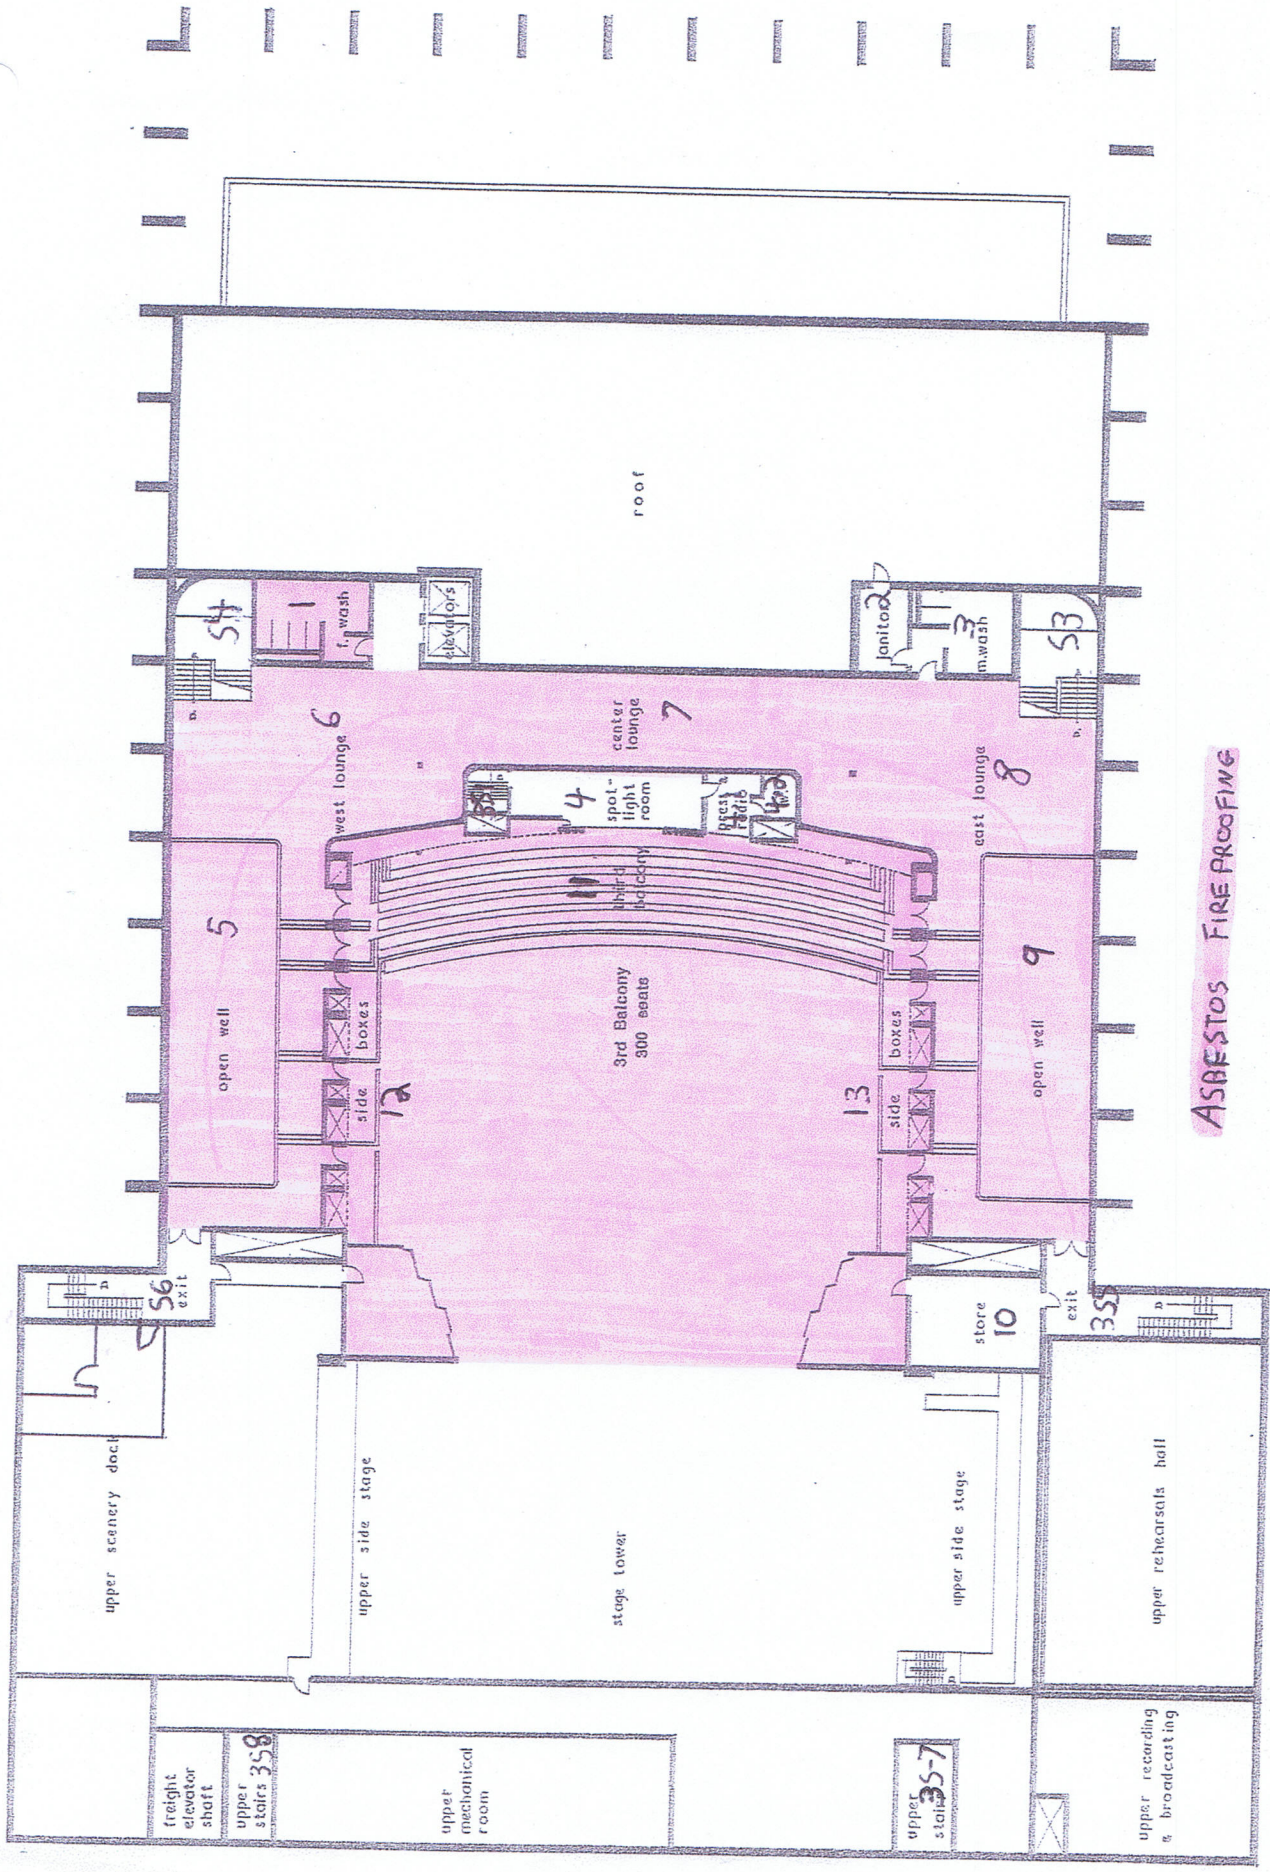
# SASKATOON CENTENNIAL AUDITORIUM THIRD FLOOR PLAN

ASBESTOS FIRE PROOFING

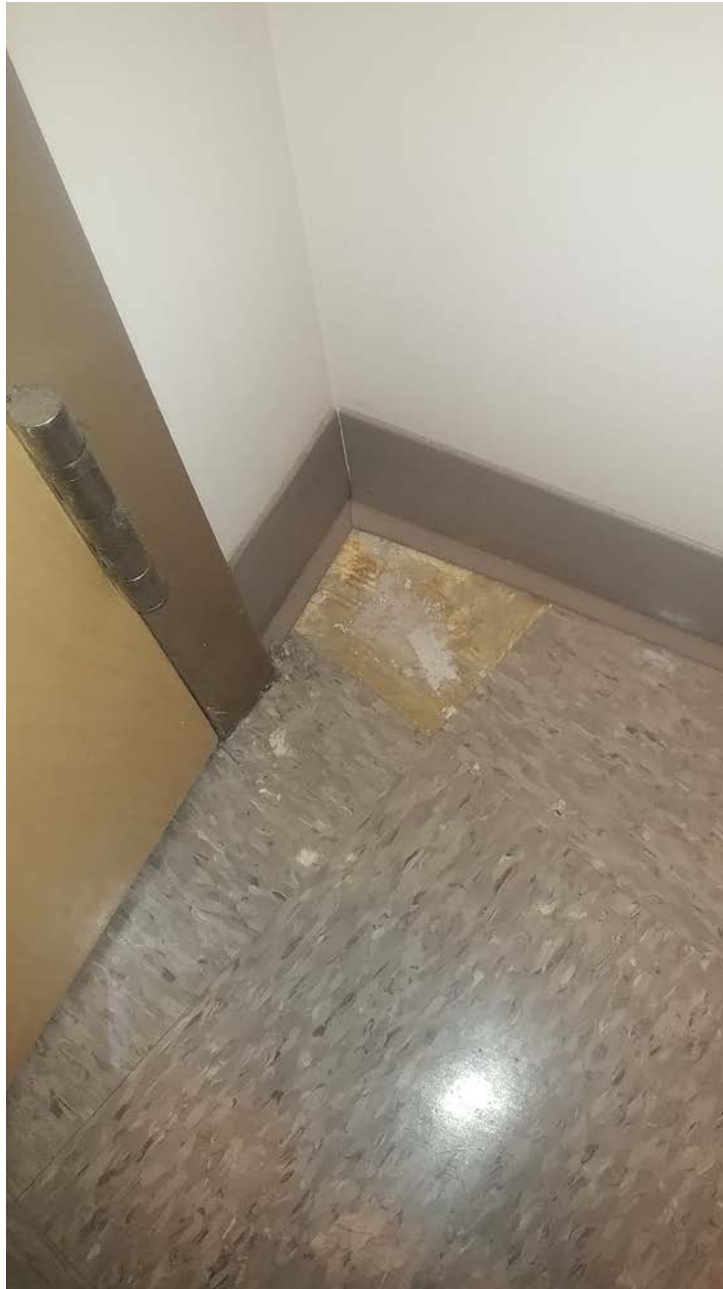
**PHOTO 1 – Electrical Room Floor- Floor Tile Removed**

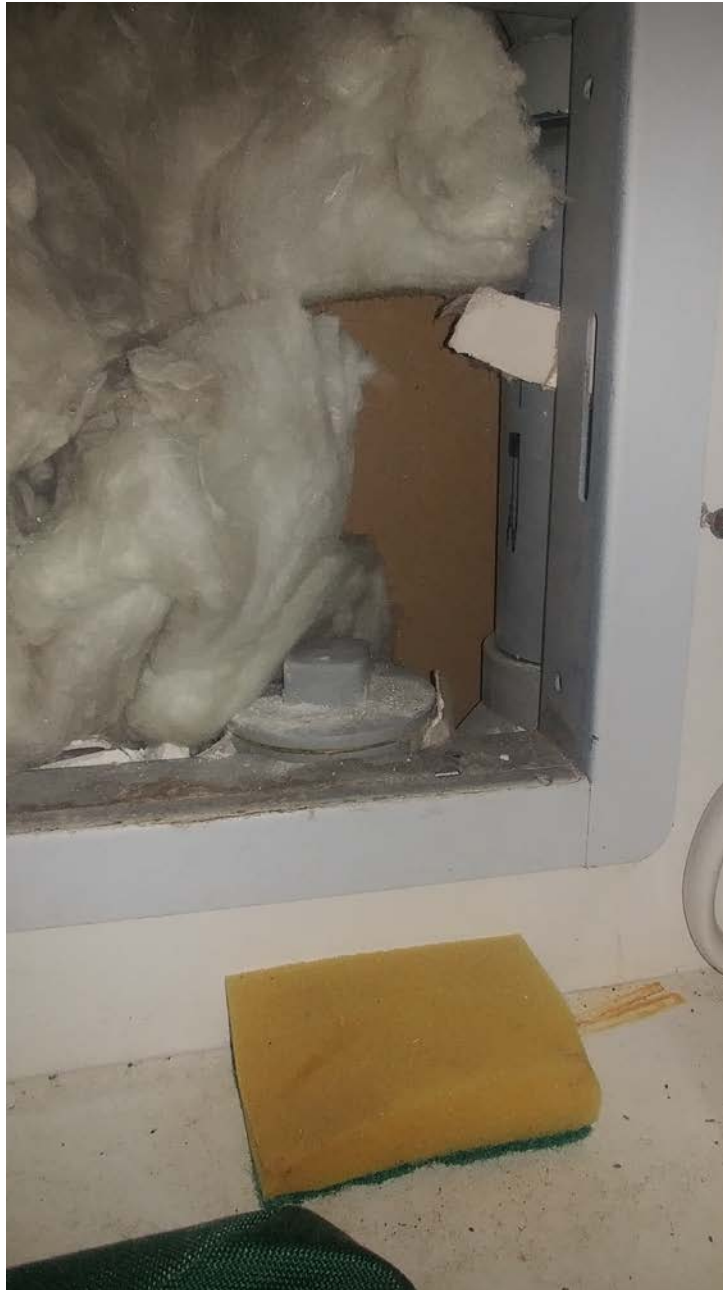
**PHOTO 2 – Box Office Washroom- Wall Access Showing Fiberglass Insulation**

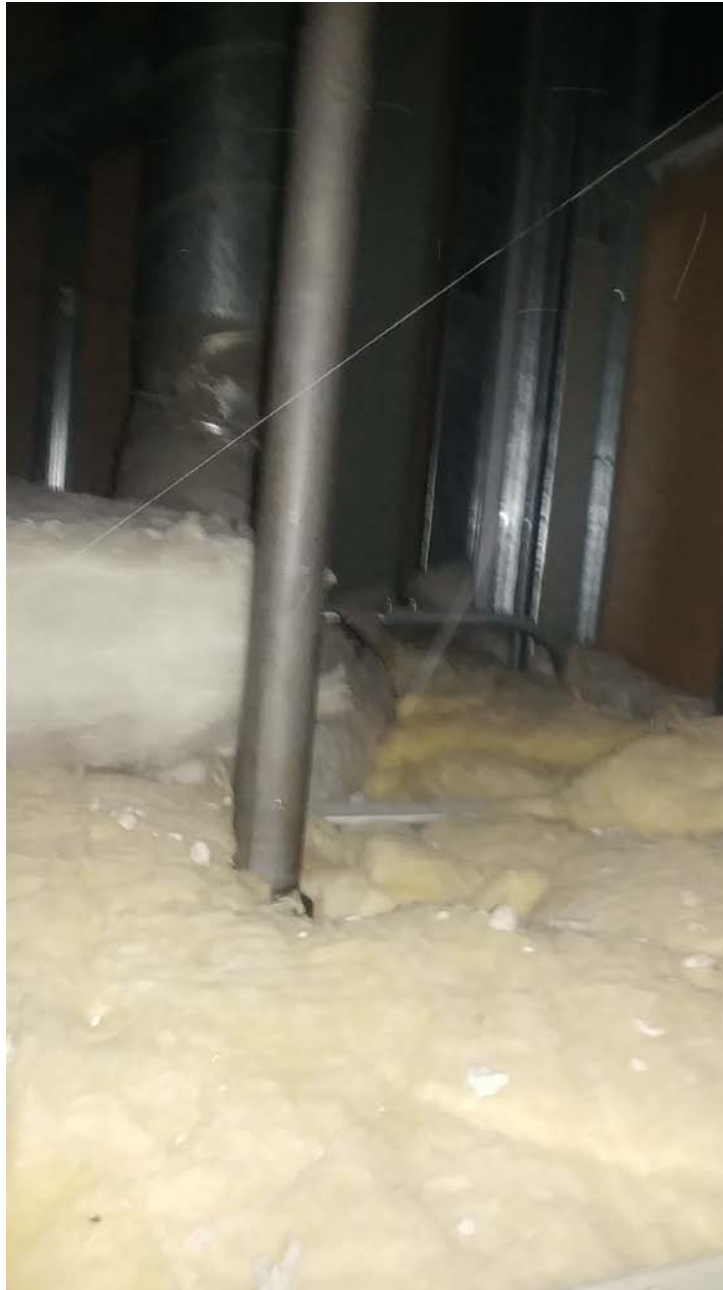
**PHOTO 3 – Box Office Washroom Ceiling Space- Fiberglass Insulation**

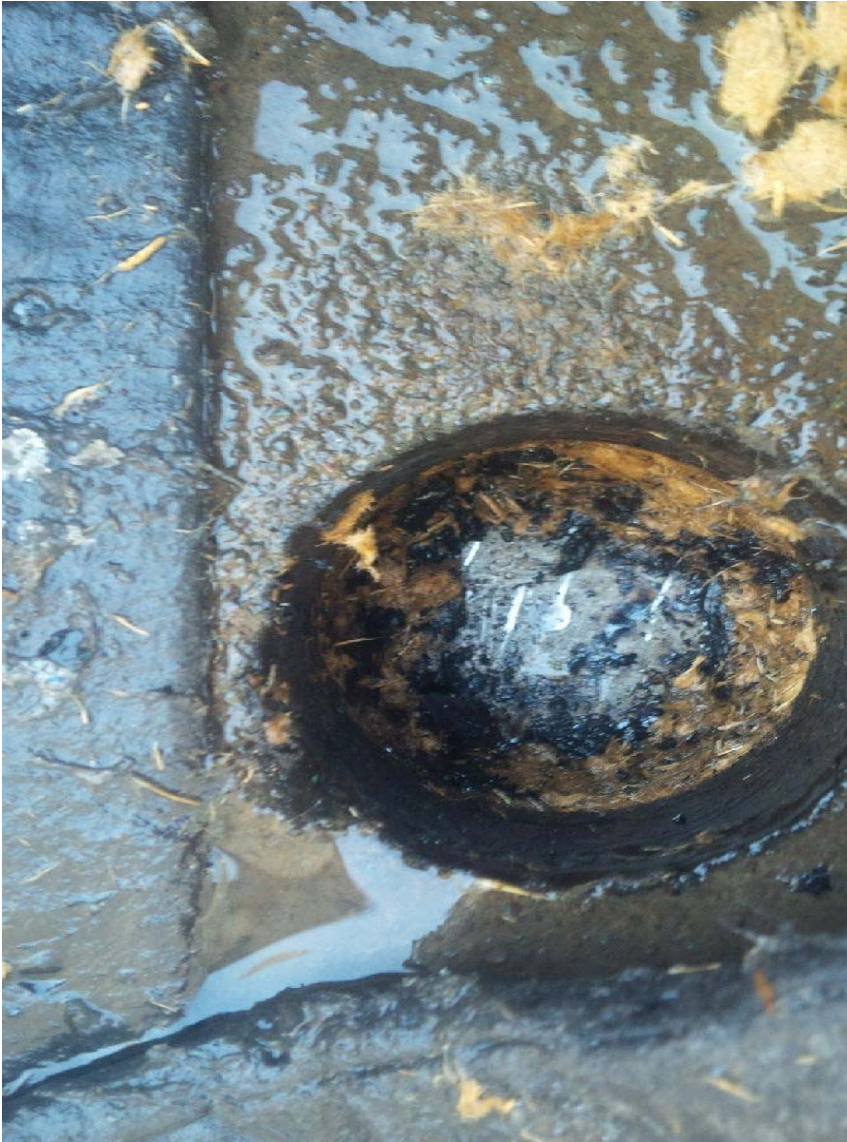
**Looking Downward At The Roof Surface – Cored Thru To Metal Decking**

Top layer of asphalt roof membrane, tar layer, fibre board and metal decking.
