**Trades Offices
Asbestos Survey Report**

January 2014

Prepared For: City Of Saskatoon- Infrastructure Services Department
1101 Avenue P North, Saskatoon, SK.
Attn: Brent Anderson

Prepared By: Bersch & Associates Ltd.
Project No. : B67SRD30

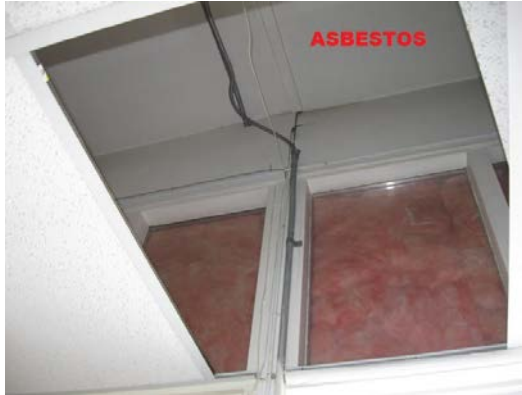
- **Transite Board** is located above the windows and on the ceiling above the suspended ceiling of various rooms on the ground floor.
- **Heat Shield Material** is located within the incandescent light fixture within 101 Main Entry.

#1) Transite Board

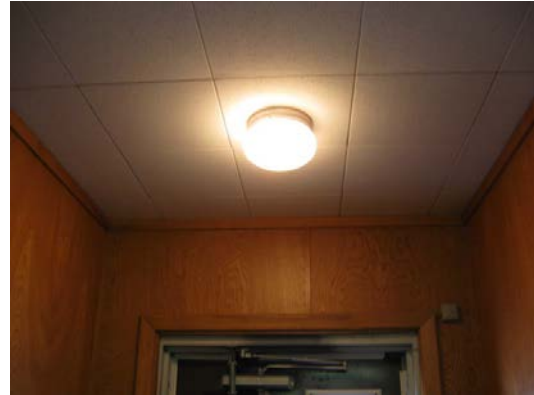
#7) Heat Shield in Light Fixture

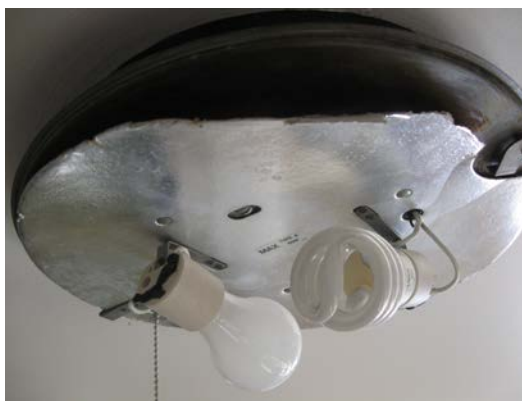
#7) Heat Shield in Light Fixture

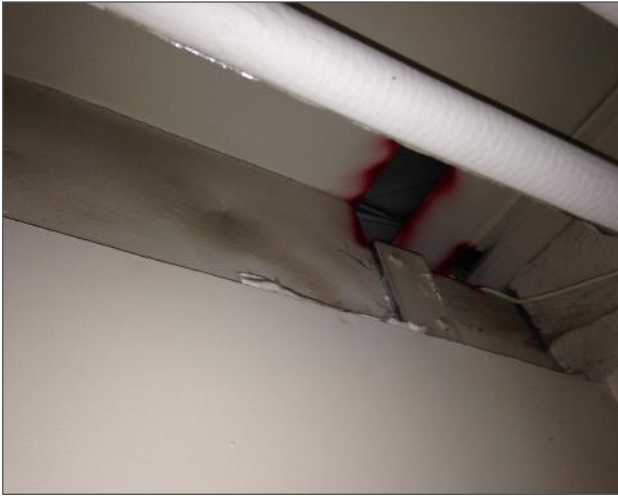
Photo 1 - Non-Asbestos containing fibreglass piping insulation on piping above acoustic ceiling tiles in hallway location 117.

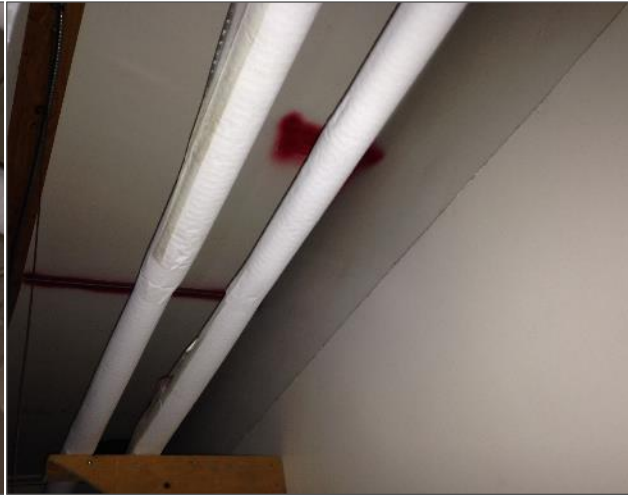
Photo 2 - Non-Asbestos containing fibreglass piping insulation on piping above acoustic ceiling tiles in hallway location 117.

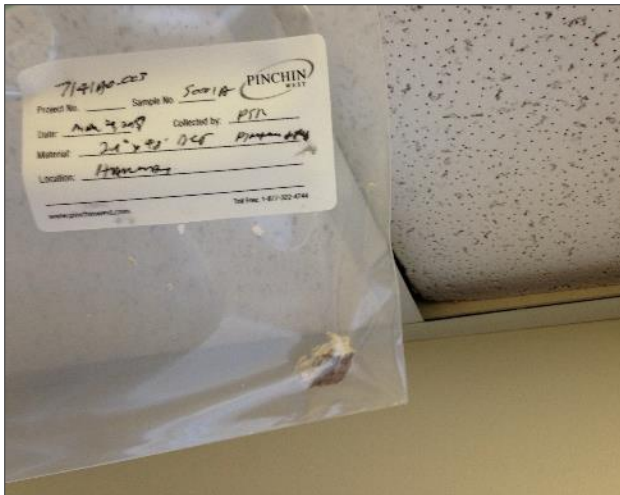
Photo 4: Acoustic Ceiling Tile, 24"x48" Pinhole and Fissure (Sample S0001A-C) Hallway Location (117).

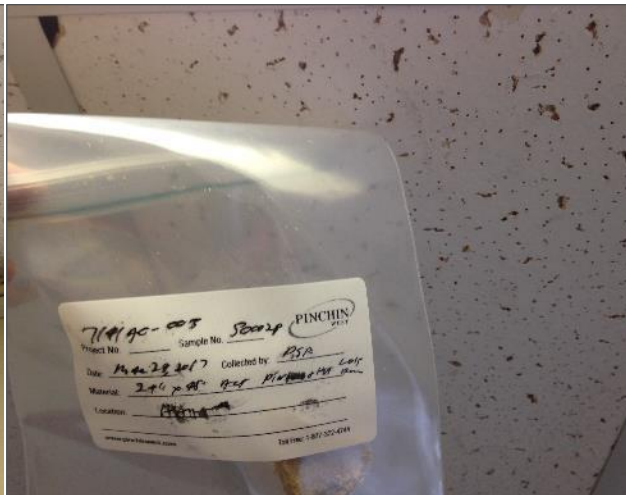
Photo 5: Acoustic Ceiling Tile, 24"x48" Pinhole and Fissure "Pattern less dense" (Sample S0002A-C) Hallway Location (117).

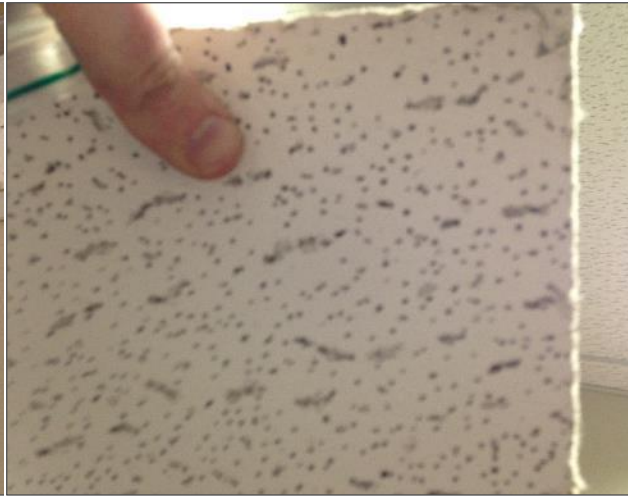
Photo 7: Acoustic Ceiling Tile, 24"x48" Pinhole and Fissure, Date Stamp 05/13/13, Office Location (119).

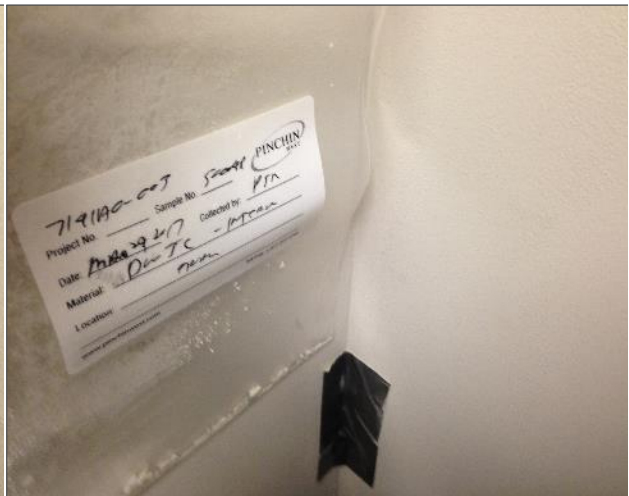
Photo 9 - Drywall Joint Compound on interior walls (Sample S0004A-C) Office Location 119

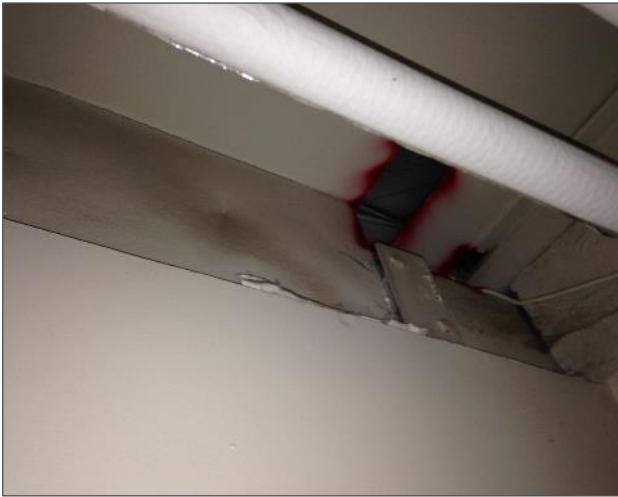
Transite board, containing Chrysotile asbestos, is present in the assessed area. The transite board is known to contain asbestos based on sampling conducted in the report from Bersch & Associates Ltd titled "Trades Offices Asbestos Survey Report" dated January 2014.

Photo 10 Asbestos-containing Transite panels above drywall along north exterior wall and across the ceiling. Non-asbestos containing fiberglass pipe insulation.

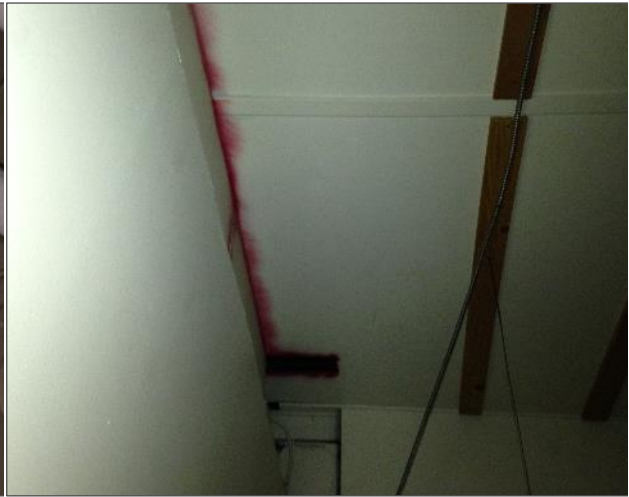
Photo 11 Asbestos-containing Transite panels across the ceiling.

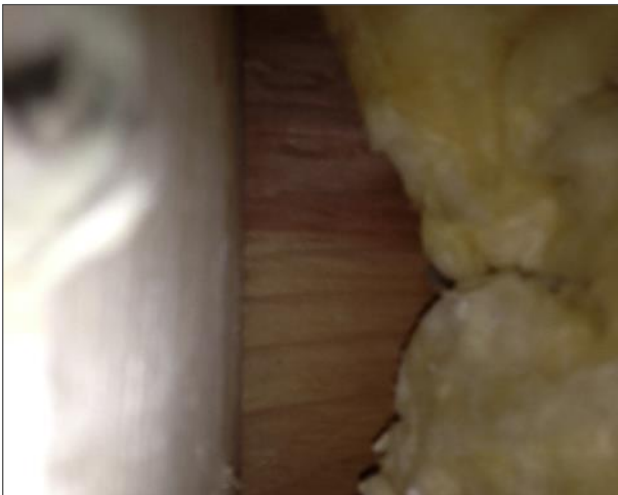
Photo 12 Intrusive hole through north exterior drywall wall (Below the transite board shown in Photo 10), fiberglass insulation, plywood exterior sheathed with metal siding.

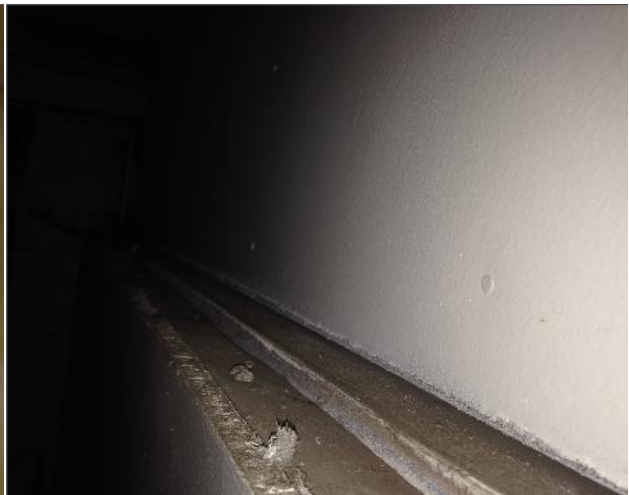
Photo 13 Asbestos-containing Transite panels along the top of the north exterior wall transition to drywall below.
