February 5, 2018

CITY OF SASKATOON

# Asbestos-Containing Building Materials Assessment Report - Trailer 702

**Report Number: 1667963**

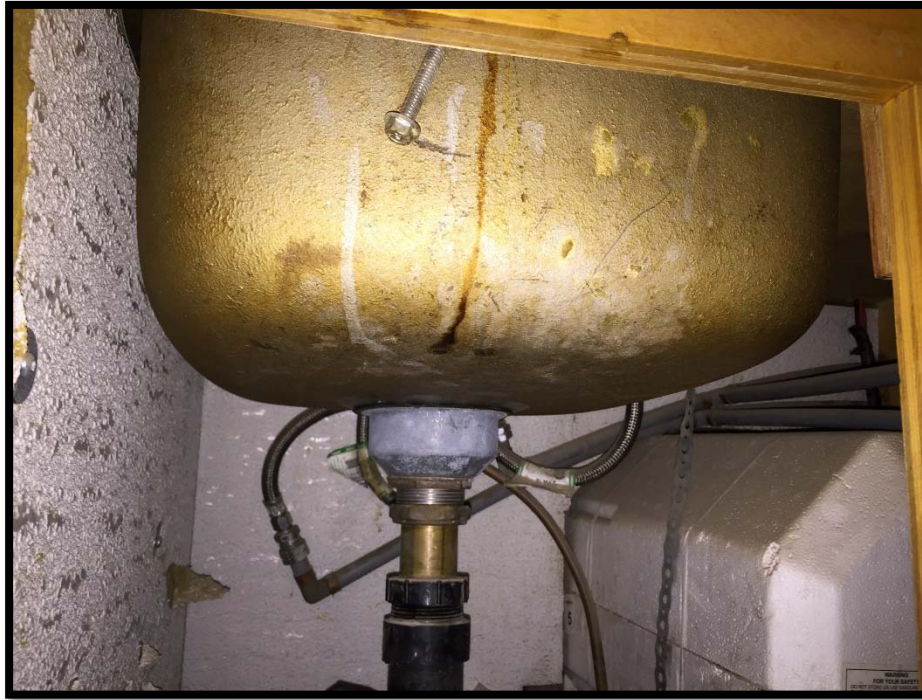
One (1) sample of gold sink undercoat was collected during the assessment. The sample collected was found to contain 2.2% Chrysotile asbestos. Asbestos-containing gold sink undercoat (see Photograph 1 in Appendix B) was observed in the following location:

- Room 100 (approximately 1 sink).

**Photograph 1: Asbestos-Containing Gold Sink Undercoat.**

If scheduled for impact, sinks with asbestos-containing gold undercoat should be abated following low-risk abatement work procedures as outlined in the *Saskatchewan Asbestos Abatement Manual (2017)*. Alternatively, as the gold sink undercoat was observed in good condition, and with a priority rating of 5 (please see the room by room spreadsheet provided in Appendix C for a description of the priority ratings), it can be managed in place if not scheduled for impact.

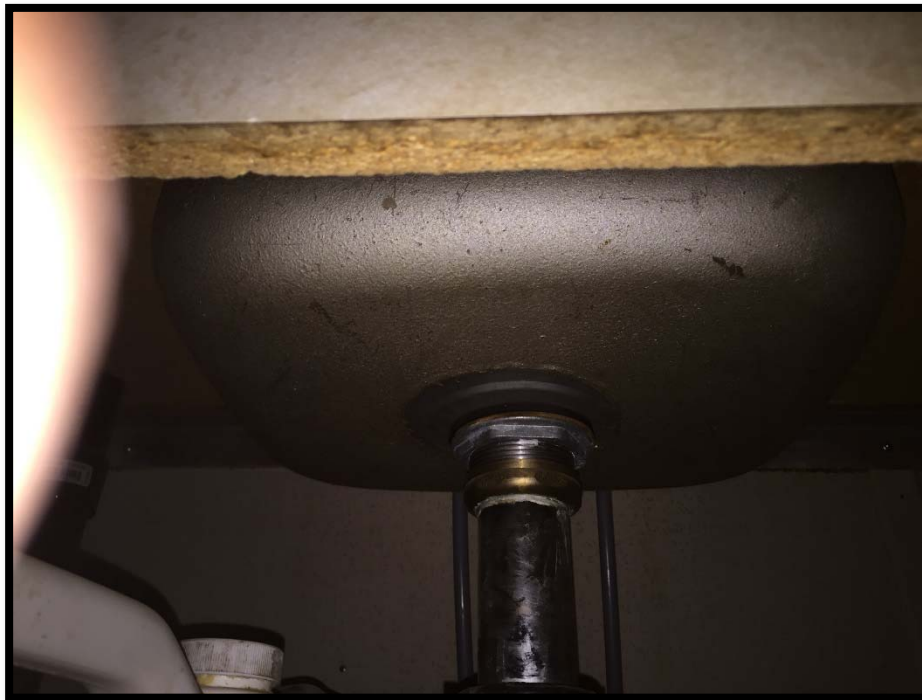
One (1) sample of silver sink undercoat was collected during the assessment. The sample collected was found to contain 2.1% Chrysotile asbestos. Asbestos-containing silver sink undercoat (see Photograph 2 in Appendix B) was observed in the following location:

- Room 101 (approximately 1 sink).

**Photograph 2: Asbestos-Containing Silver Sink Undercoat.**

If scheduled for impact, sinks with asbestos-containing silver undercoat should be abated following low-risk abatement work procedures as outlined in the *Saskatchewan Asbestos Abatement Manual (2017)*. Alternatively, as the silver sink undercoat was observed in good condition, and with a priority rating of 5 (please see the room by room spreadsheet provided in Appendix C for a description of the priority ratings), it can be managed in place if not scheduled for impact.

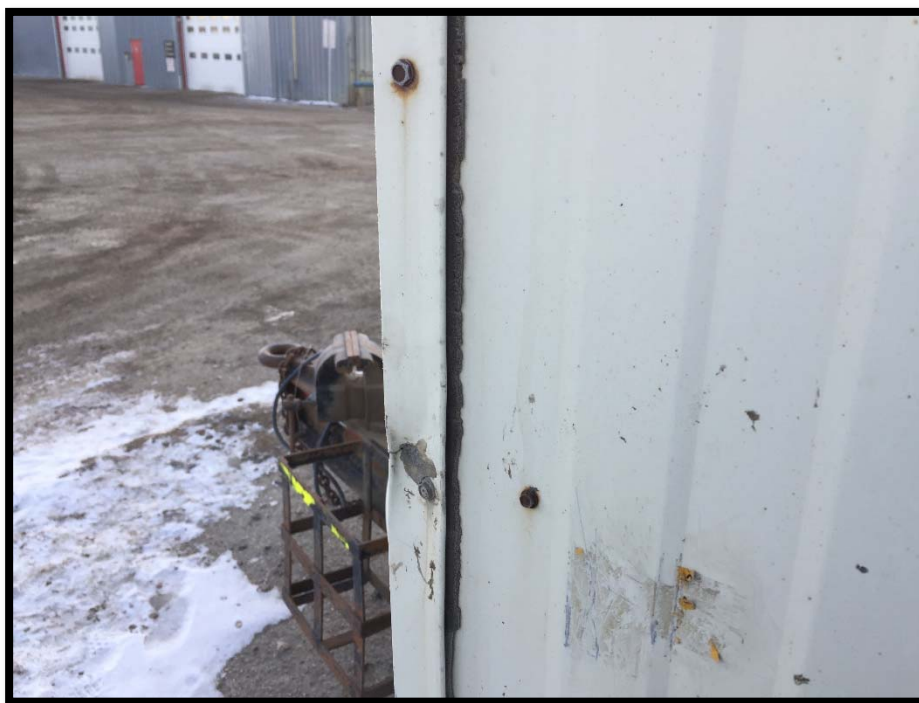
Two (2) samples of black building caulking were collected during the assessment. One of the samples collected was found to contain 4.4% Chrysotile asbestos. Asbestos-containing black building caulking (see Photograph 3 in Appendix B) was observed in the following location:

- Exterior (approximately 75 linear ft).

**Photograph 3: Asbestos-Containing Black Building Caulking.**

If scheduled for impact, asbestos-containing black building caulking should be abated following low-risk abatement work procedures as outlined in the *Saskatchewan Asbestos Abatement Manual (2017)*. Alternatively, as the black building caulking was observed in good condition, and with a priority rating of 5 (please see the room by room spreadsheet provided in Appendix C for a description of the priority ratings), it can be managed in place if not scheduled for impact.
