February 5, 2018

CITY OF SASKATOON

# Asbestos-Containing Building Materials Assessment Report - Trailer 703

**Report Number: 1667963**

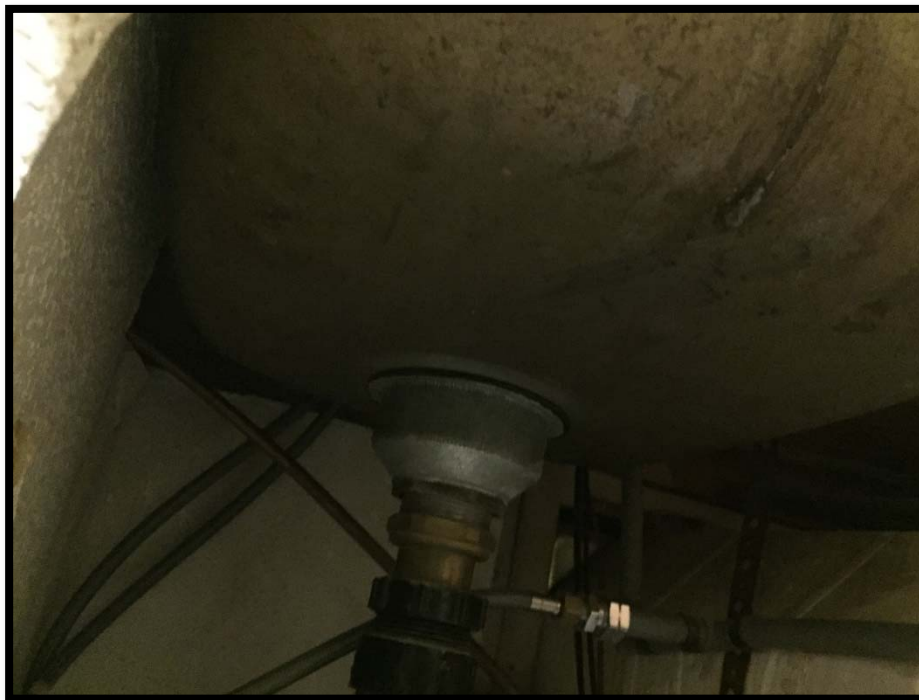
One (1) sample of silver sink undercoat was collected during the assessment. The sample collected was found to contain 2.5% Chrysotile asbestos. Asbestos-containing silver sink undercoat (see Photograph 1 in Appendix B) was observed in the following location:

- Room 100 (approximately 1 sink).

**Photograph 1: Asbestos-Containing Silver Sink Undercoat.**

If scheduled for impact, sinks with asbestos-containing silver undercoat should be abated following low-risk abatement work procedures as outlined in the *Saskatchewan Asbestos Abatement Manual* (2017). Alternatively, as the silver sink undercoat was observed in good condition, and with a priority rating of 5 (please see the room by room spreadsheet provided in Appendix C for a description of the priority ratings), it can be managed in place if not scheduled for impact.

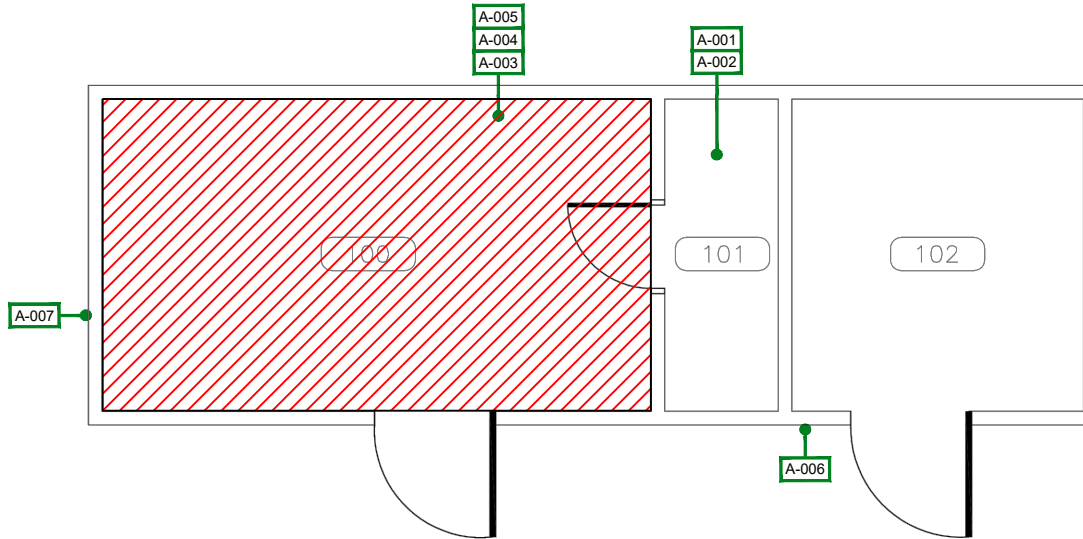
FIGURE  
1

- ASBESTOS SAMPLE LOCATION
- ASBESTOS - CONTAINING SINK UNDERCOAT
