CITY OF SASKATOON

Asbestos-Containing Building Materials Assessment Report - Trailer 704

Report Number: 1667963

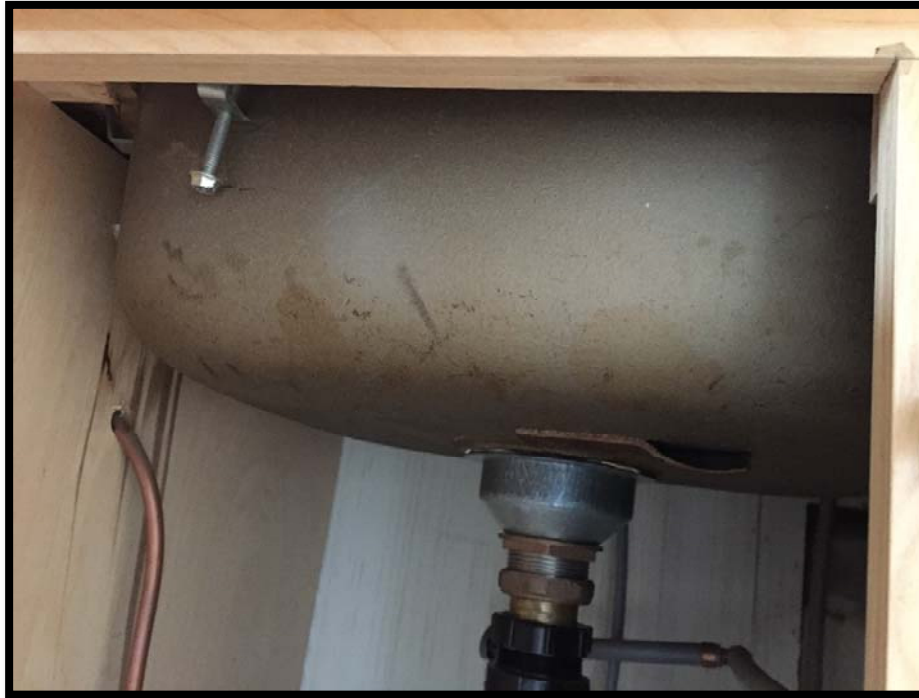
One (1) sample of gold sink undercoat was collected during the assessment. The sample collected was found to contain 3.7% Chrysotile asbestos. Asbestos-containing gold sink undercoat (see Photograph 1 in Appendix B) was observed in the following location:

- Room 100 (approximately 1 sink).

Photograph 1: Asbestos-Containing Gold Sink Undercoat.

| Included/Excluded | Floor | Room # | Area Description | Elements | Subelements | Material Description | Accessibility | Suspect? | Sampled? | Asbestos Containing Material? | Condition | Field Notes | Sample Type | Sample ID | Sample Date | Asbestos Type | ACM Product | % of asbestos | Friable | Sprayed-on | Maintenance | Inspection | Priority | Potential for Disturbance | Recommended Action | Quantity | Photograph ID | Labelling Type |
|---|---|---|---|---|---|---|---|---|---|---|---|---|---|---|---|---|---|---|---|---|---|---|---|---|---|---|---|---|
| Included | M | 100 | Lunch Room | Plumbing | Sink | Gold Sink Undercoat | High | Yes | Yes | Yes | Good | | Bulk | A-002 | 15-Jan-18 | Chrysotile | Sink Undercoat | 3.7% | No | No | No | Annually | 5 | Moderate | Manage in place. | 1 Sink | Photograph 1 | Door Jamb |

If scheduled for impact, sinks with asbestos-containing gold undercoat should be abated following low-risk abatement work procedures as outlined in the *Saskatchewan Asbestos Abatement Manual* (2017). Alternatively, as the gold sink undercoat was observed in good condition, and with a priority rating of 5 (please see the room by room spreadsheet provided in Appendix C for a description of the priority ratings), it can be managed in place if not scheduled for impact.

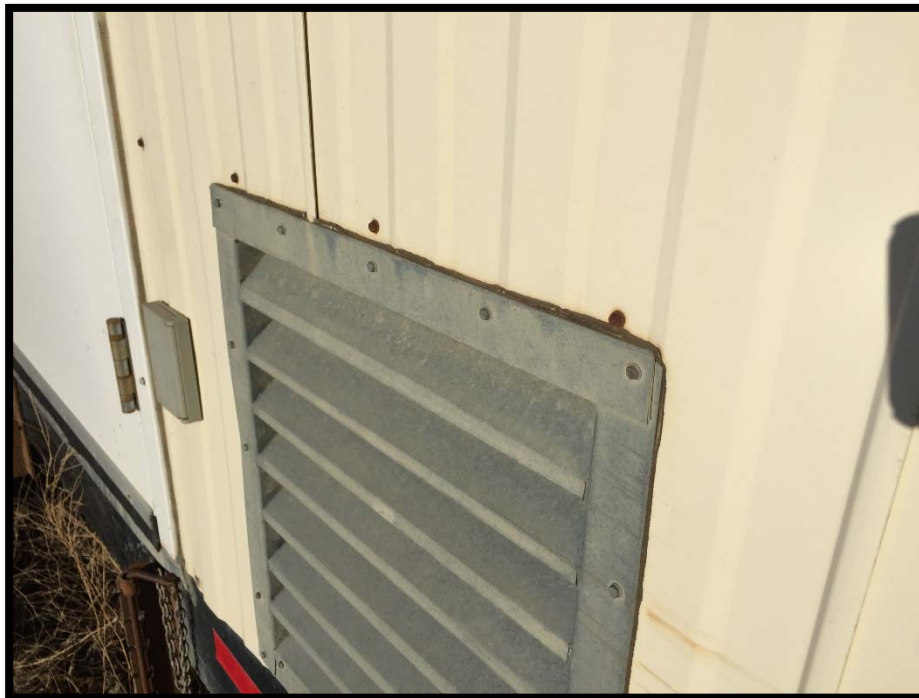
One (1) sample of black building caulking was collected during the assessment. The sample collected was found to contain 4.4% Chrysotile asbestos. Asbestos-containing black building caulking (see Photograph 2 in Appendix B) was observed in the following location:

- Exterior (approximately 65 linear feet).

Photograph 2: Asbestos-containing Black Building Caulking.

| Included/Excluded | Floor | Room # | Area Description | Elements | Subelements | Material Description | Accessibility | Suspect? | Sampled? | Asbestos Containing Material? | Condition | Field Notes | Sample Type | Sample ID | Sample Date | Asbestos Type | ACM Product | % of asbestos | Friable | Sprayed-on | Maintenance | Inspection | Priority | Potential for Disturbance | Recommended Action | Quantity | Photograph ID | Labelling Type |
|---|---|---|---|---|---|---|---|---|---|---|---|---|---|---|---|---|---|---|---|---|---|---|---|---|---|---|---|---|
| Included | E | Exterior | Exterior | Walls | Caulking | Black Building Caulking | High | No | Yes | No | Good | | Bulk | A-003 | 15-Jan-18 | Chrysotile | Caulking | 4.4% | No | No | No | Annually | 5 | Moderate | Manage in place. | 65 Feet | Photograph 2 | Door Jamb |

If scheduled for impact, asbestos-containing black building caulking should be abated following low-risk abatement work procedures as outlined in the *Saskatchewan Asbestos Abatement Manual* (2017). Alternatively, as the black building caulking was observed in good condition, and with a priority rating of 5 (please see the room by room spreadsheet provided in Appendix C for a description of the priority ratings), it can be managed in place if not scheduled for impact.
