February 7, 2018

CITY OF SASKATOON

# Asbestos-Containing Building Materials Assessment Report - Trailer 707

**Report Number: 1667963**

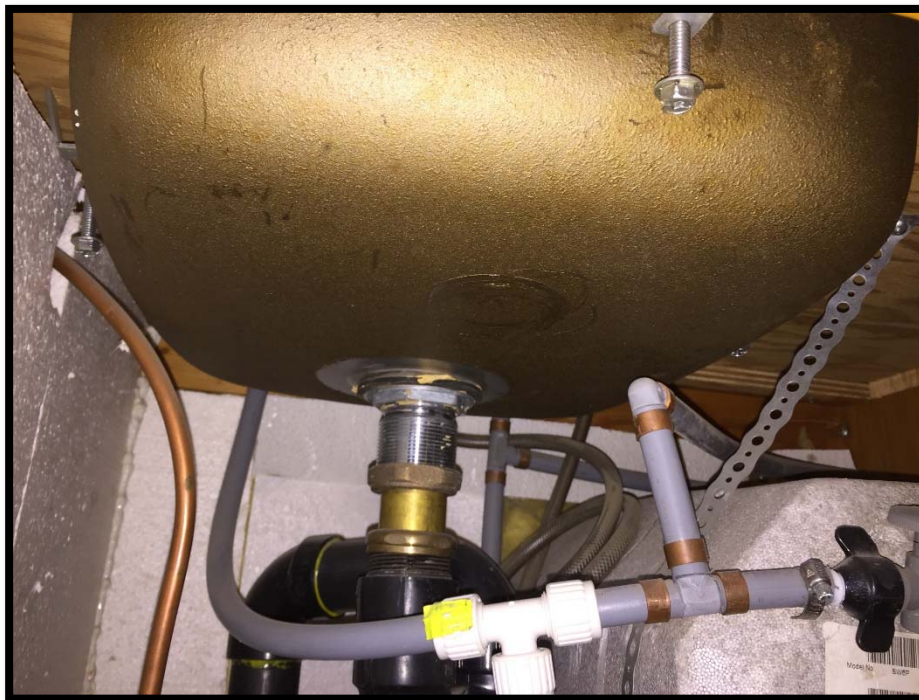
One (1) sample of gold sink undercoat was collected during the assessment. The sample collected was found to contain 2.6% Chrysotile asbestos. Asbestos-containing gold sink undercoat (see Photograph 1 in Appendix B) was observed in the following location:

- Room 100 (approximately 1 sink).

**Photograph 1: Asbestos-Containing Gold Sink Undercoat.**

If scheduled for impact, sinks with asbestos-containing gold undercoat should be abated following low-risk abatement work procedures as outlined in the *Saskatchewan Asbestos Abatement Manual* (2017). Alternatively, as the gold sink undercoat was observed in good condition, and with a priority rating of 5 (please see the room by room spreadsheet provided in Appendix C for a description of the priority ratings), it can be managed in place if not scheduled for impact.

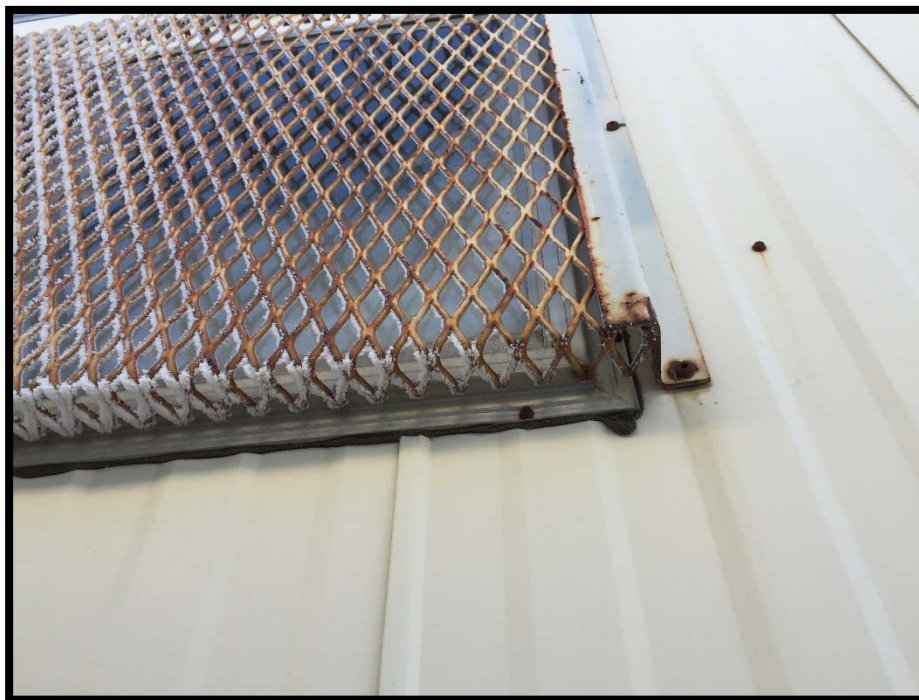
One (1) sample of black building caulking was collected during the assessment. The sample collected was found to contain 4.1% Chrysotile asbestos. Asbestos-containing black building caulking (see Photograph 2 in Appendix B) was observed in the following location:

- Exterior (approximately 50 linear feet).

**Photograph 2: Asbestos-Containing Black Building Caulking.**

If scheduled for impact, asbestos-containing black building caulking should be abated following low-risk abatement work procedures as outlined in the *Saskatchewan Asbestos Abatement Manual* (2017). Alternatively, as the black building caulking was observed in good condition, and with a priority rating of 5 (please see the room by room spreadsheet provided in Appendix C for a description of the priority ratings), it can be managed in place if not scheduled for impact.

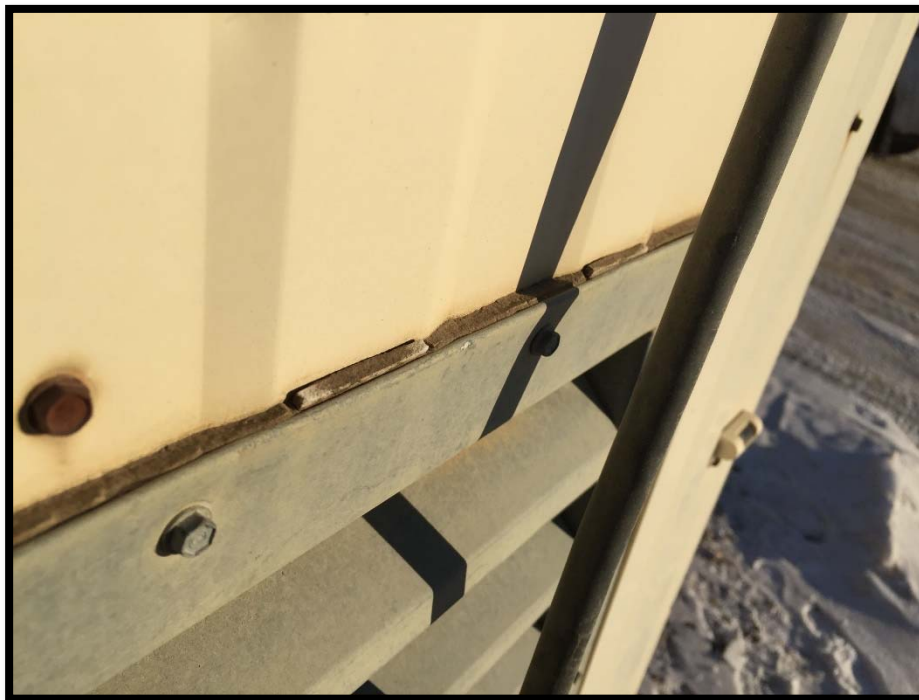
One (1) sample of white building caulking was collected during the assessment. The sample collected was found to contain 4.5% Chrysotile asbestos. Asbestos-containing white building caulking (see Photograph 3 in Appendix B) was observed in the following location:

- Exterior (approximately 50 linear feet).

**Photograph 3: Asbestos-Containing White Building Caulking.**

If scheduled for impact, asbestos-containing white building caulking should be abated following low-risk abatement work procedures as outlined in the *Saskatchewan Asbestos Abatement Manual* (2017). Alternatively, as the white building caulking was observed in good condition, and with a priority rating of 5 (please see the room by room spreadsheet provided in Appendix C for a description of the priority ratings), it can be managed in place if not scheduled for impact.

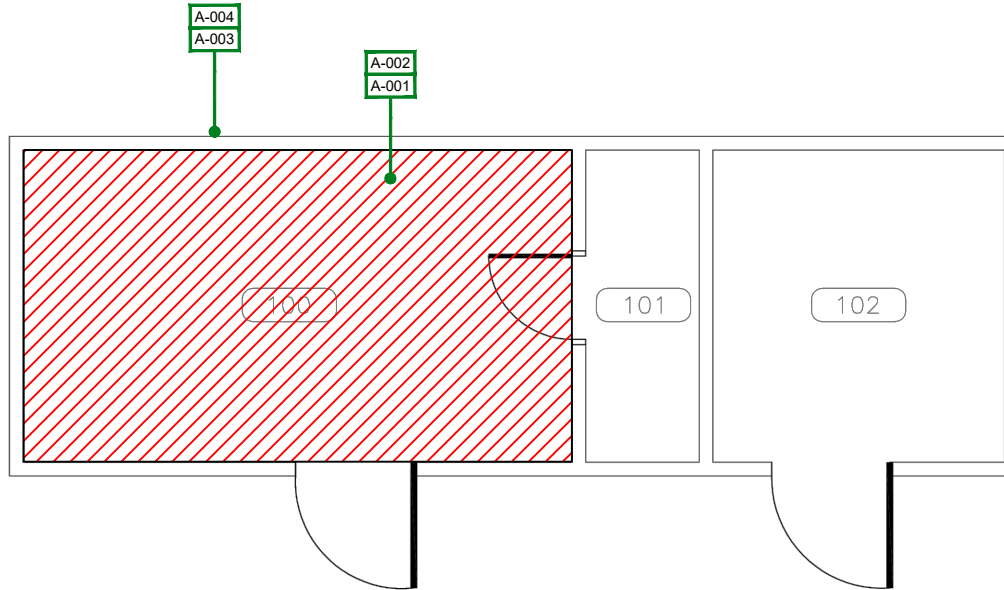
FIGURE  
 1

1. ASBESTOS IS A CARCINOGEN. DO NOT BREATHE ASBESTOS DUST.
2. ASBESTOS-CONTAINING BLACK AND WHITE BUILDING CAULKING ARE LOCATED ALONG THE EXTERIOR OF THE TRAILER.
