CITY OF SASKATOON

Asbestos-Containing Building Materials Assessment Report - Trailer 709

Report Number: 1667963

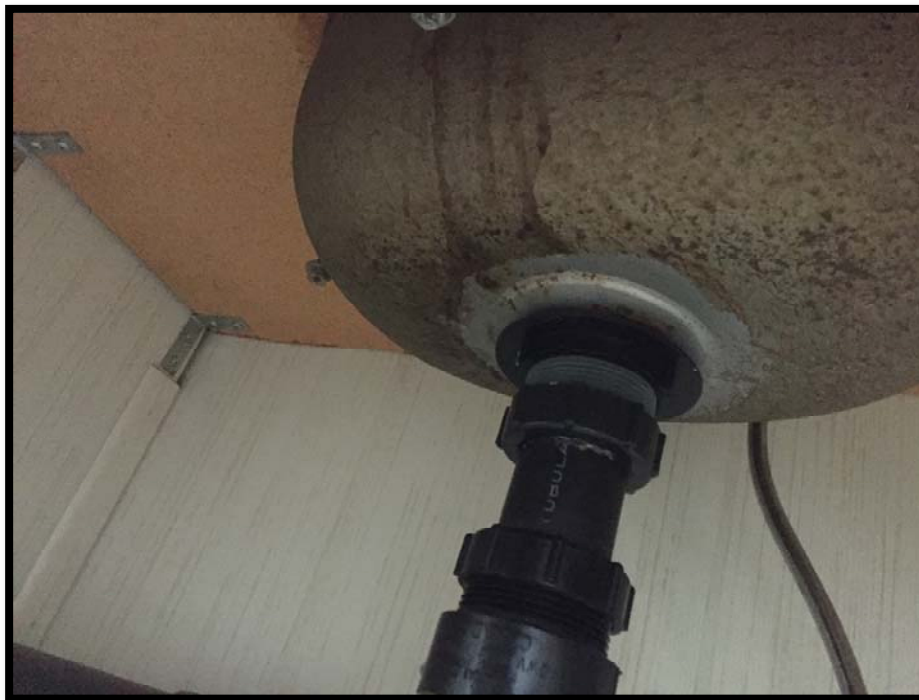
One (1) sample of silver sink undercoat was collected during the assessment. The sample collected was found to contain 1.3% Chrysotile asbestos. Asbestos-containing silver sink undercoat (see Photograph 1 in Appendix B) was observed in the following location:

- Room 100 (approximately 1 sink); and
- Room 101 (approximately 1 sink).

Photograph 1: Asbestos-Containing Silver Sink Undercoat.

If scheduled for impact, sinks with asbestos-containing silver undercoat should be abated following low-risk abatement work procedures as outlined in the *Saskatchewan Asbestos Abatement Manual (2017)*. Alternatively, as the silver sink undercoat was observed in good condition, and with a priority rating of 5 (please see the room by room spreadsheet provided in Appendix C for a description of the priority ratings), it can be managed in place if not scheduled for impact.
