CITY OF SASKATOON

Asbestos-Containing Building Materials Assessment Report - Transit Body Shop

Report Number: 1667963

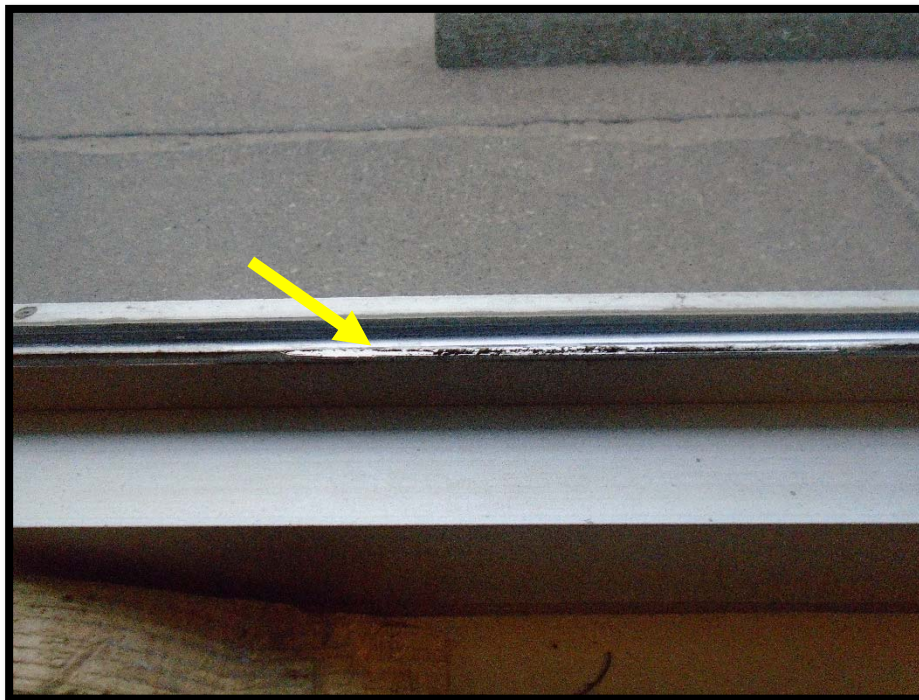
One (1) sample of black window caulking was collected during the assessment. The sample collected was found to contain 5.6% Chrysotile asbestos. Asbestos-containing black window caulking (see Photograph 1 in Appendix B) was observed in the following locations:

- Room 102 (approximately 15 linear ft).

Photograph 1: Asbestos-Containing Black Window Caulking.

If scheduled for impact, asbestos-containing black window caulking should be abated following low-risk abatement work procedures as outlined in the *Saskatchewan Asbestos Abatement Manual (2017)*. Alternatively, as the caulking was observed in good condition, and with a priority rating of 5 (please see the room by room spreadsheet provided in Appendix C for a description of the priority ratings), the caulking can be managed in place if not scheduled for impact.
