**TRANSIT STORAGE & ADMINISTRATION
BUILDING
ASBESTOS SURVEY REPORT**

April 2014

Prepared By: Bersch & Associates Ltd.
Project No. : B67SRD23

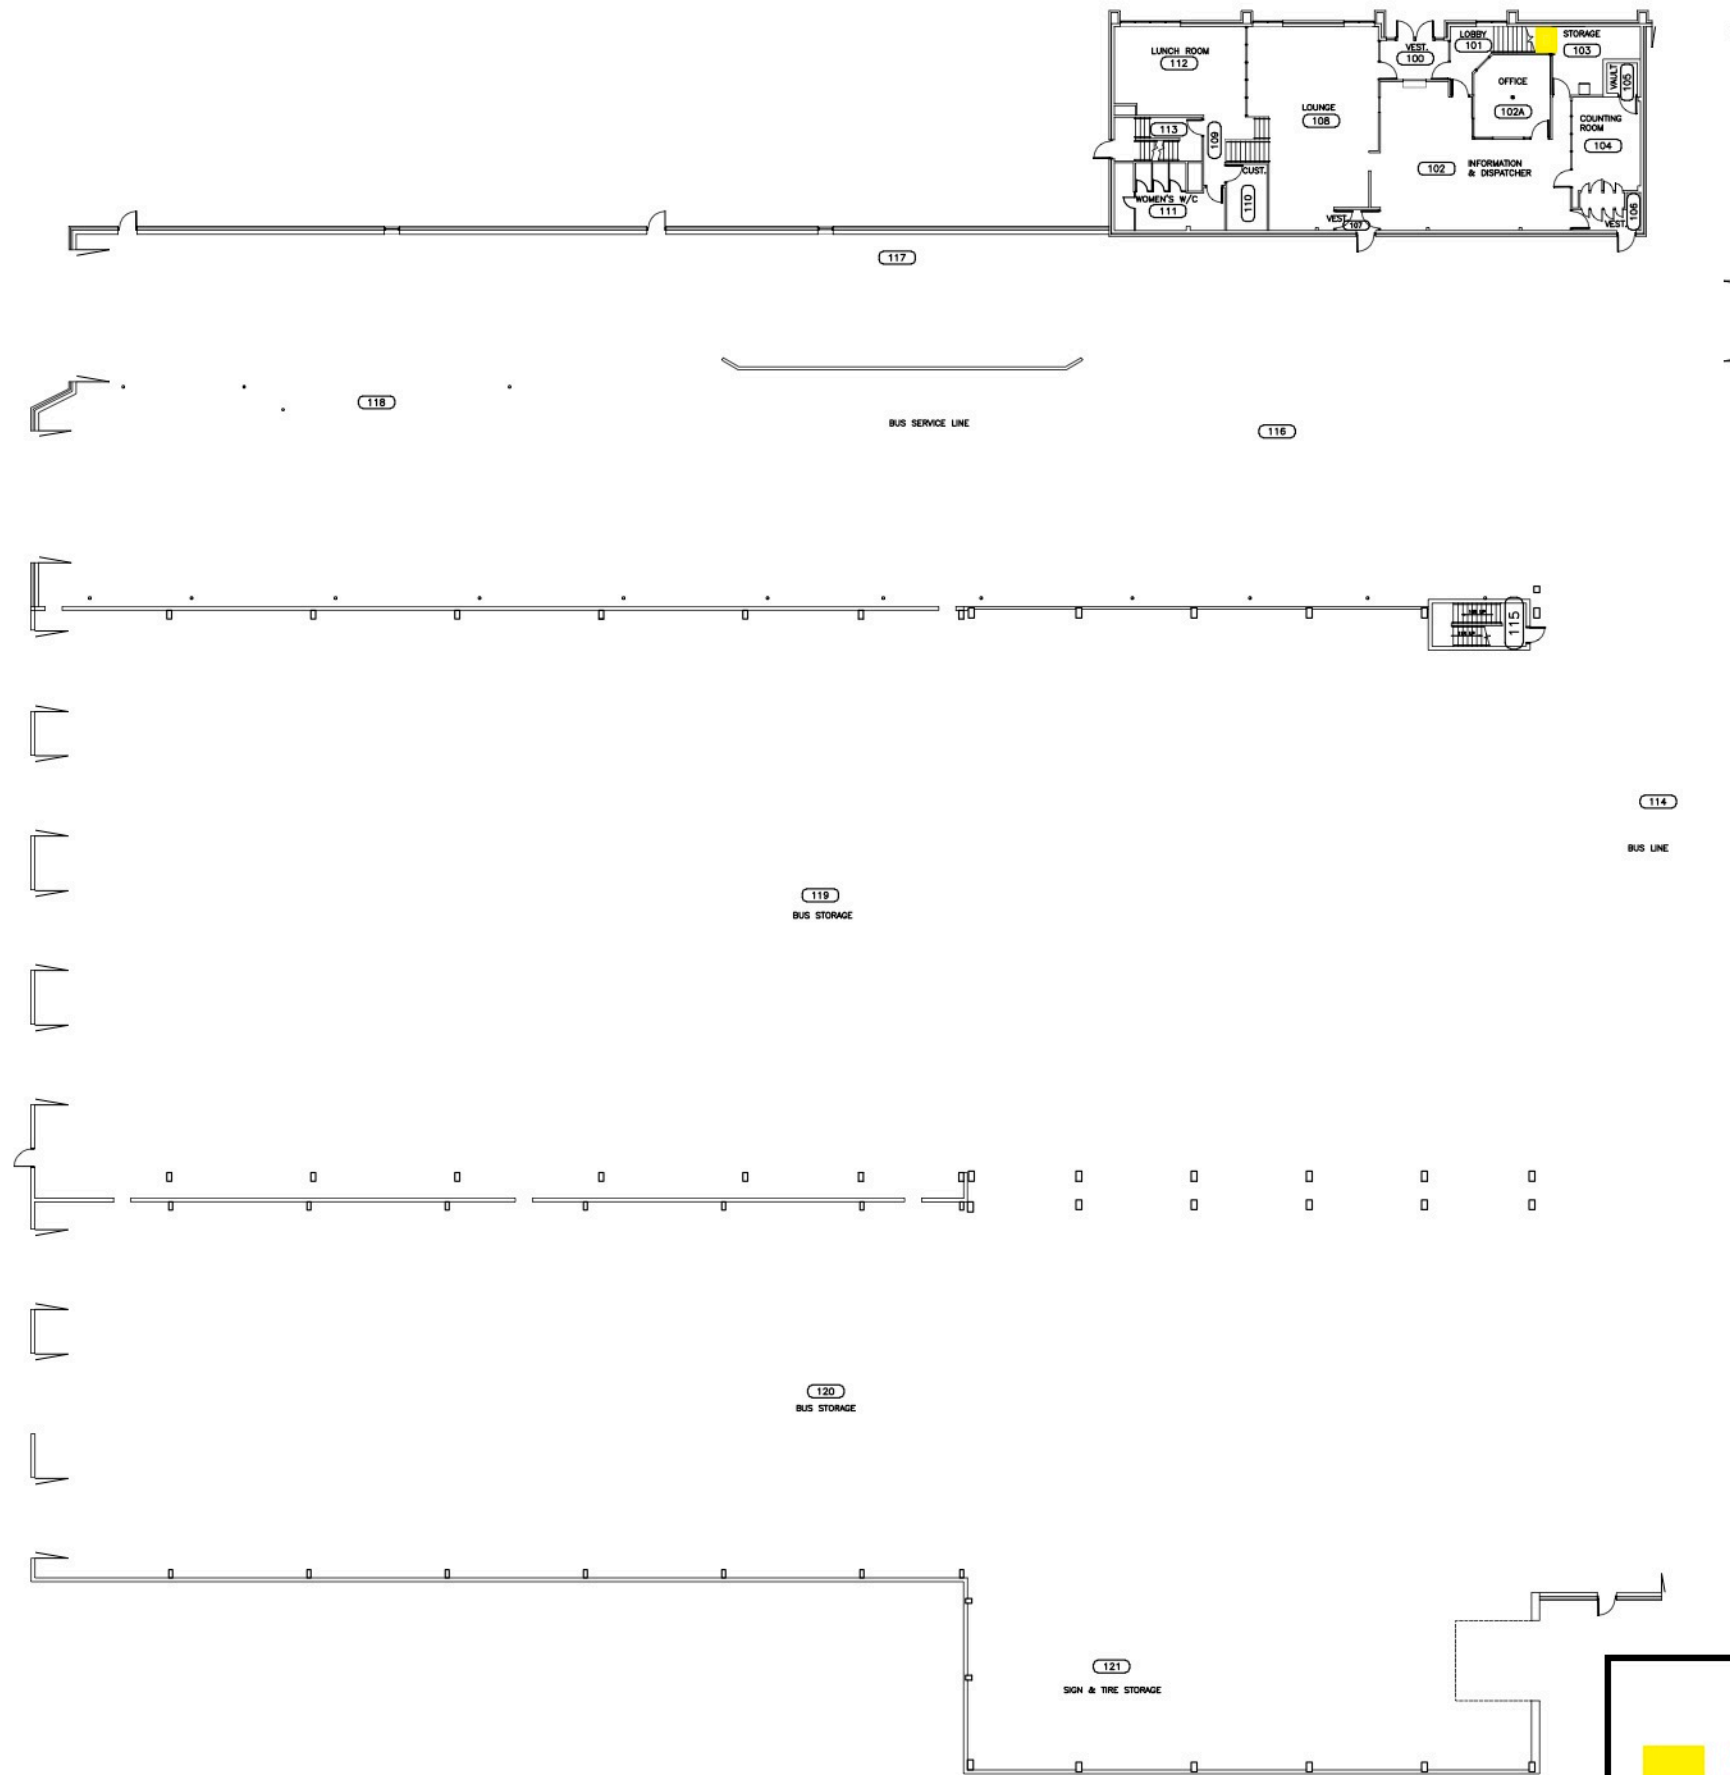
Main Floor Base Plan

- **Vinyl Asbestos Floor Tile** is located within 244 and 103 Storage Rooms. The Asbestos Floor Tile has been identified on the **Floor Plans** included in *Appendix II* of this report.
