**TRANSIT REPAIR TERMINAL NORTH
BUILDING
ASBESTOS SURVEY REPORT**

April 2014

Prepared By: Bersch & Associates Ltd.
Project No. : B67SRD21

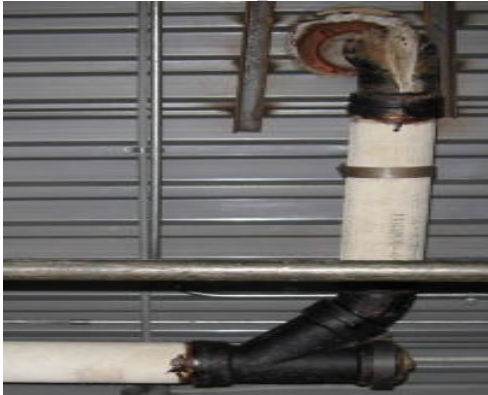
#2) Transite Pipe

Transite Drain Pipe is located at ceiling height running throughout the Shop Areas. This material is considered a non-friable material and will not produce an elevated airborne fibre release unless mechanically disturbed. Recommendation is for the management of this material until renovations warrant removal.

NO.	DATE	SAMPLE INFORMATION	ASBESTOS	%	ANALYST
1	21-May-13	Room # 110 - 1' x 1' Floor Tile, off white with dark streak	None detected		WB
2	21-May-13	Room # 111 - Transite Roof Drain Pipe	Chrysotile	40%	WB
3	21-May-13	Room # 111 - Lineal Pipeline Insulation on Hot Water Supply Line adjacent to Room # 114	None detected		WB
4	21-Apr-14	Room # 117- Office - 1' x 1' Floor Tile, off white with dark streak	None detected		WB
5	21-Apr-14	Room # 117- Office - 2' x 4' Ceiling Tile with pin hole and gash mark pattern	None detected		WB
6	21-Apr-14	Room # 117- Office - Ducting Insulation above suspended ceiling in northwest corner	None detected		WB
7	21-Apr-14	Room # 111- Repair Area - Green Tool Board on center of west wall	None detected		WB
