December 5, 2017

CITY OF SASKATOON

Asbestos-Containing Building Materials Assessment Report - Umea Vast Park Maintenance Building

Report Number: 1667963

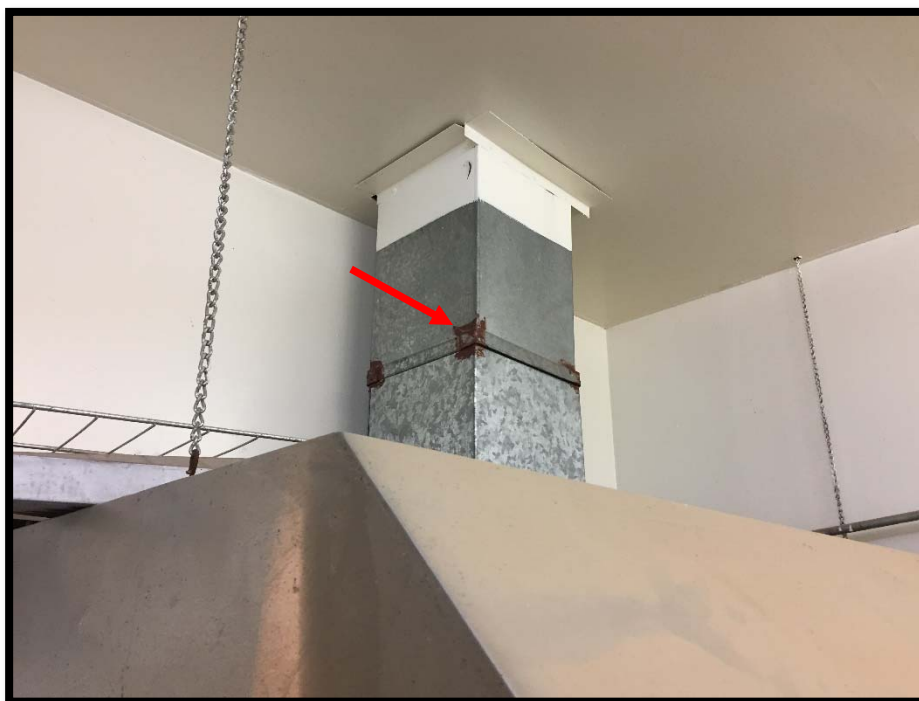
One (1) sample of red/brown duct mastic was collected during the assessment. The sample collected was found to contain 2.3% Chrysotile asbestos. Asbestos-containing red/brown duct mastic (see Photograph 1 in Appendix B) was observed in the following locations:

- Room 103 (approximately 1 ft²).

Additional red/brown duct mastic may be located on duct work above the solid ceilings throughout the Site.

Asbestos was positively identified within the red/brown duct mastic and the silver sink undercoat on Site. Asbestos was not identified in the remaining samples collected and analyzed.

Photograph 1: Asbestos-Containing Red/Brown Duct Mastic.

If scheduled for impact, asbestos-containing red/brown duct mastic should be abated following low-risk abatement work procedures as outlined in the *Saskatchewan Asbestos Abatement Manual* (2017). Alternatively, as the red/brown duct mastic was observed in good condition, and with a priority rating of 5 (please see the room by room spreadsheet provided in Appendix C for a description of the priority ratings), it can be managed in place if not scheduled for impact.
