CITY OF SASKATOON

Asbestos-Containing Building Materials Assessment Report - Vic Rempel Administration Building

Report Number: 1667963

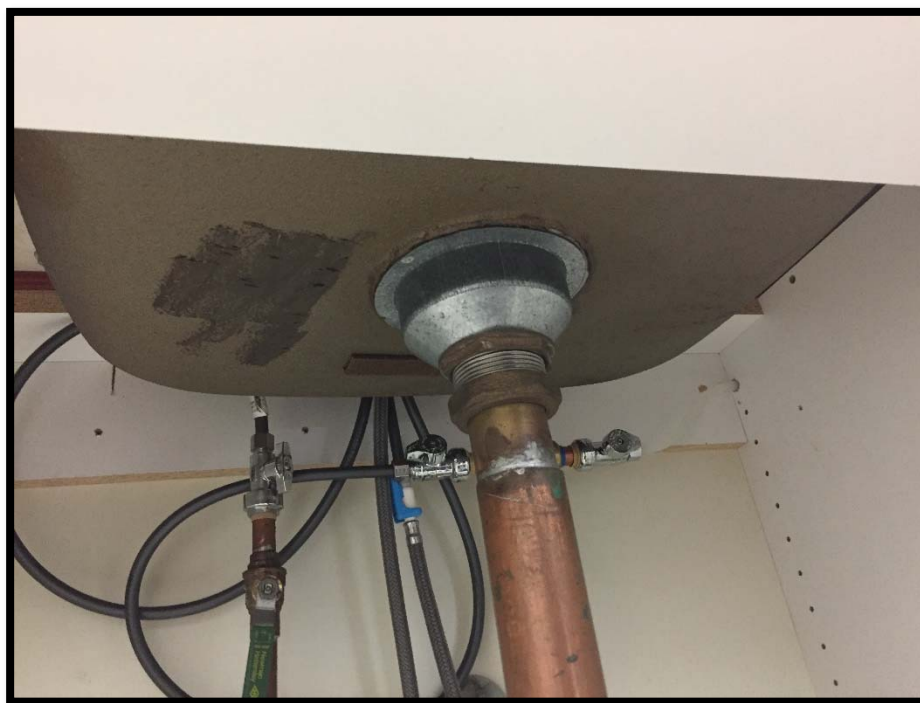
One (1) sample of gold sink undercoat was collected during the assessment. The sample collected was found to contain 4.1% Chrysotile asbestos. Asbestos-containing gold sink undercoat (see Photograph 1 in Appendix B) was observed in the following locations:

- Room 138 (approximately 1 sink).

Photograph 1: Asbestos-Containing Gold Sink Undercoat.

If scheduled for impact, asbestos-containing gold sink undercoat should be abated following low-risk abatement work procedures as outlined in the *Saskatchewan Asbestos Abatement Manual (2017)*. Alternatively, as the gold sink undercoat was observed in good condition, and with a priority rating of 5 (please see the room by room spreadsheet provided in Appendix C for a description of the priority ratings), it can be managed in place if not scheduled for impact.
