Pre-Demolition Assessment

File Number: B67PDF12H

Project: V. Rempel Yards Equip. Storage

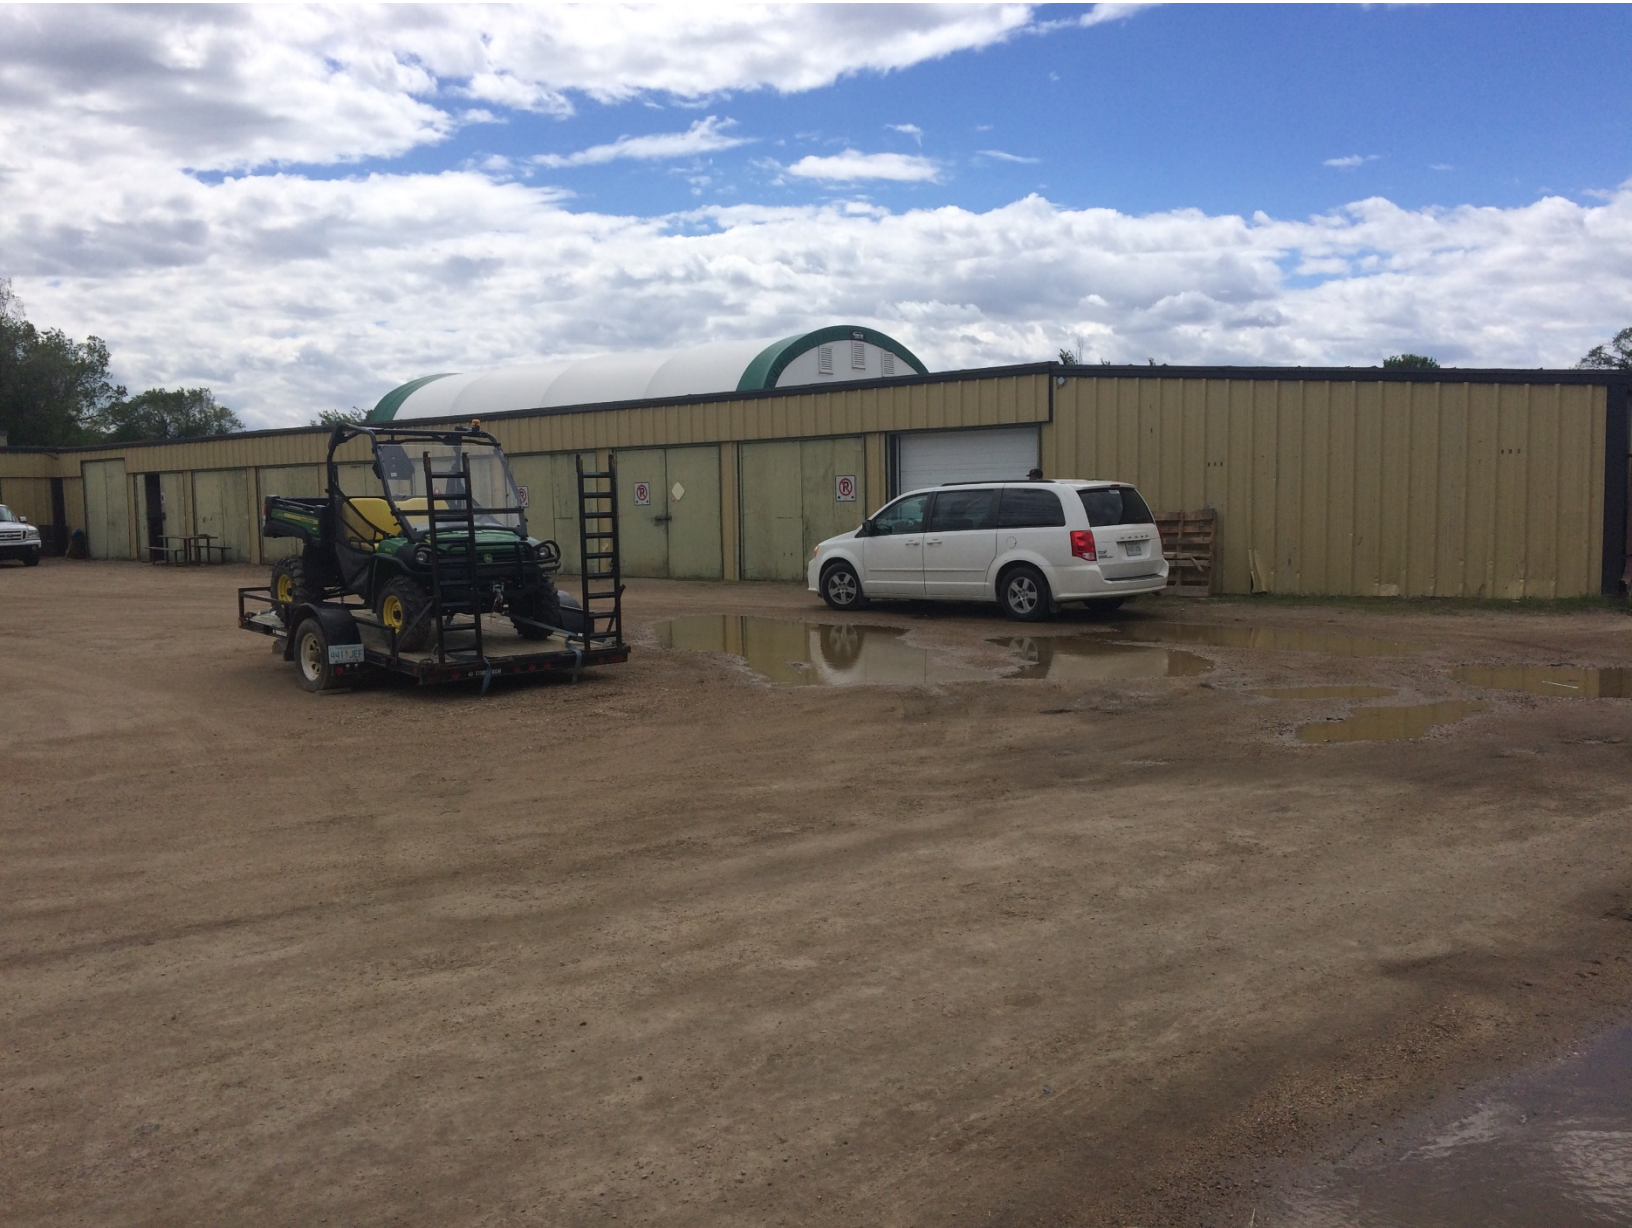
Photo 001- V. Rempel Yards Equip. Storage

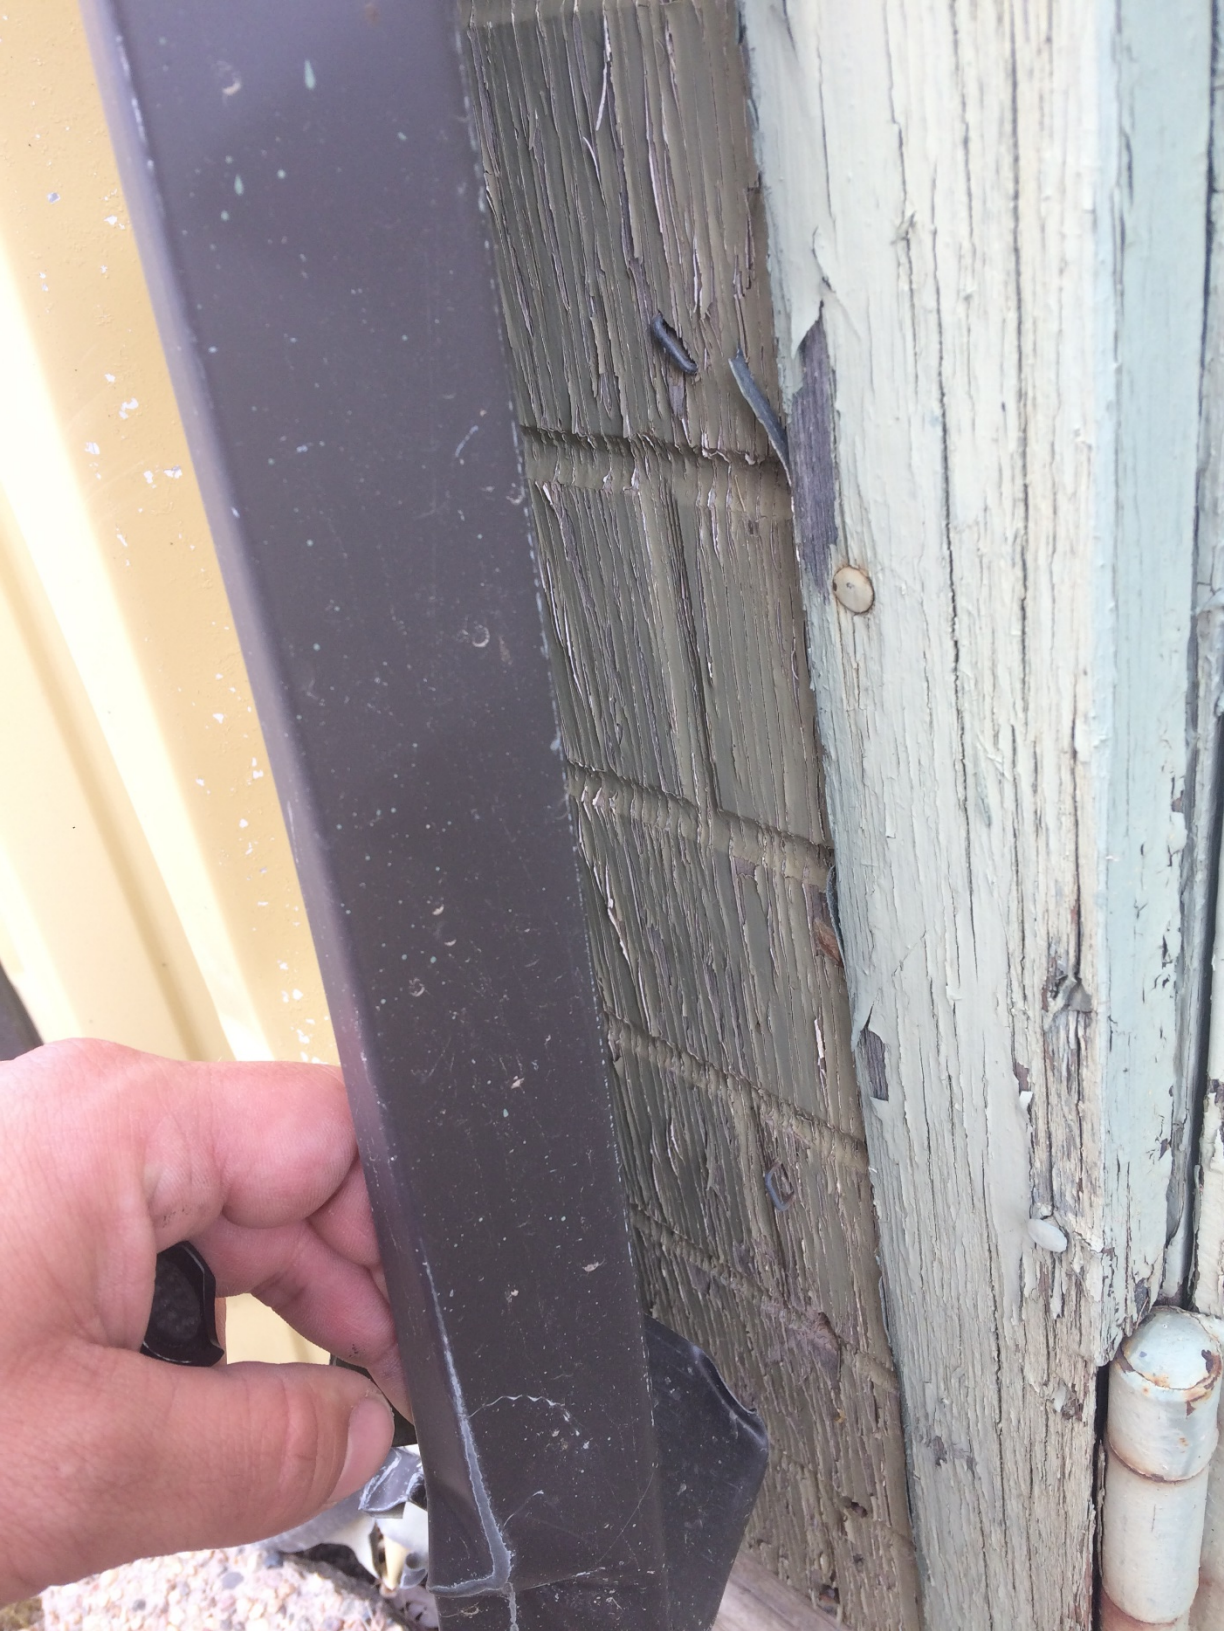
Photo 002- Faux Brick Façade behind Metal Cladding

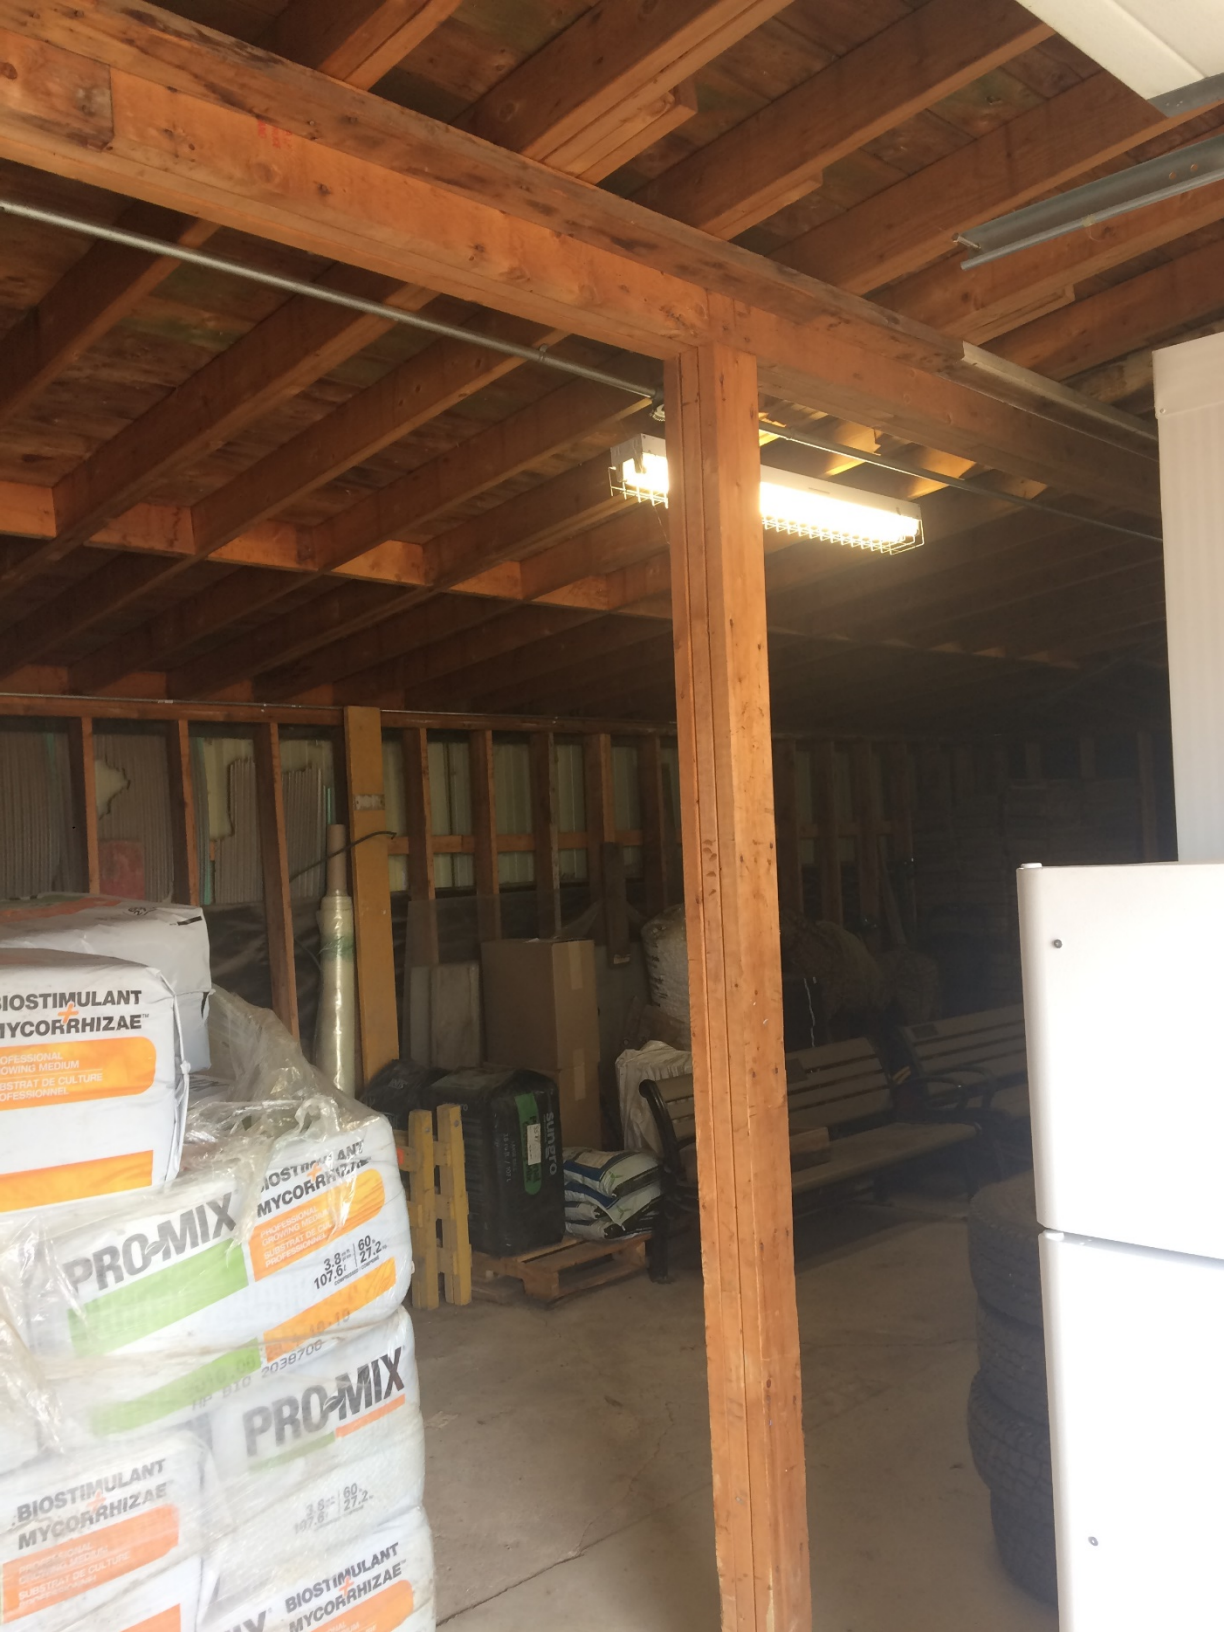
Photo 003- Interior of Unit 101

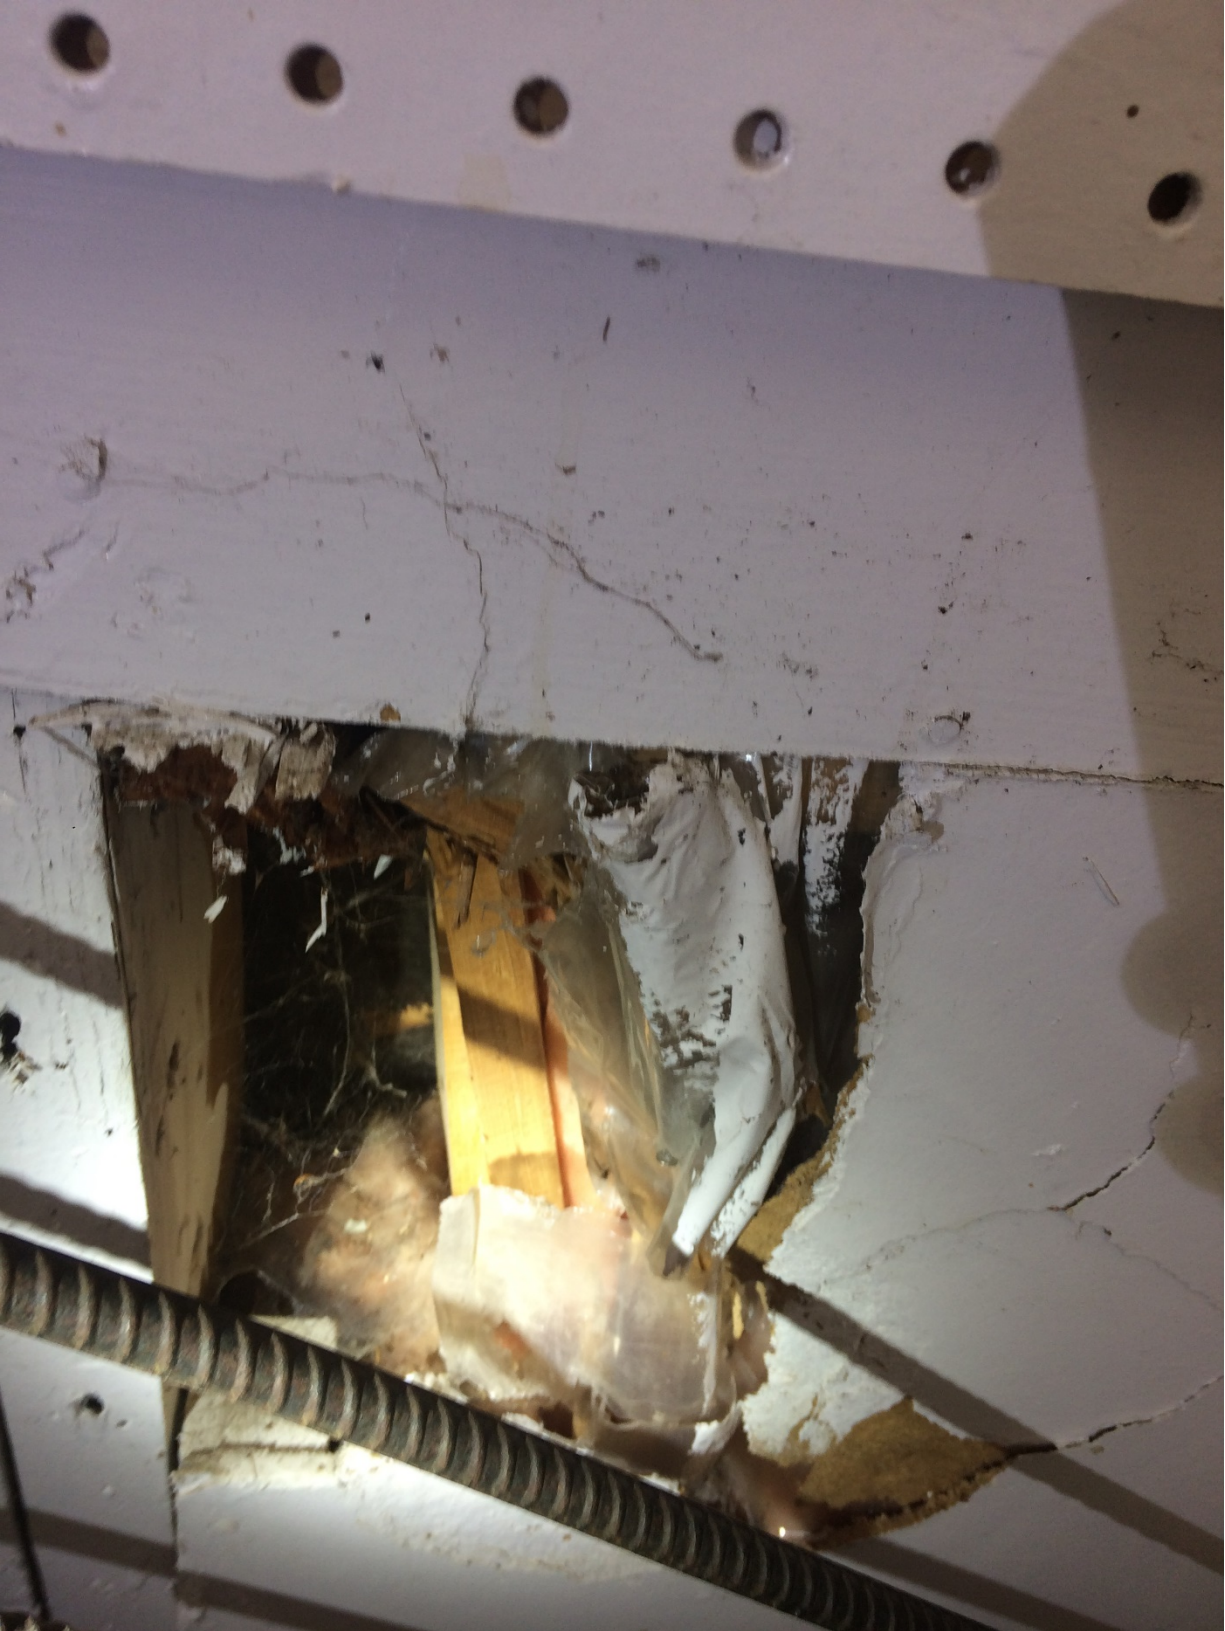
The V. Rempel Yards Equipment Storage is a wood framed storage building built directly over a concrete pad. With the exception of unit 107 the building is not insulated. The insulation within unit 107 consists of non-asbestos fiberglass insulation. The construction of the building consists of wood framing with metal cladding exterior. The lower five feet of the interior includes a tar-paper wrapped plywood sheet fastened between the cladding and wood studs. Cladding has been fastened to a previous faux brick, particle board façade in some areas. The roof of the building consists of lapping wood boards with a tar-paper layer followed by plywood, tar roofing and rolled on shingles. Please see **Appendix II** for site photos. Samples of tar-paper, concrete, ceiling tile, tar-roofing and shingle were collected. Please see **Appendix III** for sample locations. All sample were tested for the presence/absence of asbestos. Asbestos was not detected within the samples.

Photo 004- Wall Insulation- Unit 107

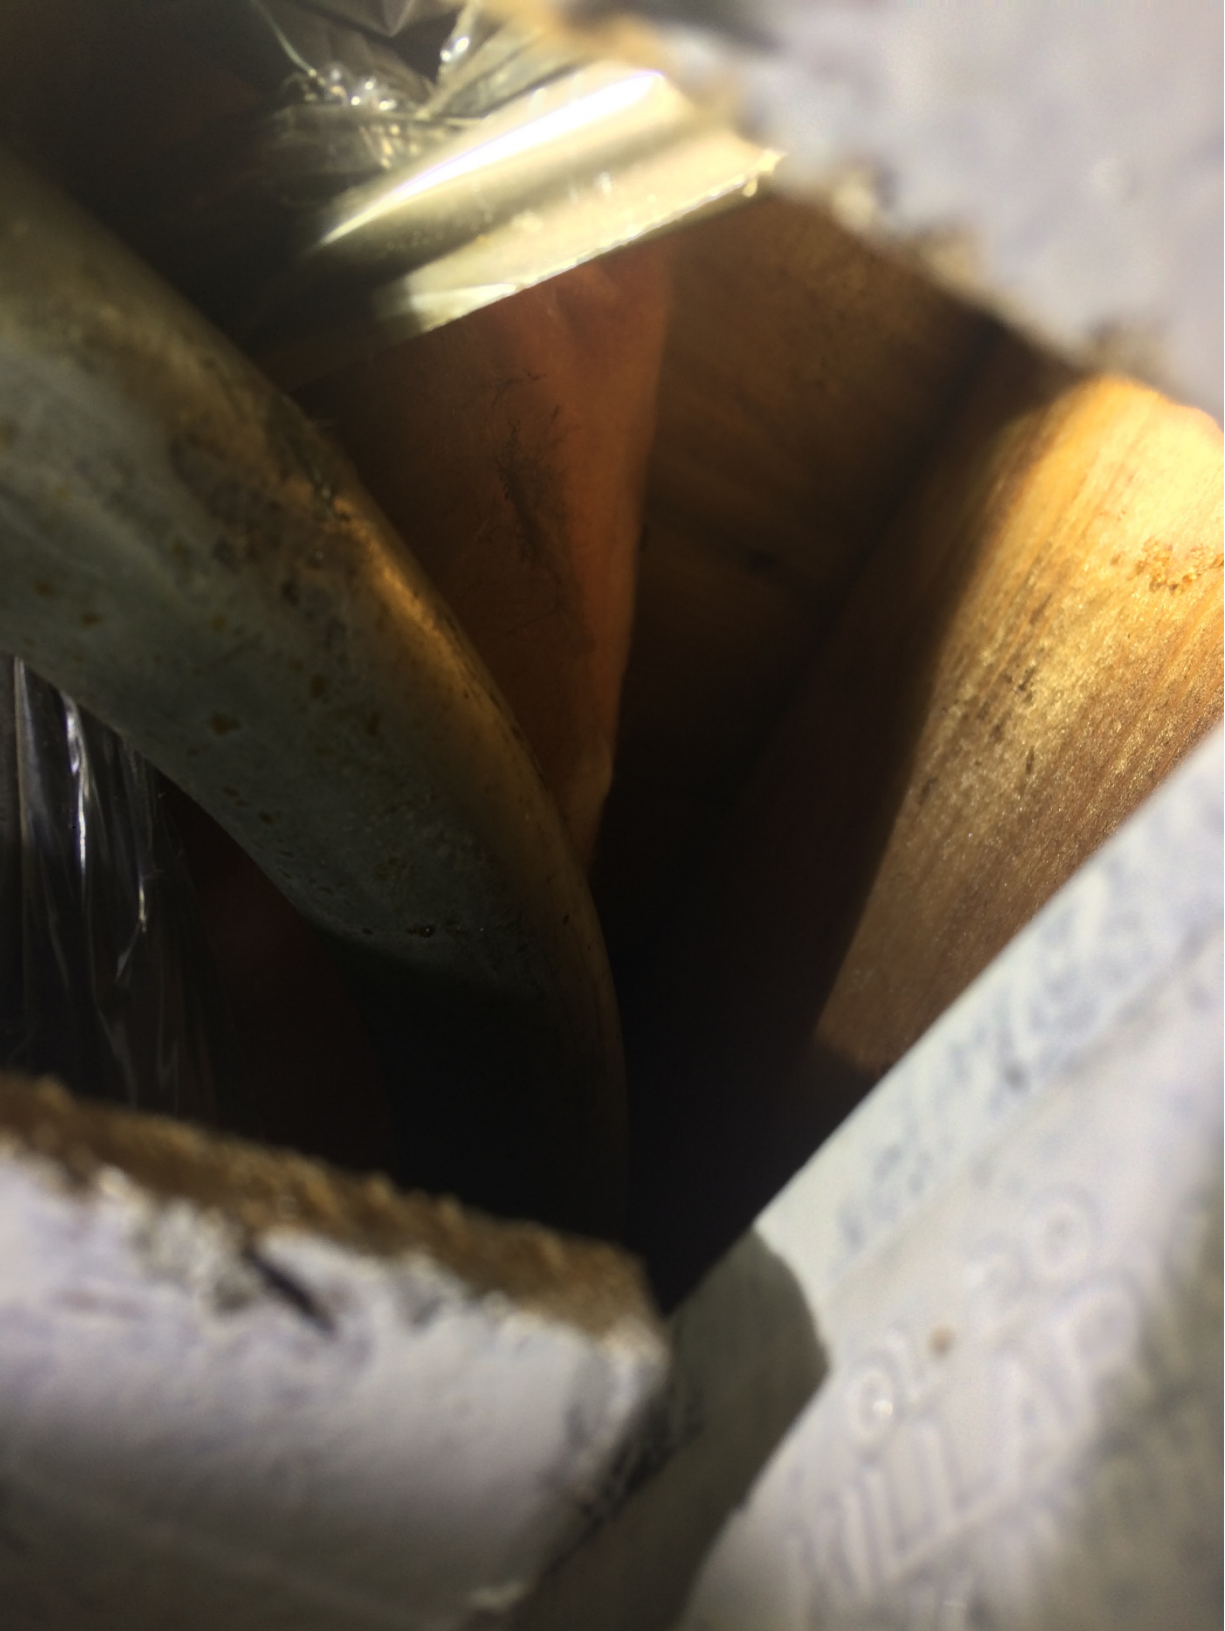
Photo 005- Roof Insulation- Unit 007

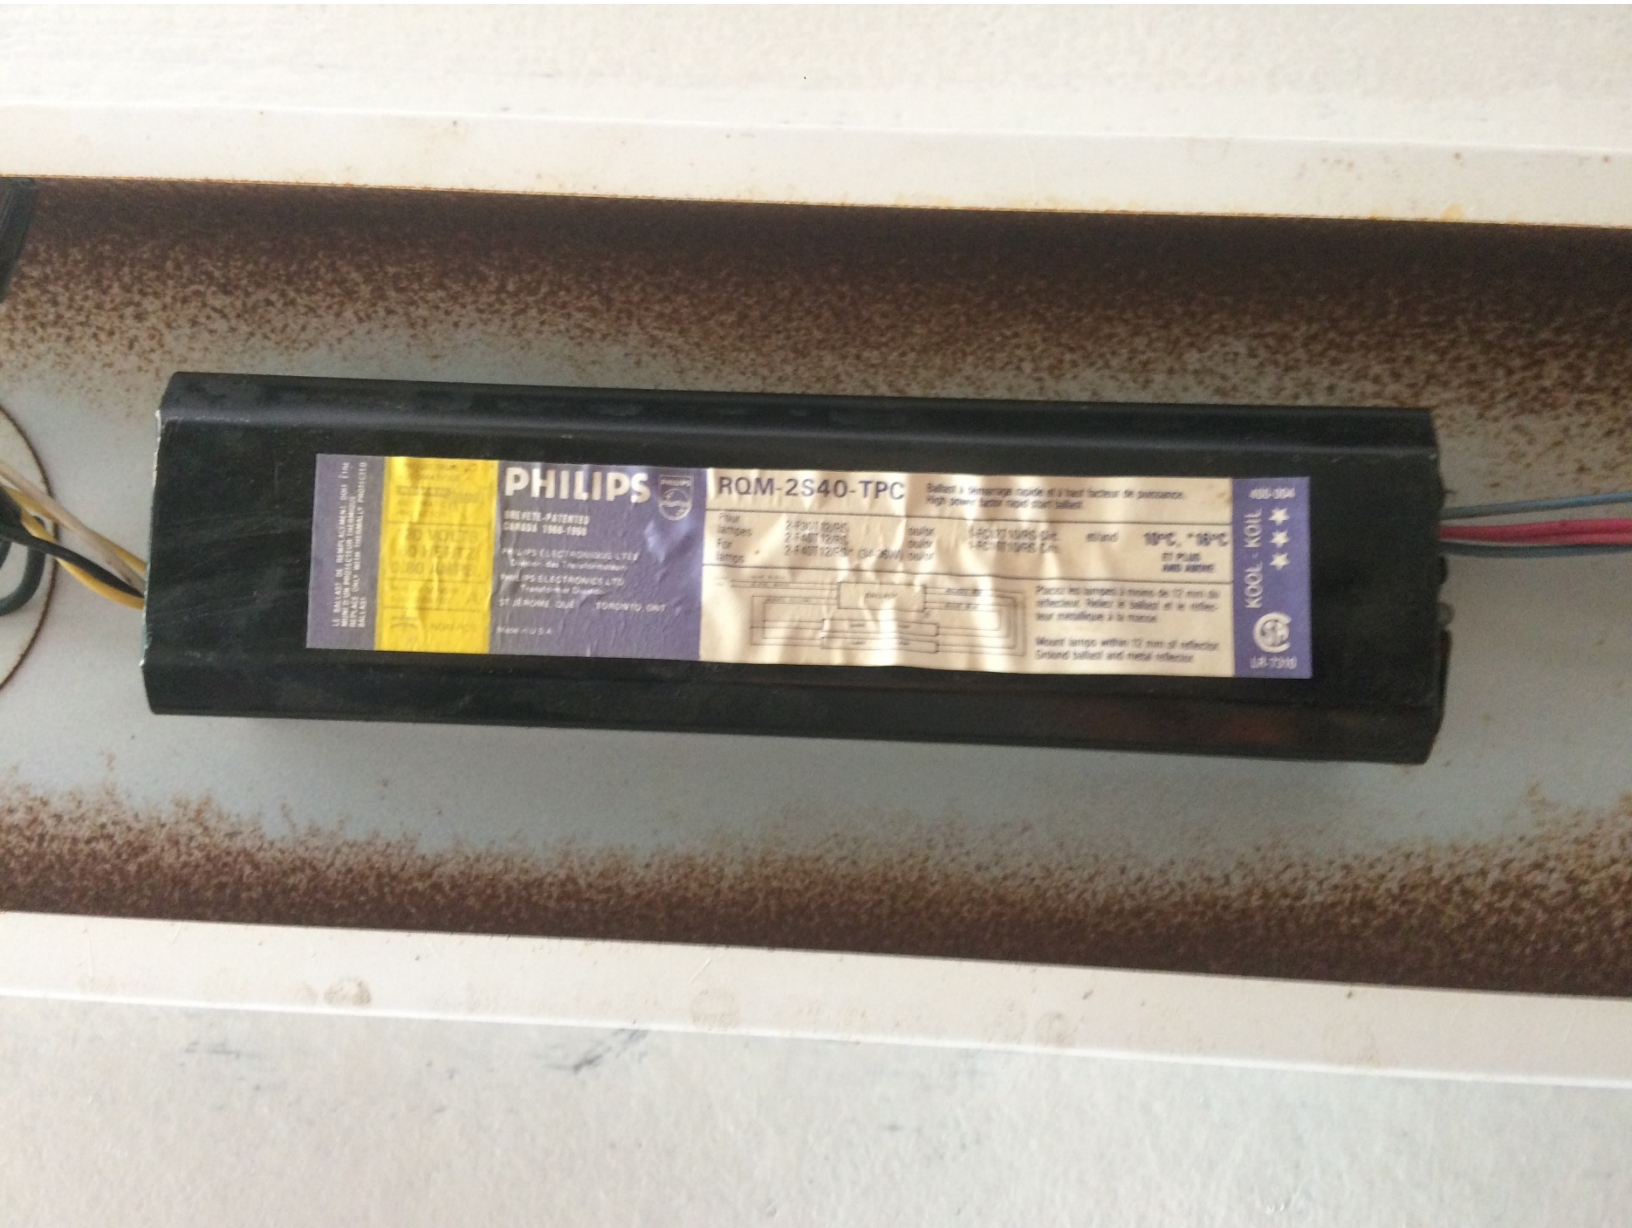
lighting equipped with electronic ballasts. Fixtures containing outdated T8 florescent tubes were examined and found to contain ballasts labelled “non-PCB”.

Photo 006- Non-PCB Light Ballast- Unit 007

The building is illuminated by florescent lighting in most areas. Prior to demolition florescent tubes should be removed and recycled appropriately. In most areas florescent light consists of modern T6 florescent
