December 7, 2017

CITY OF SASKATOON

# Asbestos-Containing Building Materials Assessment Report - Waste Water Primary Clarifiers and Access Buildings

**Report Number: 1667963**

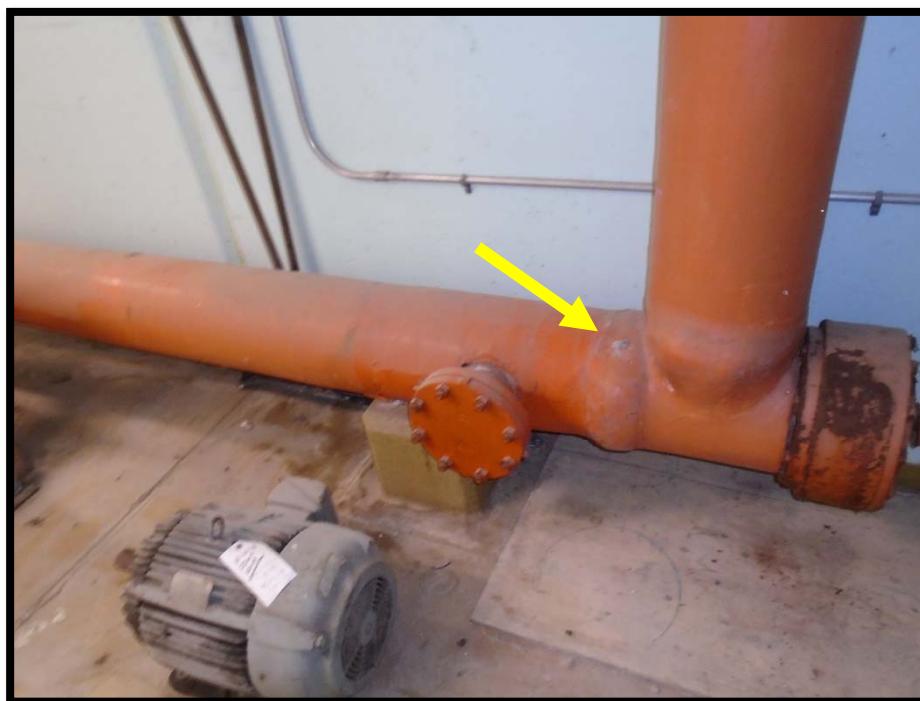
Seven (7) samples of pipe-fitting insulation were collected during the assessment. The sample collected from the aerator line within the North Stairwell was found to contain 60% Chrysotile asbestos. Asbestos-containing pipe-fitting insulation (see Photograph 1 in Appendix B) was observed in the following locations:

- North Stairwell - Aerator line (approximately 25 fittings).

**Photograph 1: Asbestos-Containing Pipe-Fitting Insulation, Aerator Line.**

If scheduled for impact, asbestos-containing pipe-fitting insulation within the North Stairwell should be abated following moderate-risk glovebag or high-risk abatement work procedures as outlined in the *Saskatchewan Asbestos Abatement Manual* (2017). Alternatively, as the pipe-fitting insulation was observed in good condition, and with a priority rating of 5 (please see the room by room spreadsheet provided in Appendix C for a description of the priority ratings), the pipe-fitting insulation can be managed in place if not scheduled for impact.
