CITY OF SASKATOON

Asbestos-Containing Building Materials Assessment Report - Waste Water Sodium Hypochlorite Building

Report Number: 1667963

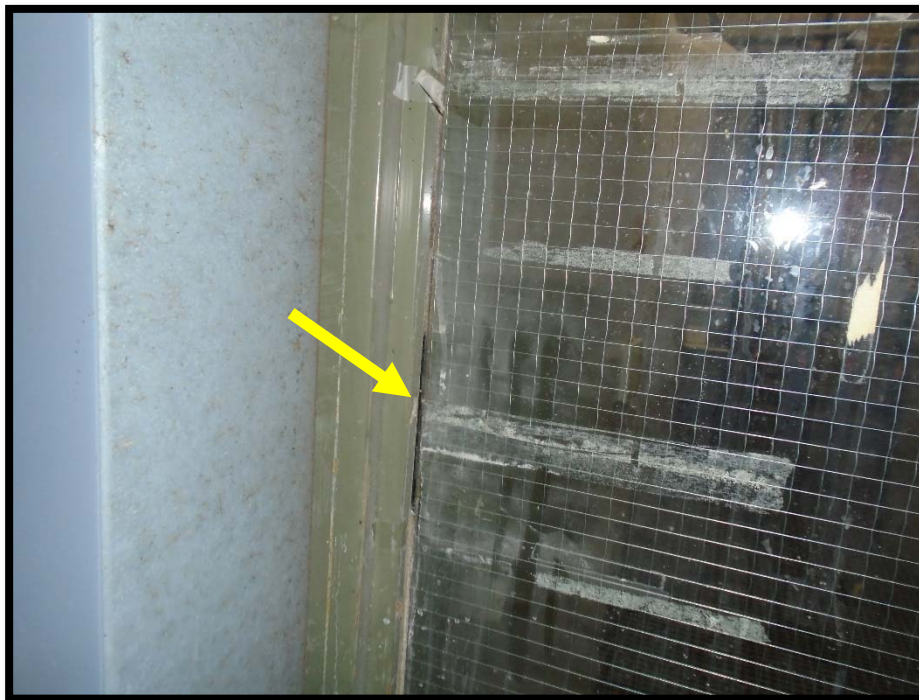
One (1) sample of black window glazing was collected during the assessment. The sample collected was found to contain 10% Chrysotile asbestos. Asbestos-containing black window glazing (see Photograph 1 in Appendix B) was observed in the following locations:

- Room 100 (approximately 10 ft);
- Room 102 (approximately 20 ft);
- Room 103 (approximately 20 ft); and
- Room 104 (approximately 40 ft).

Photograph 1: Asbestos-Containing Black Window Glazing.

If scheduled for impact, asbestos-containing black window glazing should be abated following low-risk abatement work procedures as outlined in the *Saskatchewan Asbestos Abatement Manual (2017)*. Alternatively, as the glazing was observed in good condition, and with a priority rating of 5 (please see the room by room spreadsheet provided in Appendix C for a description of the priority ratings), the glazing can be managed in place if not scheduled for impact.

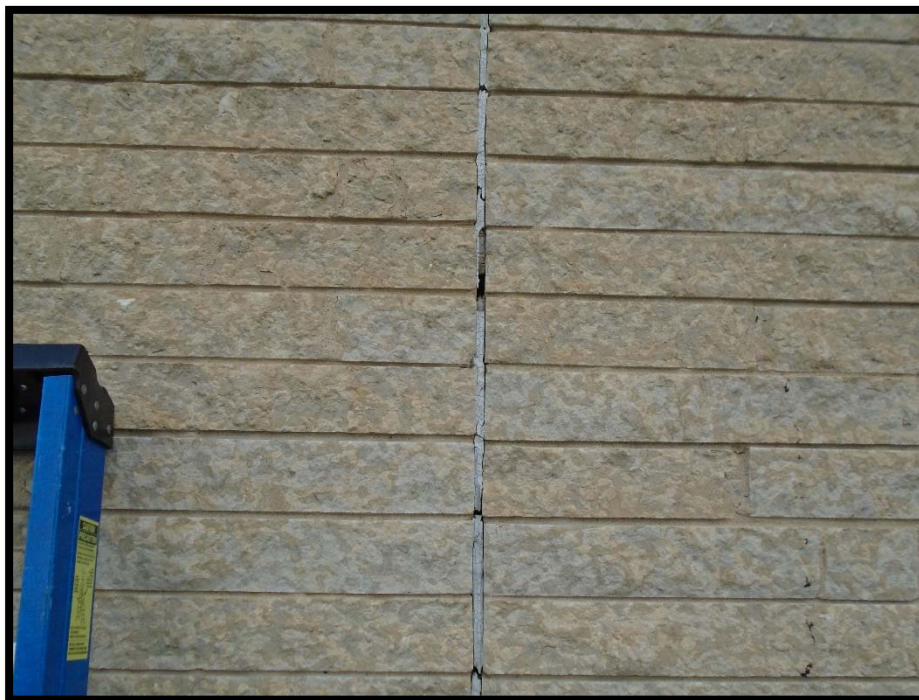
One (1) sample of exterior grey expansion joint caulking was collected during the assessment. The sample collected was found to contain 2.1% Chrysotile asbestos. Asbestos-containing grey expansion joint caulking (see Photograph 2 in Appendix B) was observed in the following locations:

- Exterior (approximately 100 ft).

Photograph 2: Asbestos-Containing Grey Expansion Joint Caulking.

If scheduled for impact, asbestos-containing grey expansion joint caulking should be abated following low-risk abatement work procedures as outlined in the *Saskatchewan Asbestos Abatement Manual (2017)*. Alternatively, as the caulking was observed in good condition, and with a priority rating of 5 (please see the room by room spreadsheet provided in Appendix C for a description of the priority ratings), the caulking can be managed in place if not scheduled for impact.
