December 7, 2017

## CITY OF SASKATOON

# Asbestos-Containing Building Materials Assessment Report - Water Meter Shop

**Report Number: 1667963**

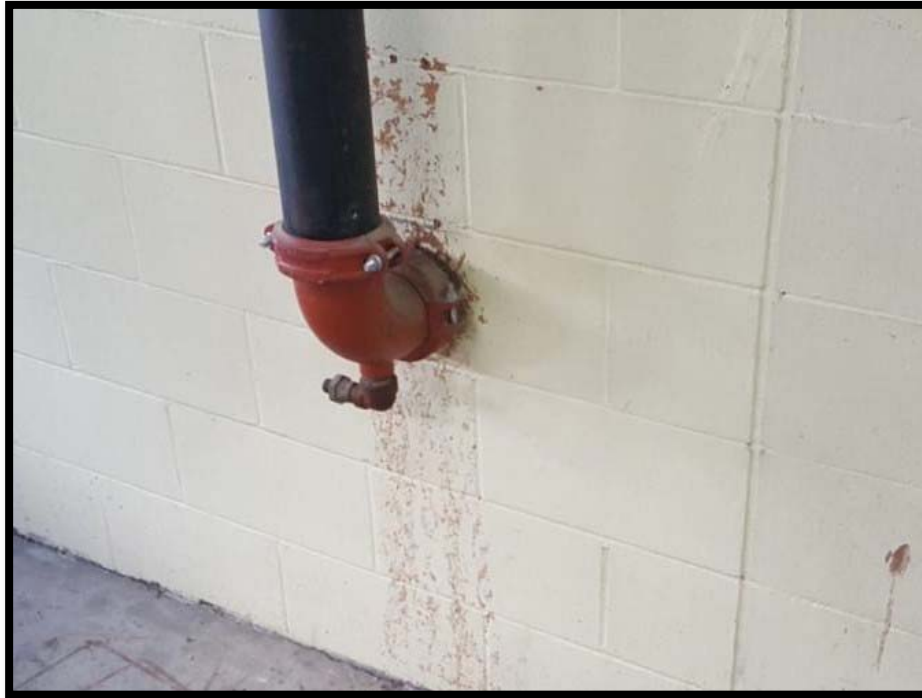
One (1) sample of loose-fill vermiculite insulation was collected during the assessment. The sample collected was found to contain trace amount of Actinolite asbestos. Asbestos-containing loose-fill vermiculite insulation (see Photograph 1 in Appendix B) was observed to have leaked from the wall cavity in Room 131. The loose vermiculite was subsequently cleaned by the Client following its identification.

There is the potential for the material to be present within other cinderblock walls throughout the building.

**Lab No.:** 6371048      **Analyst Observation:** Brown Vermiculite      **Location:** Rm 131  
**Client No.:** 003      **Client Description:** Loose-Fill Vermiculite Insulation      **Facility:**  
Percent Asbestos:      Percent Non-Asbestos Fibrous Material:      Percent Non-Fibrous Material:  
*PC Trace Tremolite*      None Detected      100

**Photograph 1: Block Wall with Potential Asbestos-Containing Loose-Fill Vermiculite Insulation.**

If scheduled for impact, asbestos-containing loose-fill vermiculite insulation should be abated following high-risk abatement work procedures as outlined in the *Saskatchewan Asbestos Abatement Manual (2017)*. Alternatively, as the loose-fill vermiculite insulation is located within the cinderblock wall cavities, and with a priority rating of 5 (please see the room by room spreadsheet provided in Appendix C for a description of the priority ratings), the vermiculite can be managed in place if not scheduled for impact. If vermiculite is observed to have leaked from openings within the cinderblock walls, the material should be cleaned up following low-risk abatement work procedures as outlined in the *Saskatchewan Asbestos Abatement Manual (2017)*.
