PRE-RENOVATION ASSESSMENT

502 48TH STREET EAST

File Number: B67PRAL04H

Project: 502 48th Street East Pre-Renovation / Pre-Occupancy

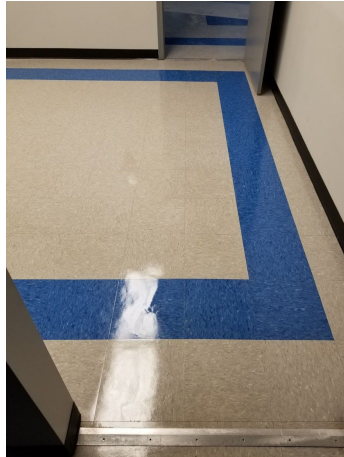
3) 1' X 1' floor tile (non-asbestos)

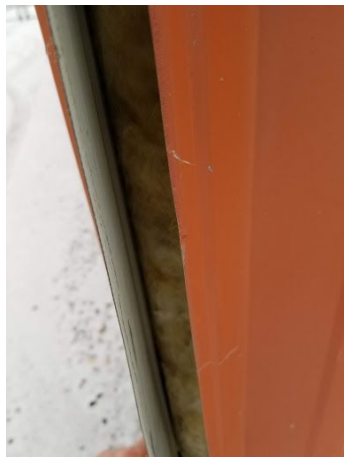
4) Fiberglass Exterior Wall Insulation (non-asbestos)
