FINAL Hazardous Building Materials Assessment

Water Treatment Plant
1030 Avenue H South,
Saskatoon, SK

September 26, 2016

PWL File: 7587F

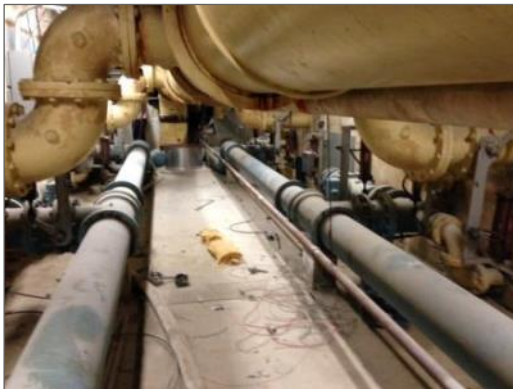
All paint samples collected on the pipes in the 1928 Pipe Gallery (loc. 1) are lead containing. The paint on the concrete walls in the settling tanks in the 1928 Plant Settling Tank Area (loc. 2) is also lead containing.

Photo 1 – View of lead based paints in the pipe gallery.

Dispose of painted non-metallic materials exceeding the criteria for leachable lead as hazardous waste. Well adhered paints containing elevated levels of lead on metal substrates do not require leachable lead analysis as the materials can be recycled with the paint intact.

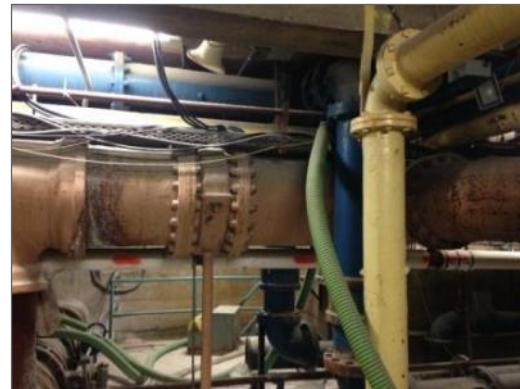
Photo 2 – view of various lead based paint in the pipe gallery

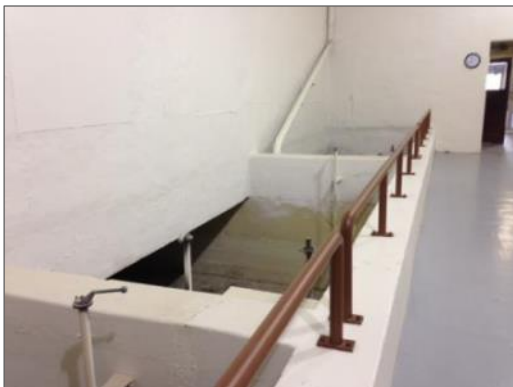
Photo 3– View of lead based paints in the 1928 plant settling tank area.

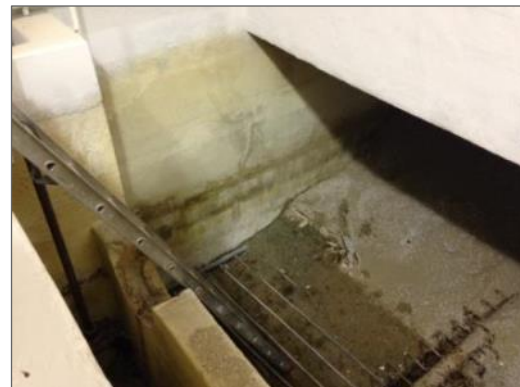
Photo 4– View of white and green lead based paint in a filter tank.
