**Weaver Park
Asbestos Survey Report**

City of
Saskatoon

February 2014

Prepared By: Bersch & Associates Ltd.
Project No. : B67SRE22

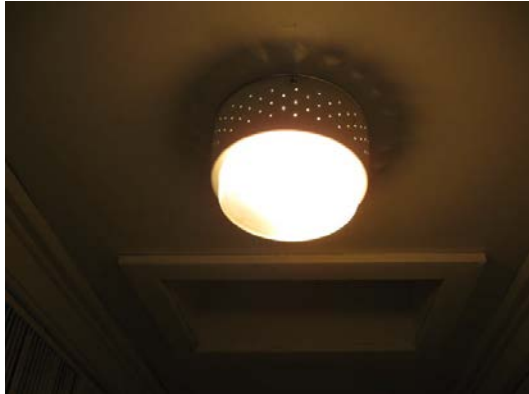
#1) Light Fixture Heat Shield

- **Transite Board** is located on the ceiling of the Furnace Room.
- **Heat Shield Material** is found within nine light fixtures throughout the facility.

M	4	Furnace Room	Sample	B67-ASB.2	22-May-13	Chrysotile	30%	Transite Board	Good	3	Corridor adjacent Washroom - Light fixture heat shield material	Transite Board on Ceiling	Low/Mod	Manage	Heat shield material is contained within eight light fixtures. Replace the globe of one light fixture to prevent disturbance.
M	5	Dressing Rooms	Sample Rep	B67-ASB.1	22-May-13	Chrysotile	60%	Heat Shield Material	Good	2		Heat Shield Material in Light Fixture	Moderate	Manage	All attic accesses have been nailed shut and were inaccessible at time of survey.
A		Attic
