CITY OF SASKATOON

Asbestos-Containing Building Materials Assessment Report - Wildwood Golf Course Clubhouse

Report Number: 1667963

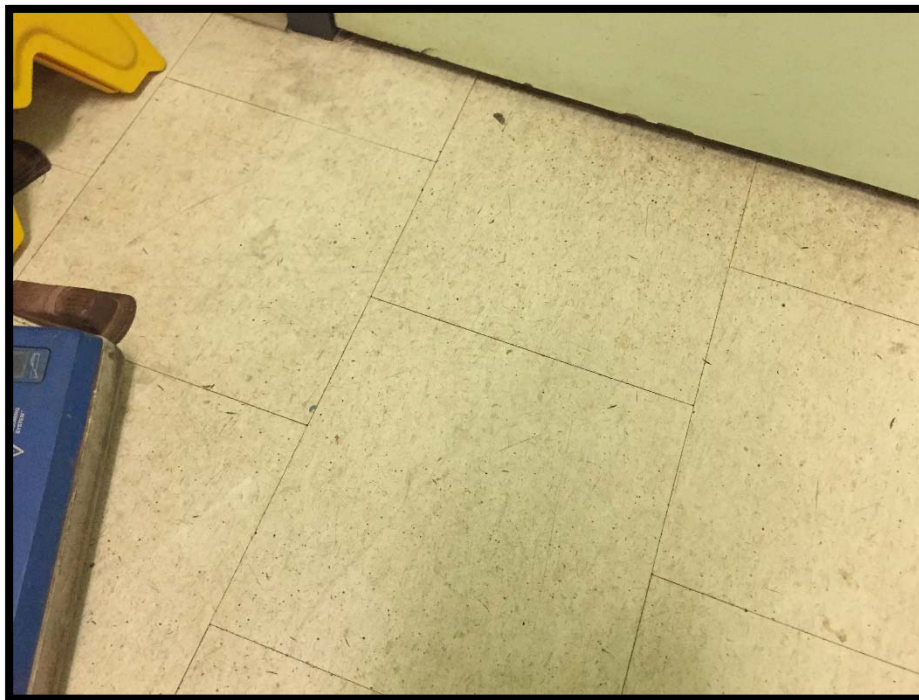
12"x12" Off-White Floor Tile with Black Flecks

One (1) sample of 12"x12" off-white floor tile with black flecks was collected during the assessment. The sample collected was found to contain 0.75% Chrysotile asbestos. Asbestos-containing 12"x12" off-white floor tile with black flecks (see Photograph 1 in Appendix B) was observed in the following locations:

- Room 108 (approximately 70 ft²);
- Room 112 (approximately 75 ft²); and
- Room 113 (approximately 265 ft²).

Photograph 1: Asbestos-Containing 12"x12" Off-White Floor Tile with Black Flecks.

If scheduled for impact, asbestos-containing 12"x12" off-white floor tile with black flecks should be abated following low-risk abatement work procedures as outlined in the *Saskatchewan Asbestos Abatement Manual* (2017). Alternatively, as the 12"x12" off-white floor tile with black flecks was observed in good condition, and with a priority rating of 5 (please see the room by room spreadsheet provided in Appendix C for a description of the priority ratings), it can be managed in place if not scheduled for impact.

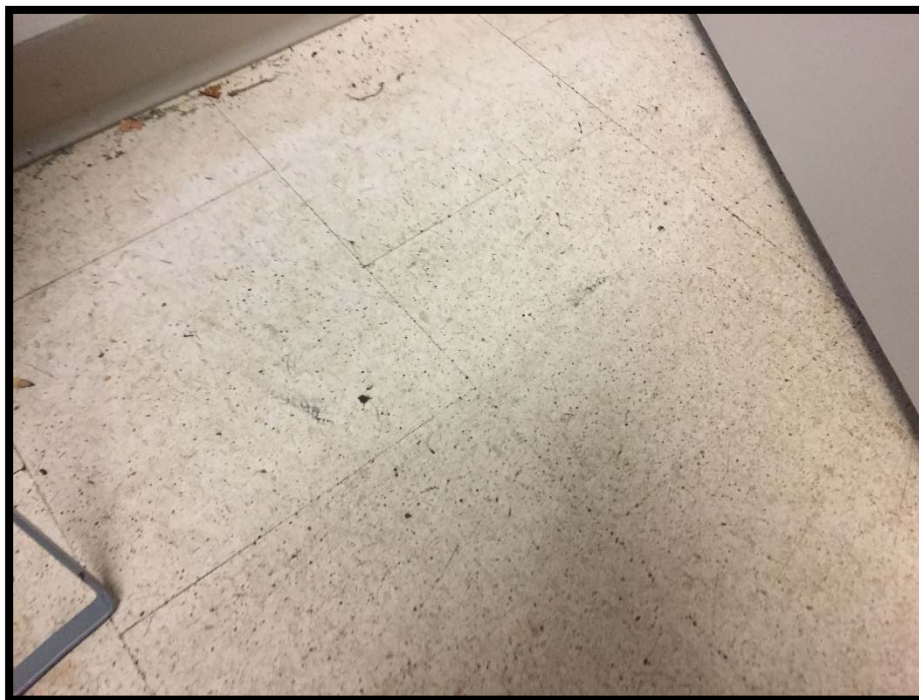
12"x12" Off-White Floor Tile with Black Dots

One (1) sample of 12"x12" off-white floor tile with black dots was collected during the assessment. The sample collected was found to contain 0.5% Chrysotile asbestos. Asbestos-containing 12"x12" off-white floor tile with black dots (see Photograph 2 in Appendix B) was observed in the following location:

- Room 105 (approximately 200 ft²).

Photograph 2: Asbestos-Containing 12"x12" Off-White Floor Tile with Black Dots.

If scheduled for impact, asbestos-containing 12"x12" off-white floor tile with black dots should be abated following low-risk abatement work procedures as outlined in the *Saskatchewan Asbestos Abatement Manual* (2017). Alternatively, as the 12"x12" off-white floor tile with black dots was observed in good condition, and with a priority rating of 5 (please see the room by room spreadsheet provided in Appendix C for a description of the priority ratings), it can be managed in place if not scheduled for impact.

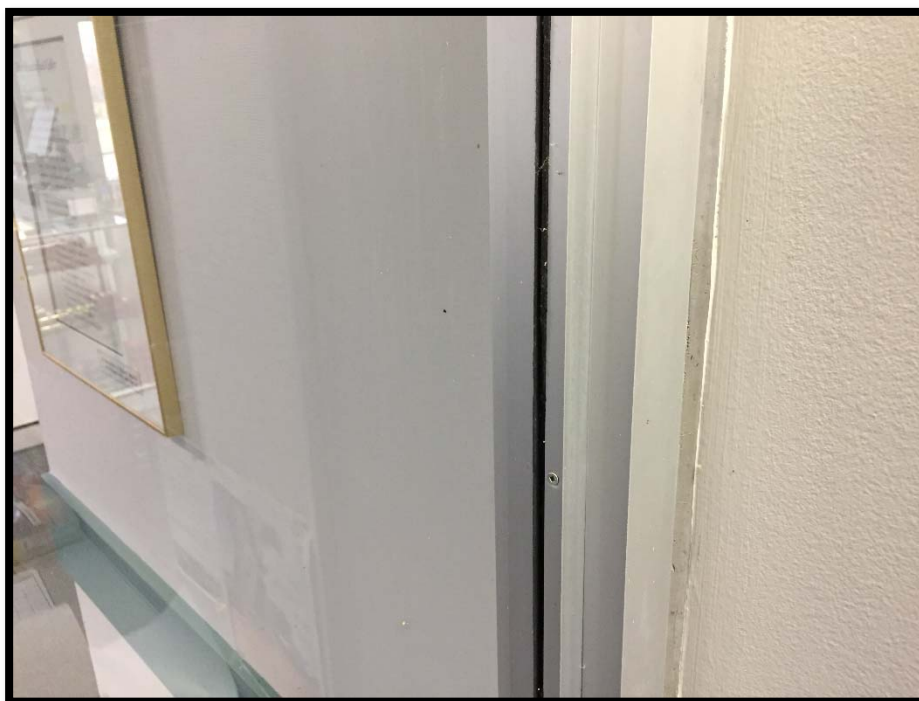
Black Interior Window Caulking

One (1) sample of black interior window caulking was collected during the assessment. The sample collected was found to contain 3.8% Chrysotile asbestos. Asbestos-containing black interior window caulking (see Photograph 3 in Appendix B) was observed in the following location:

- Room 106 (approximately 20 linear feet).

Photograph 3: Asbestos-Containing Black Interior Window Caulking.

If scheduled for impact, asbestos-containing black interior window caulking should be abated following low-risk abatement work procedures as outlined in the *Saskatchewan Asbestos Abatement Manual* (2017). Alternatively, as the black interior window caulking was observed in good condition, and with a priority rating of 5 (please see the room by room spreadsheet provided in Appendix C for a description of the priority ratings), it can be managed in place if not scheduled for impact.

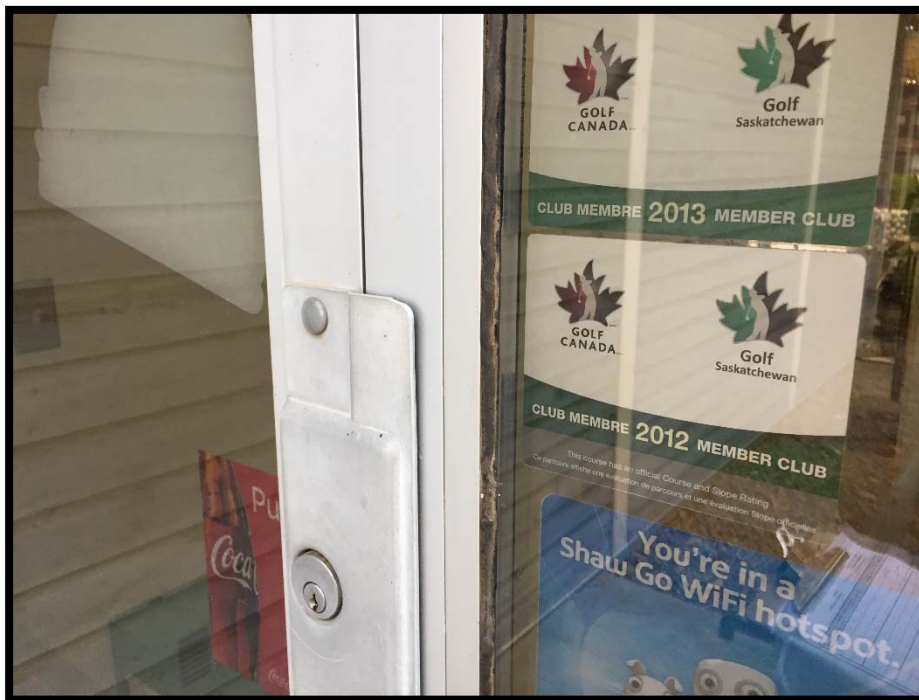
Black Exterior Window Caulking

One (1) sample of black exterior window caulking was collected during the assessment. The sample collected was found to contain 5.3% Chrysotile asbestos. Asbestos-containing black exterior window caulking (see Photograph 4 in Appendix B) was observed in the following location:

- Exterior (approximately 275 linear feet).

Photograph 4: Asbestos-Containing Black Exterior Window Caulking.

If scheduled for impact, asbestos-containing black exterior window caulking should be abated following low-risk abatement work procedures as outlined in the *Saskatchewan Asbestos Abatement Manual* (2017). Alternatively, as the black exterior window caulking was observed in good condition, and with a priority rating of 5 (please see the room by room spreadsheet provided in Appendix C for a description of the priority ratings), it can be managed in place if not scheduled for impact.
