November 21, 2017

CITY OF SASKATOON

Asbestos-Containing Building Materials Assessment Report - William A. Reid Park Rec Unit

Report Number: 1667963

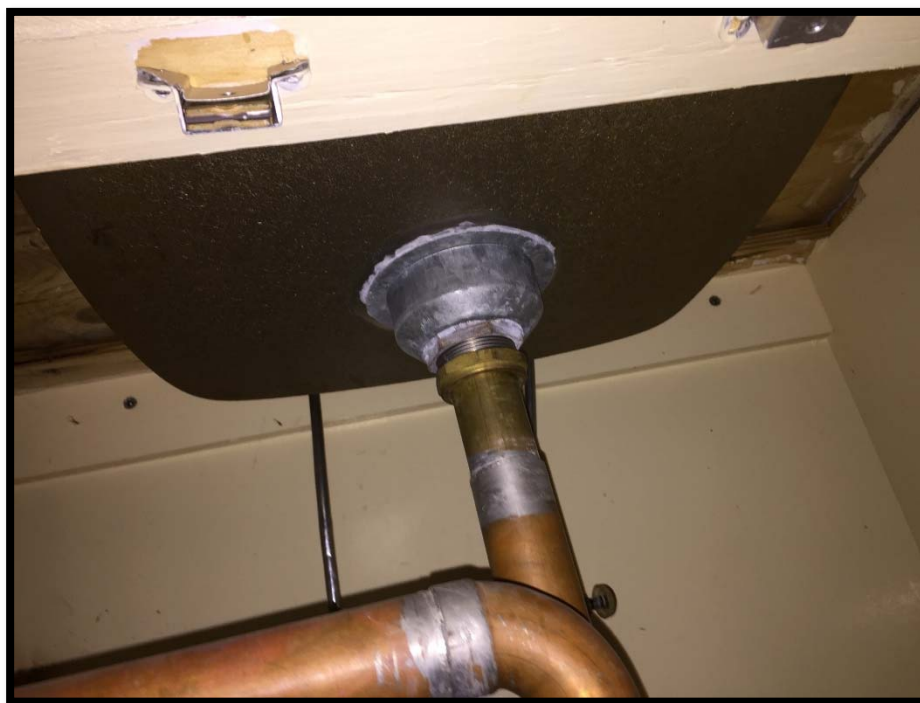
One (1) sample of gold sink undercoat was collected during the assessment. The sample collected was found to contain 1.9% Chrysotile asbestos. Asbestos-containing gold sink undercoat (see Photograph 1 in Appendix B) was observed in the following location:

- Room 106 (approximately 1 sink).

Photograph 1: Asbestos-Containing Gold Sink Undercoat.

Included	M	106	Washroom	Plumbing	Sink	Gold Sink Undercoat	High	Yes	Yes	Yes	Good		Bulk	A-004	14-Oct-17	Chrysotile	Gold Sink Undercoa	1.90%	No	No	No	Annually	5	Moderate	Manage in place	1 Sink	Photograph 1	Door Jamb
Included	E	Exterior	Exterior	Walls	Walls	Stucco	High	No	Yes	No	Good		Bulk	A-006, A-009, A-010	14-Oct-17													
Included	E	Exterior	Exterior	Walls	Walls	Construction Paper	High	No	Yes	No	Good		Bulk	A-012	14-Oct-17													
Included	E	Exterior	Exterior	Doors	Caulking	Brown Door Caulking	High	No	Yes	No	Good		Bulk	A-011	14-Oct-17													
Included	E	Exterior	Exterior	Ceiling	Ceiling	Plywood Overhang	High	No	No	No	Good																	
Excluded		Exterior	Roof	Exterior Roof	Exterior Roof							Not assessed due to scope of work.

If scheduled for impact, asbestos-containing gold sink undercoat should be abated following low-risk abatement work procedures as outlined in the *Saskatchewan Asbestos Abatement Manual* (2017). Alternatively, as the gold sink undercoat was observed in good condition, and with a priority rating of 5 (please see the room by room spreadsheet provided in Appendix C for a description of the priority ratings), it can be managed in place if not scheduled for impact.
