**ETERNAL MEMORIALS
ASBESTOS SURVEY REPORT**

February 2014

Prepared For: City of Saskatoon – Infrastructure Services Department
1101 Avenue P North, Saskatoon SK, Canada S7L 7K6
Attn: Brent Anderson

Prepared By: Bersch & Associates Ltd.
Project No. : B67SRB04

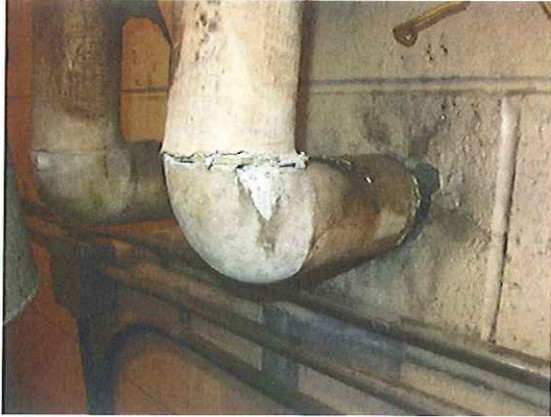
#1) Pipeline Fitting

NO.	DATE	SAMPLE INFORMATION	ASBESTOS	%	ANALYST
B1	13-May-13	Furnace Room - Pipeline fitting on small line adjacent water heater	None detected		WB
B2	13-May-13	Furnace Room - Duct insulation	None detected		WB
