CITY OF SASKATOON

Asbestos-Containing Building Materials Assessment Report - Avenue C Substation

Report Number: 1667963

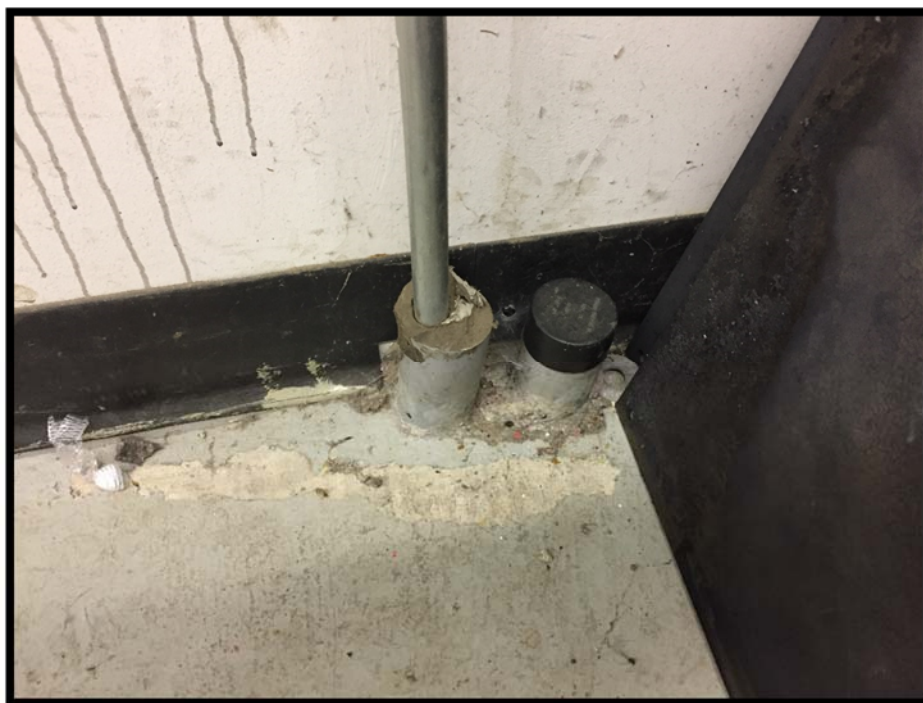
One (1) sample of grey firestop was collected during the assessment. The sample was found to contain 2.4% Chrysotile asbestos. The asbestos-containing grey firestop was observed to be in good condition at the time of the assessment and in a non-friable form. Asbestos-containing grey firestop (see Photograph 1) was observed in the following locations:

- Room 100 (approximately 1 ft²).

Photograph 1: Asbestos-Containing Grey Firestop.

If scheduled for impact, asbestos-containing grey firestop should be abated following low-risk abatement work procedures as outlined in the *Saskatchewan Asbestos Abatement Manual* (2017). Alternatively, as the firestop is non-friable, in good condition, and with a priority rating of 5 (please see the room by room spreadsheet provided in Appendix C for a description of the priority ratings), it can be managed in place and inspected annually if not scheduled for impact.
