ETERNAL MEMORIALS ASBESTOS SURVEY REPORT

February 2014

Prepared For: City of Saskatoon – Infrastructure Services Department
1101 Avenue P North, Saskatoon SK, Canada S7L 7K6
Attn: Brent Anderson

Prepared By: Bersch & Associates Ltd.
Project No. : B67SRB04

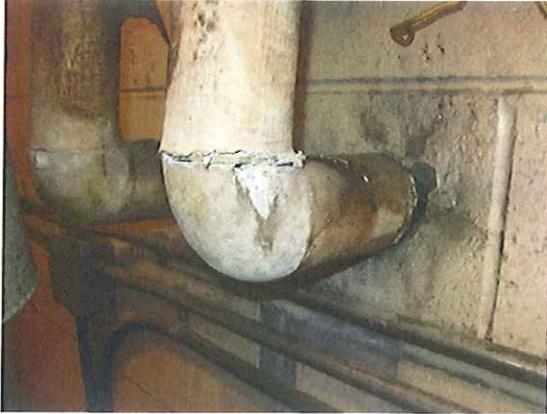
#1) Pipeline Fitting

NO.	DATE	SAMPLE INFORMATION	ASBESTOS	%	ANALYST
B1	13-May-13	Furnace Room - Pipeline fitting on small line adjacent water heater	None detected		WB
B2	13-May-13	Furnace Room - Duct insulation	None detected		WB
