PHASE I ASBESTOS INSPECTION REPORT

Conducted At: Building #2
1101 Avenue P North
Saskatoon, SK

got mold?™ Project Number: 2721AI

Inspection Date: June 21, 2016
Report Date: August 15, 2016

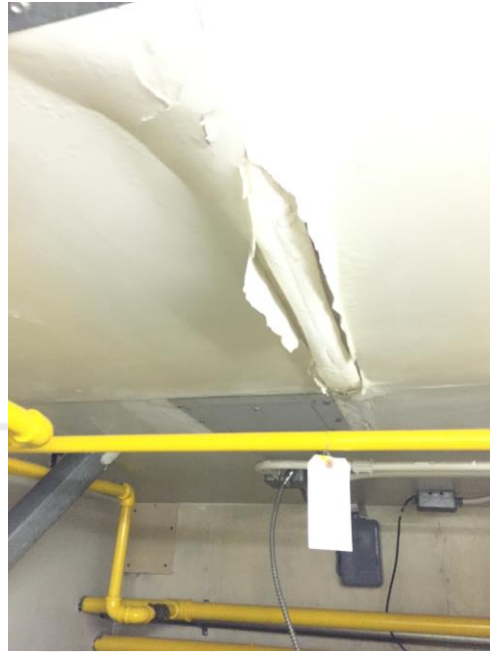
Ceiling Damage

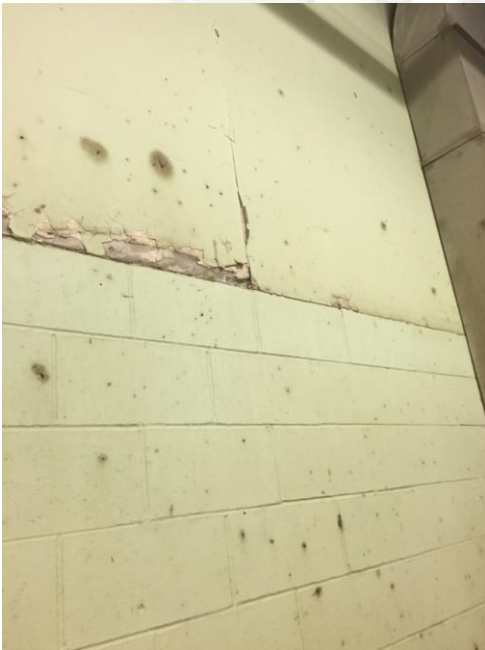
- The drywall on the concrete block wall to the left of the overhead door is beginning to crumble. This could be an indication of water infiltration.
- There's some damage to the wall insulation at the top left of the overhead door.

Damaged Drywall

While no asbestos containing materials were found as a result of our inspection, we would like to bring to your attention a couple of observations that may warrant further investigation on the part of the building owner.

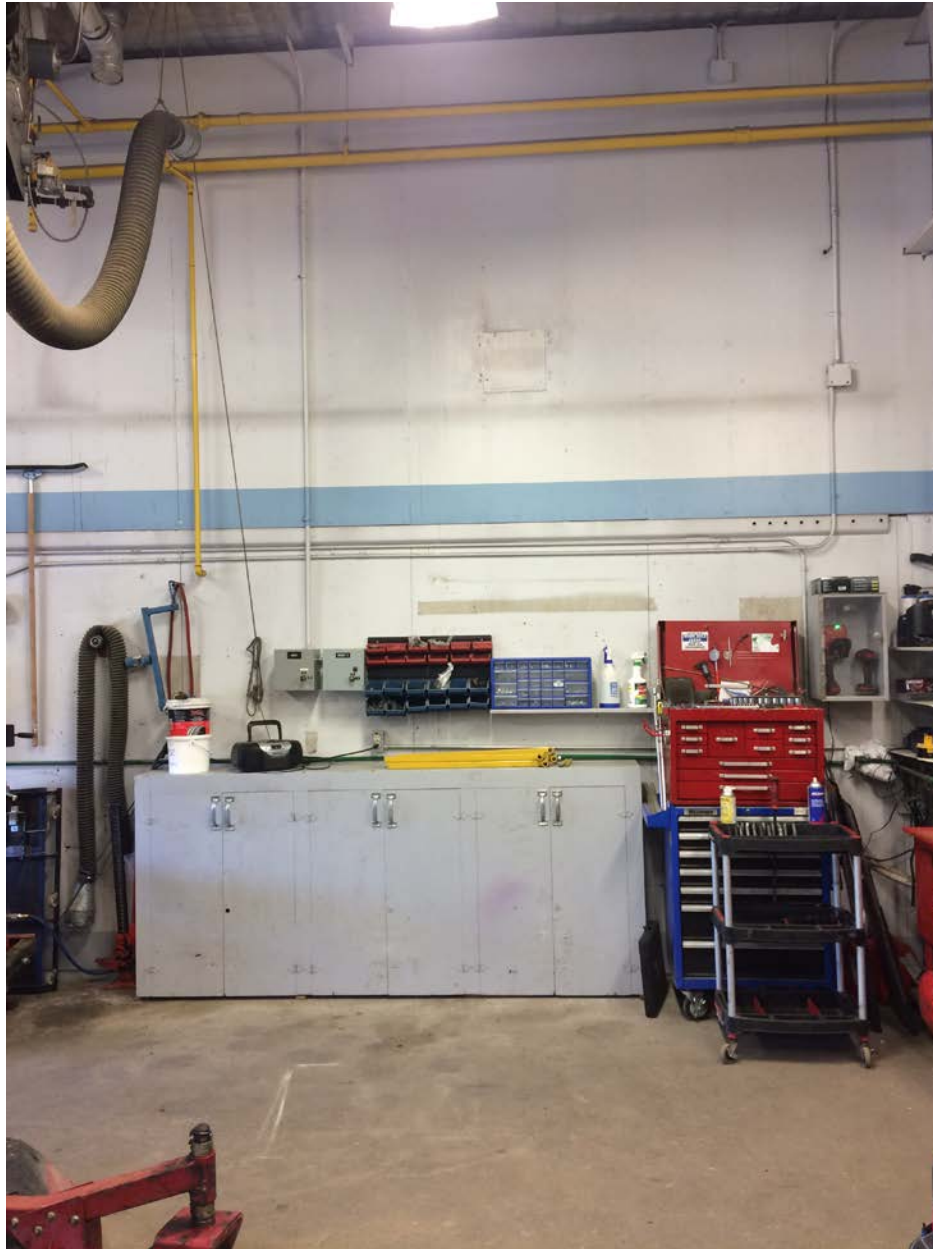
The project involves the installation of a central vacuum system on the east shop wall. The lower, approximately 8 feet of this wall is finished with transite board. One (1) sample, of the transite board was collected and analyzed for the presence/ absence of asbestos. Asbestos **was** detected within the sample. Above the transite board is a steel lintel above which the wall is finished with 1/2in plywood sheathing. A small patch of the plywood wall was removed to determine the materials located in the wall space. The interior of the wall was determined to be wood framing with a metal clad exterior. The wall is insulated with fiberglass insulation. One sample of the insulation was collected and analyzed. The insulation was found to not contain asbestos. The vacuum is to be vented into the small storage shed on the exterior of the building. The west interior wall is the same metal cladding as the exterior of the building. There are no asbestos concerns within this area.

Based on observations during the site visit and the results of bulk sampling, there is an asbestos concern regarding the transite board identified on the lower portion of the shop wall. The vacuum

Figure 1- East wall of Maintenance Shop- Lower portion finished with Transite Board.

system can be mounted and plumbed above the metal lintel on the plywood section of wall without disturbing the transite board wall covering on the lower portion. A second option is to remove and replace a panel of transite board following low-risk procedures (avoiding cutting, breaking, drilling or grinding the board) to facilitate the installation of the vacuum system.

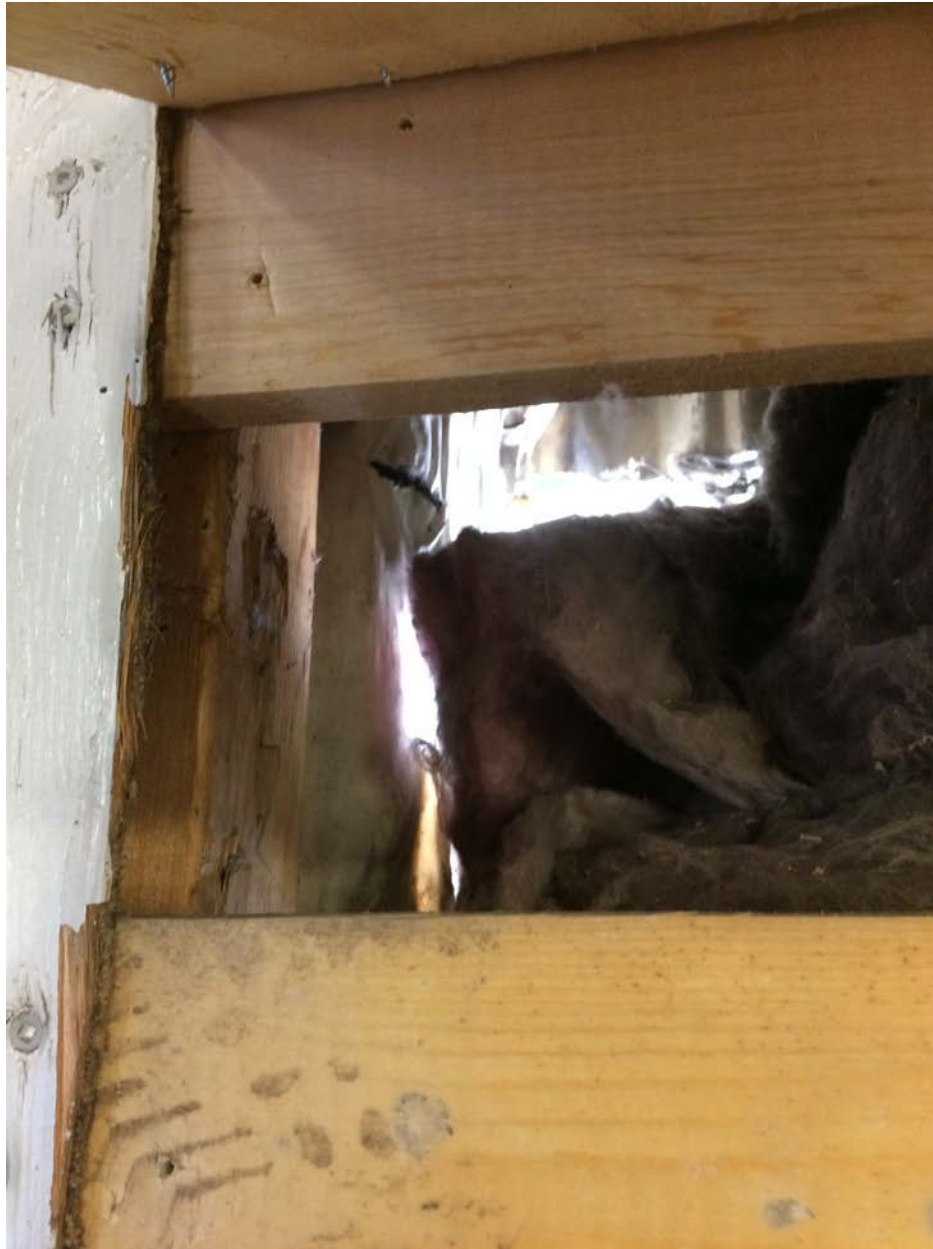
Figure 2- Wall cavity accessed from patch.
