October 25, 2017

CITY OF SASKATOON

Asbestos-Containing Building Materials Assessment Report - Bowerman House Garage

Report Number: 1667963

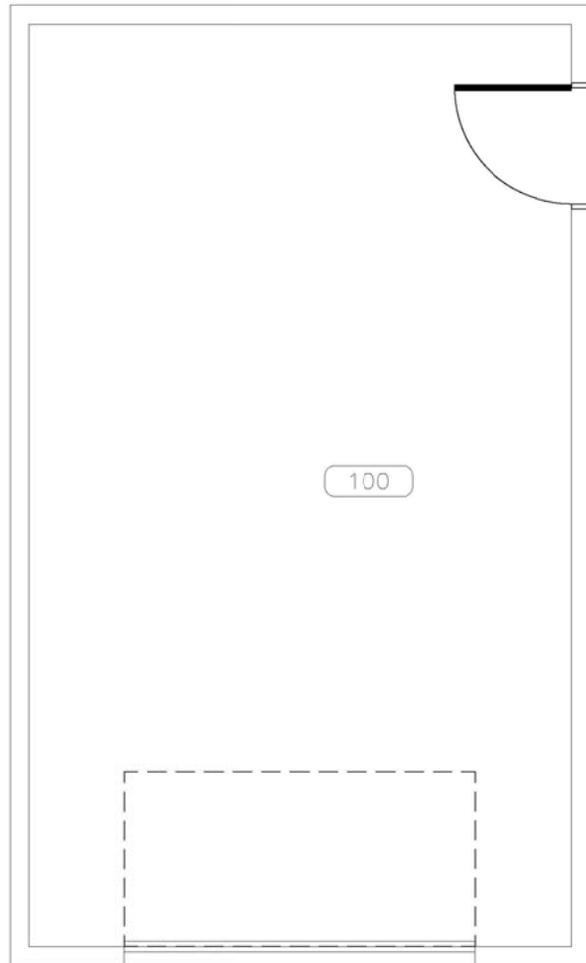
FIGURE
 1

1. ASBESTOS IS A CARCINOGEN. DO NOT BREATHE ASBESTOS DUST.
2. ASBESTOS-CONTAINING MATERIALS WERE NOT OBSERVED WITHIN THE GARAGE AT THE TIME OF THE ASSESSMENT.
