**CITY OF SASKATOON – BOWERMAN HOUSE
ASBESTOS SURVEY REPORT**

APRIL 2013

Prepared By: Bersch & Associates Ltd.
Project No. : B67SRD29B

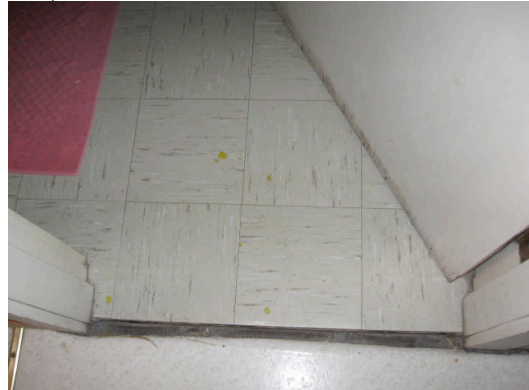
#4) 9" X 9" Floor Tile

9-inch by 9-inch floor tile was identified as containing asbestos. This material was observed to be in good condition with a low potential for disturbance. The material may be managed, however due to the quantity present, removal of the floor tile may be considered to eliminate all concerns in the future.

PRIORITY:	THREE
CONDITION:	GOOD
POTENTIAL FOR DISTURBANCE:	LOW
ACTION:	MANAGE / REMOVE

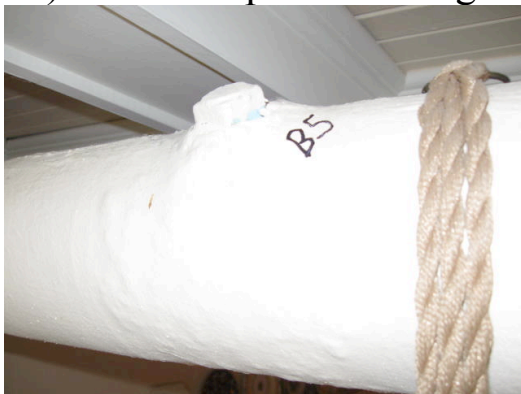
#5) Mud Compound Fitting

Mud compound on the pipeline fittings was identified as containing asbestos. This material was observed to be in good condition with a low potential for disturbance. The material may be managed, however due to the quantity present, removal of the mud compound may be considered to eliminate all concerns in the future.

PRIORITY:	THREE
CONDITION:	GOOD
POTENTIAL FOR DISTURBANCE:	LOW
ACTION:	MANAGE / REMOVE
