CITY OF SASKATOON

Asbestos-Containing Building Materials Assessment Report - Bob Van Impe Ballfield Grandstands

Report Number: 1667963

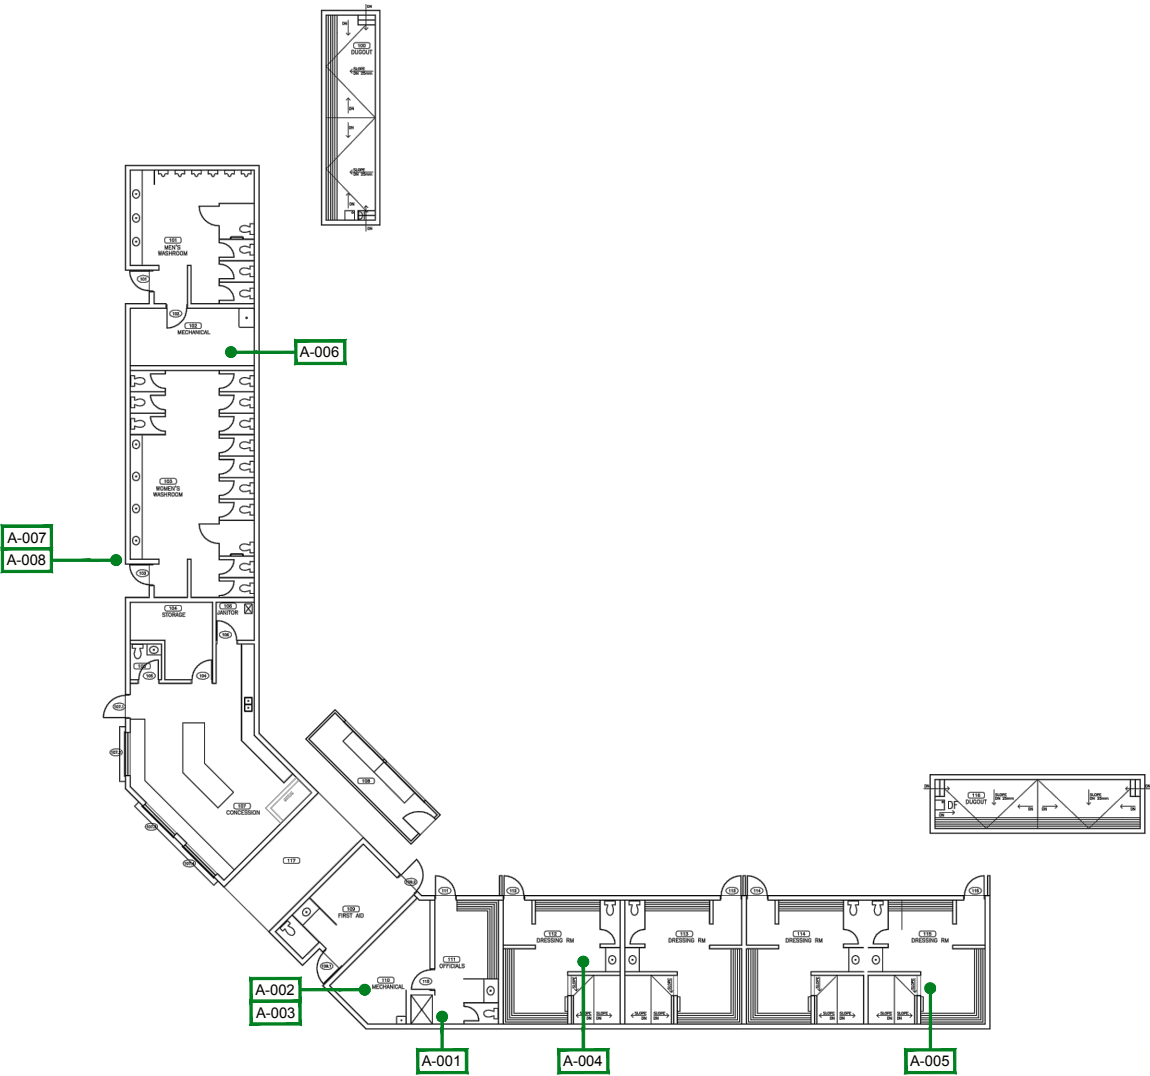
TITLE
MAIN FLOOR

NOTE(S)
1. ASBESTOS IS A CARCINOGEN. DO NOT BREATHE ASBESTOS DUST.
2. ASBESTOS-CONTAINING MATERIALS WERE NOT OBSERVED WITHIN THE BUILDING AT THE TIME OF THE ASSESSMENT.
