July 14, 2017

## CITY OF SASKATOON

# Asbestos-Containing Building Materials Assessment Report - Bob Van Impe Ballfield Ticket Building

**Report Number: 1667963**

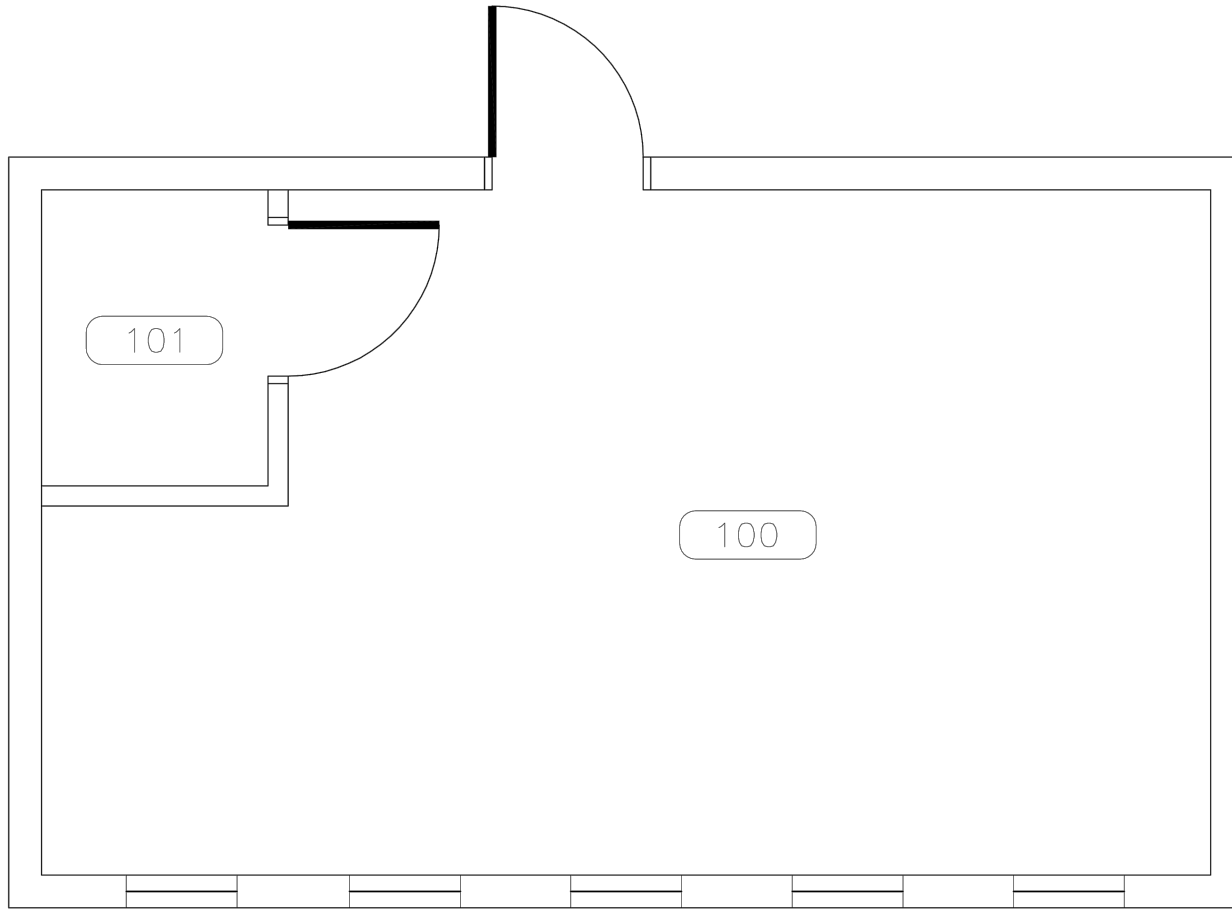
FIGURE  
 1

1. ASBESTOS IS A CARCINOGEN. DO NOT BREATHE ASBESTOS DUST.
2. ASBESTOS-CONTAINING MATERIALS WERE NOT OBSERVED WITHIN THE TICKET BUILDING AT THE TIME OF THE ASSESSMENT.

If suspect asbestos-containing building materials are encountered during renovation or demolition activities, sampling should be undertaken to evaluate asbestos content.
