**Cosmo Civic Centre
Saskatoon, SK.**

**Asbestos Survey Report
March 2015**

Prepared By: Bersch & Associates Ltd.
Project No. : B67SRL17

Subject: Pre-Renovation Assessment – Cosmo Civic Centre – South Ramp Replacement

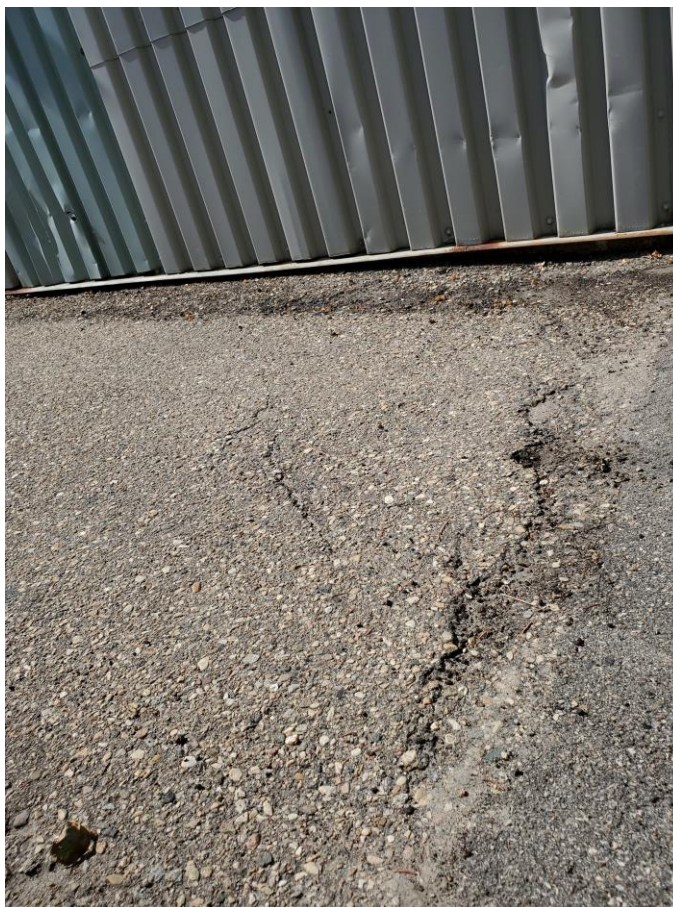
B67PRG13J - 002

Ramp on South Side of the
Building – Composite Sample.

Non-asbestos asphalt.

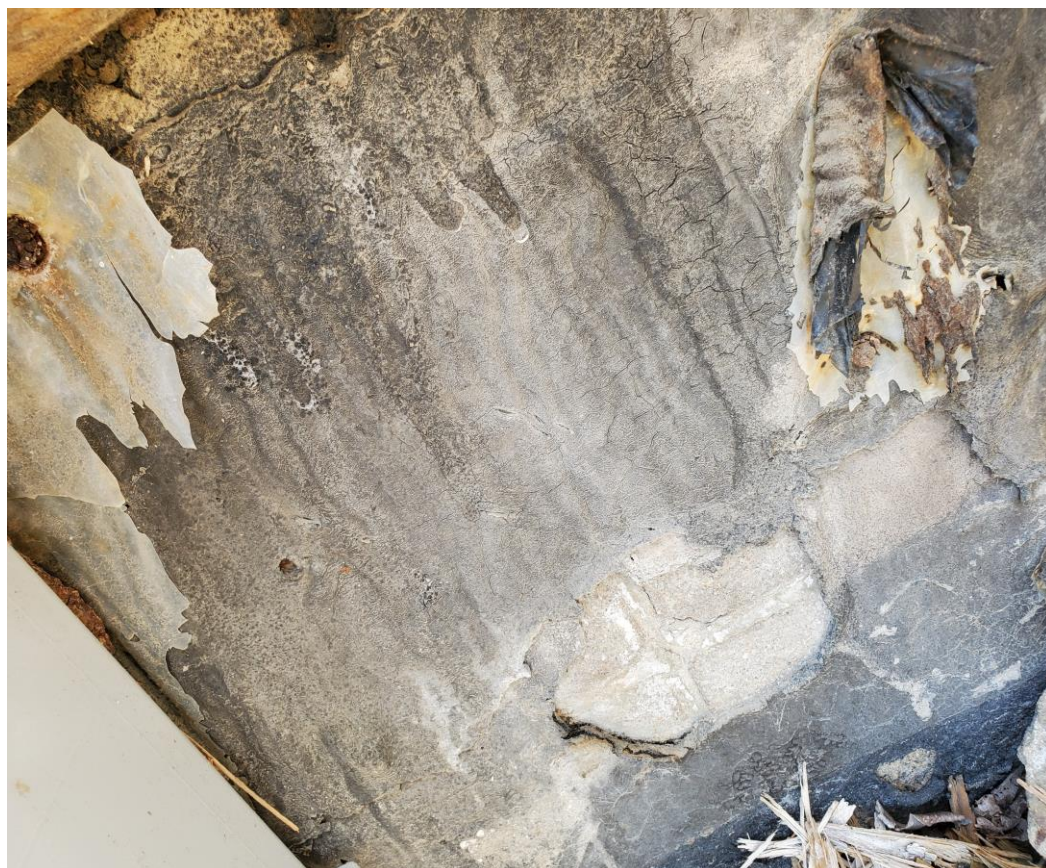
B67PRG13J - 003

Ramp on South Side of the
Building. Portion of Retaining
Wall Adjacent the Fiber Optic Pull
Box.

Non-asbestos tar wall membrane.

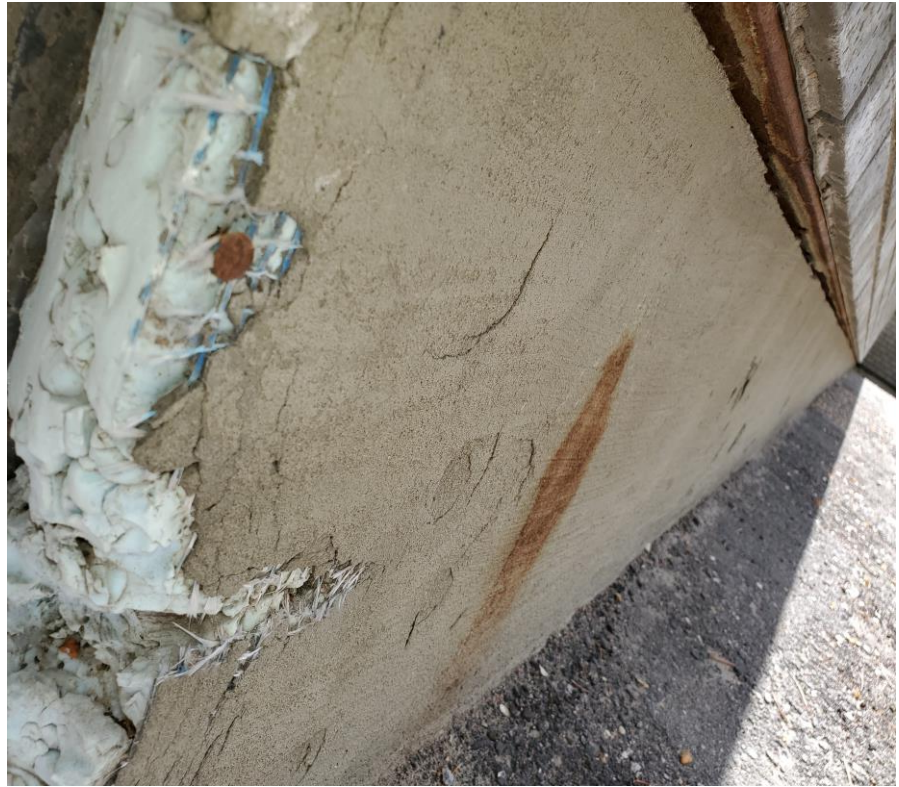
B67PRG13J - 004

Asbestos containing tar.

Non-asbestos parging.

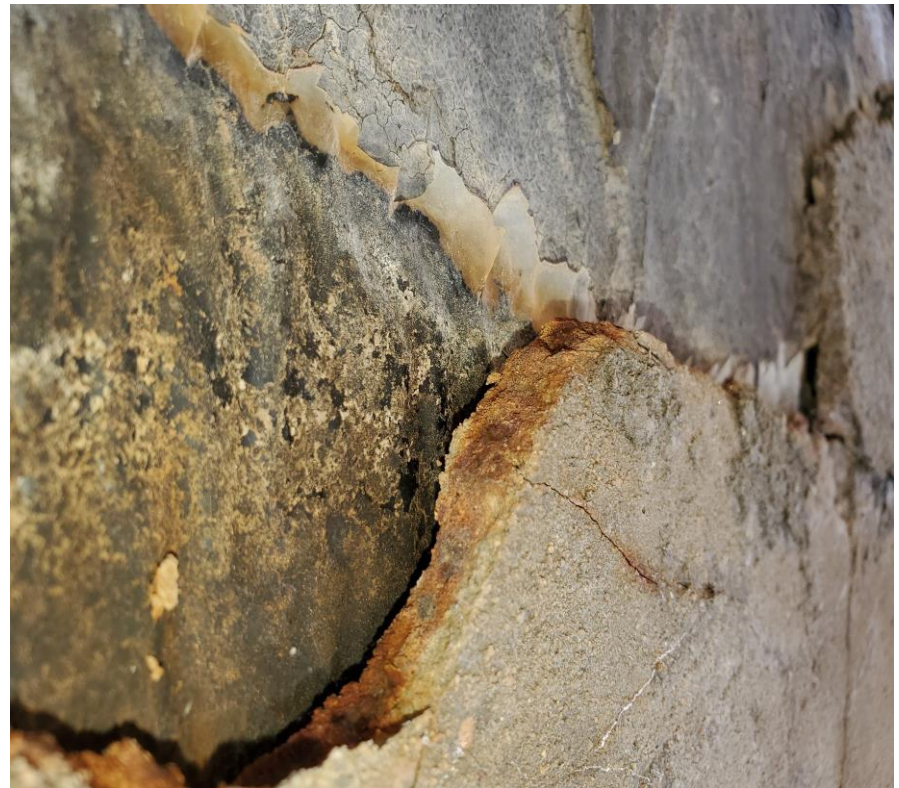
B67PRG13J – 005

Ramp on South Side of the Building, Lower Guardrail Wall Adjacent the Fiber Optic Pull Box.

Non-asbestos parging.

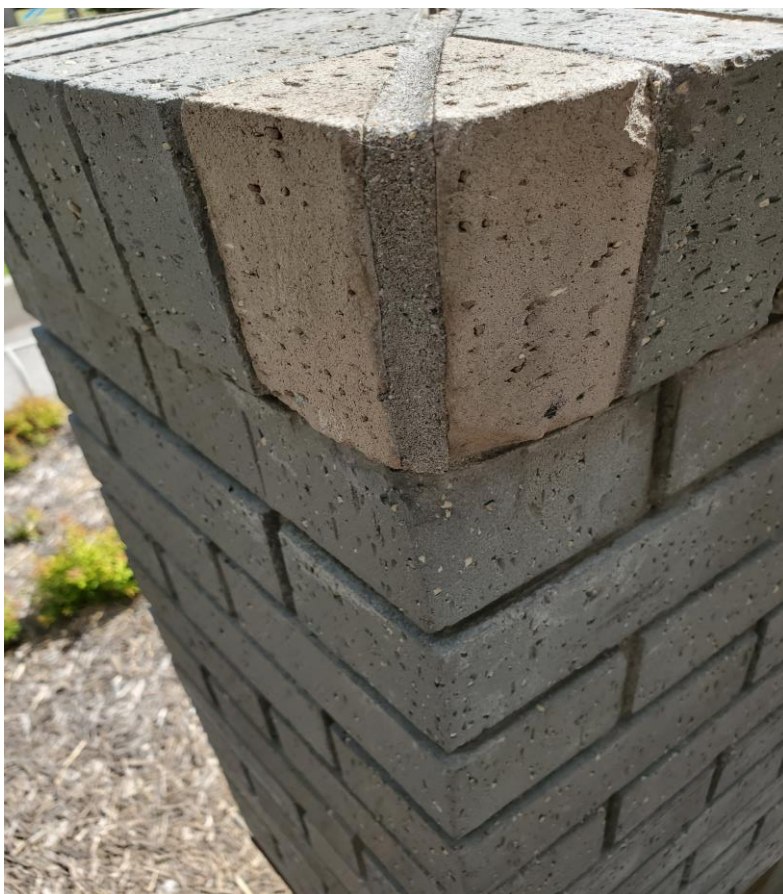
B67PRG13J – 006

Ramp on South Side of the Building.

Non-asbestos brick mortar.

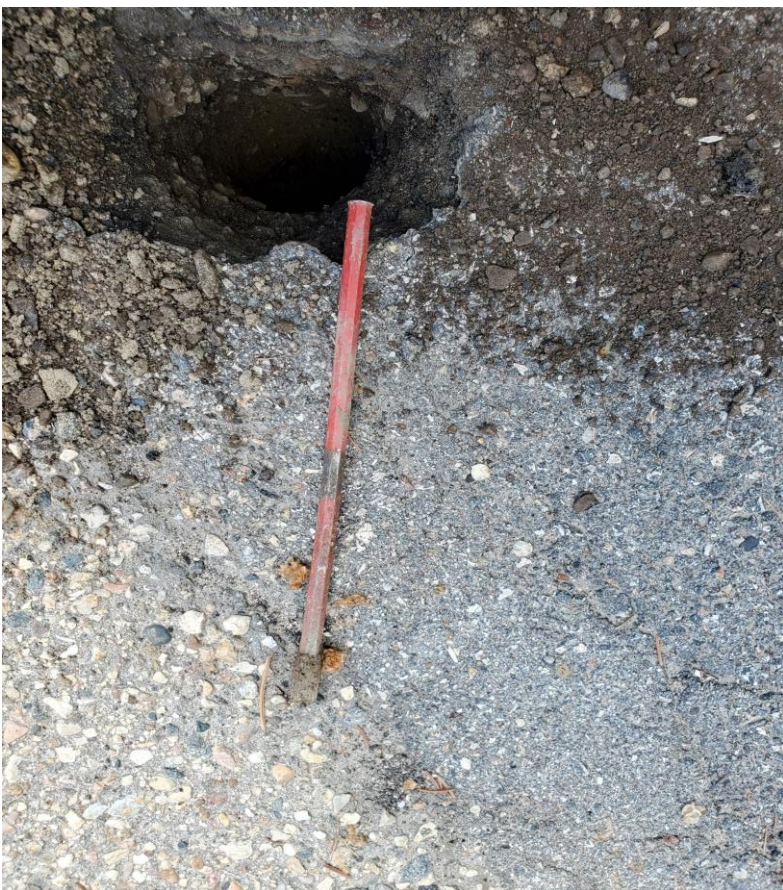
B67PRG13J – 007

Ramp on South Side of the Building. Material below the Asphalt/Dirt/Styrofoam.

Non-asbestos tar waterproofing.

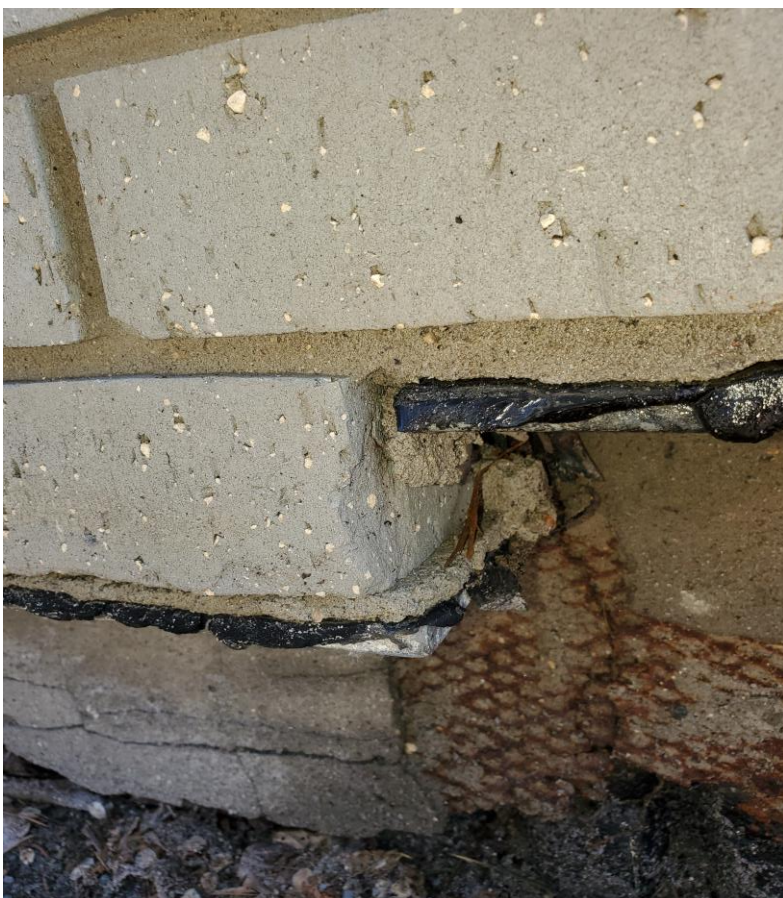
B67PRG13J – 008

Southwest Angled Wall Thru-wall
Flashing at the base of the brick
on the angle.

Asbestos containing flashing
membrane.

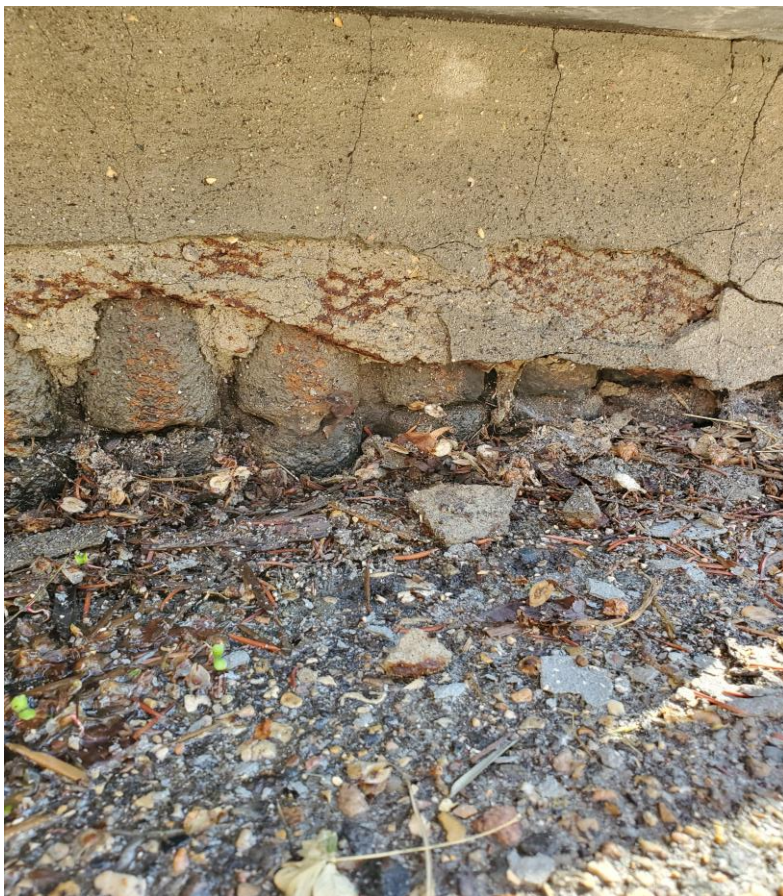
B67PRG13J – 009

Lower Southwest Angled Wall
below the Hose Bib.

Non-asbestos parging.

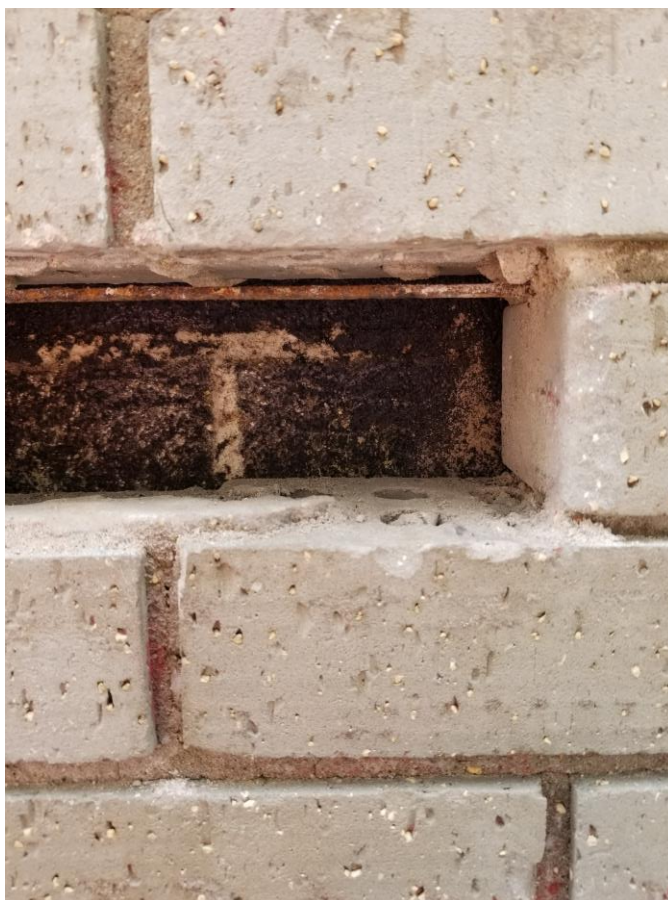
B67PRG13J – 010

Guardrail north wall surface
behind brick.

Asbestos containing
waterproofing.

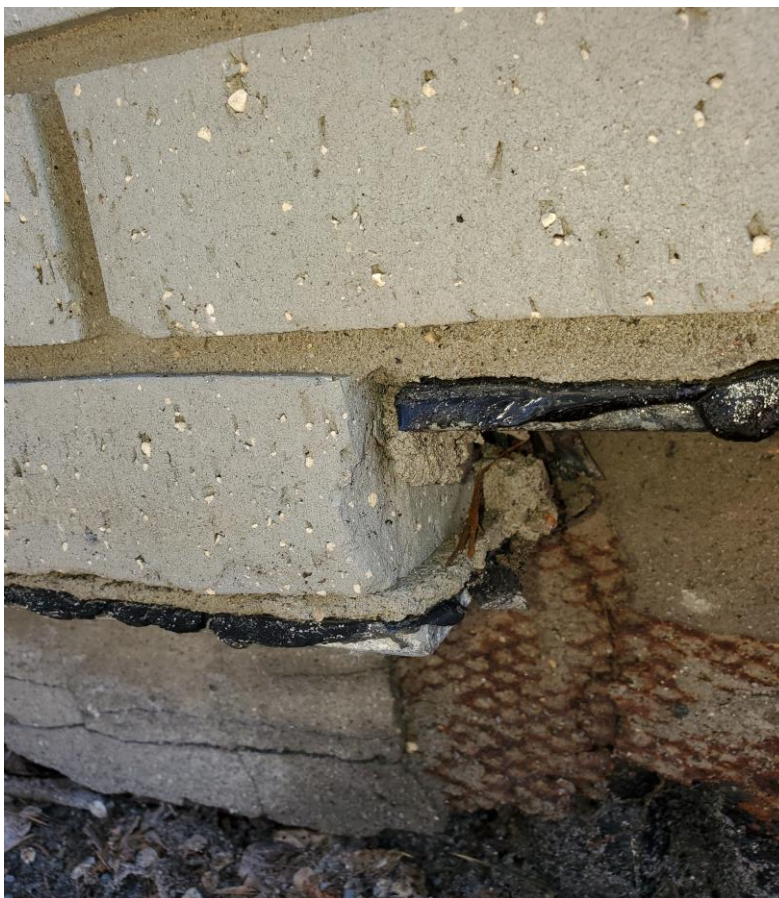
B67PRG13J – 011

Guardrail wall on the south side
of the wall. Thru-wall Flashing at
the base of the brick on the step
angle.

Asbestos containing.

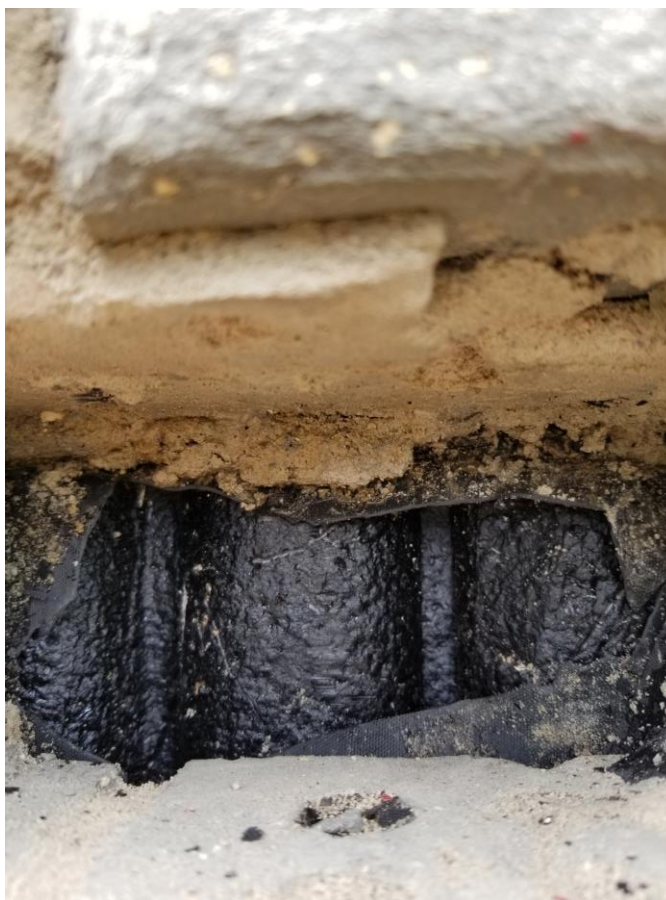
B67PRG13J – 012

Guardrail south wall surface
behind the brick. EPDM
waterproofing and tar coating.

Asbestos containing.

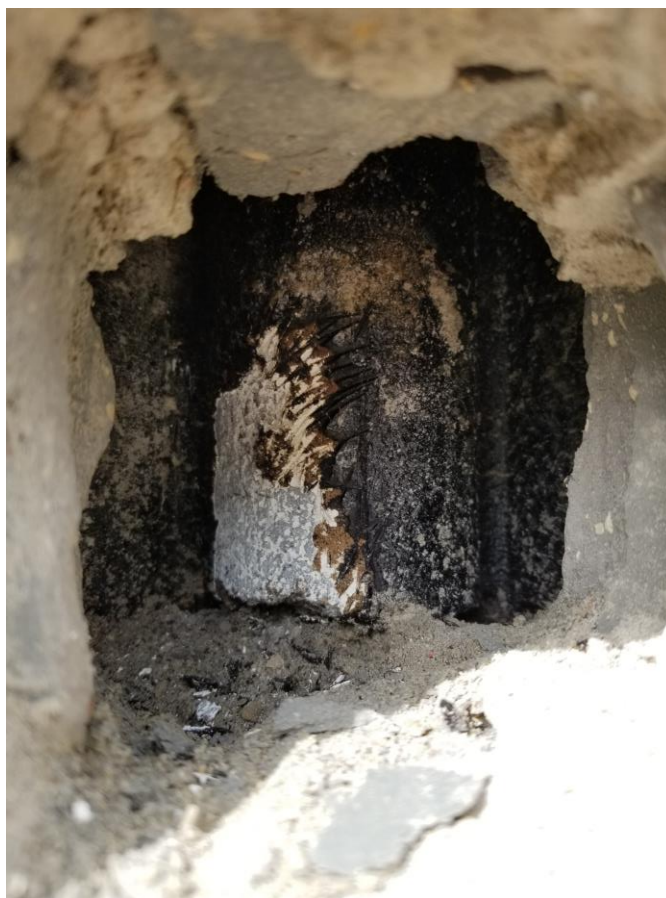
B67PRG13J – 013

Southwest angled wall surface
behind brick.

Asbestos containing
waterproofing.

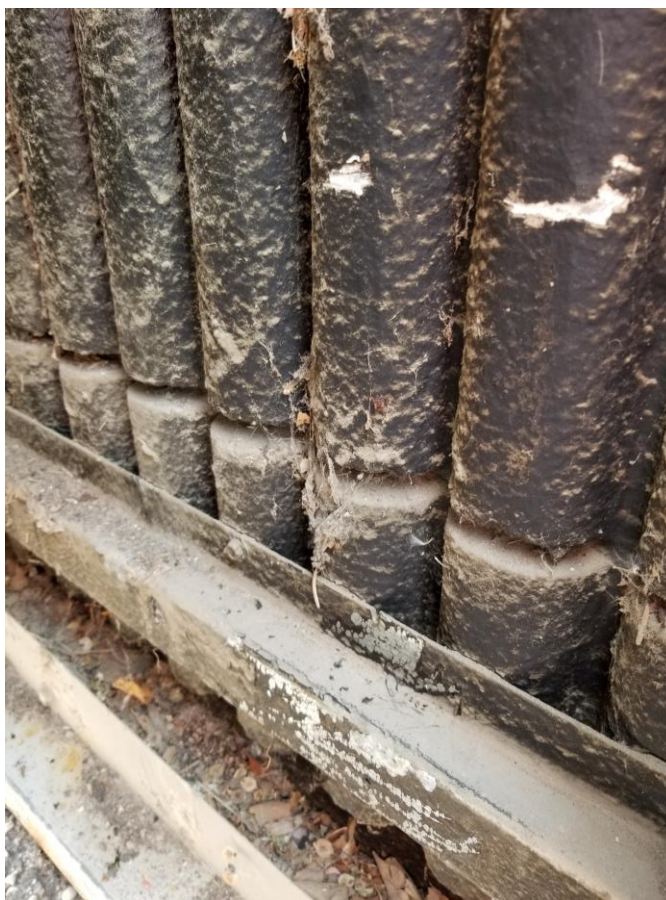
South building wall surfaces
behind cladding.

Asbestos containing
waterproofing.
