**City Hall North
Asbestos Survey Report**

January 2015

Prepared For: City of Saskatoon Infrastructure Services - Facilities Branch
3130 Laurier Drive, Saskatoon, SK.
Attn: Brent Anderson

Prepared By: Bersch & Associates Ltd.
Project No. : B67SRA16

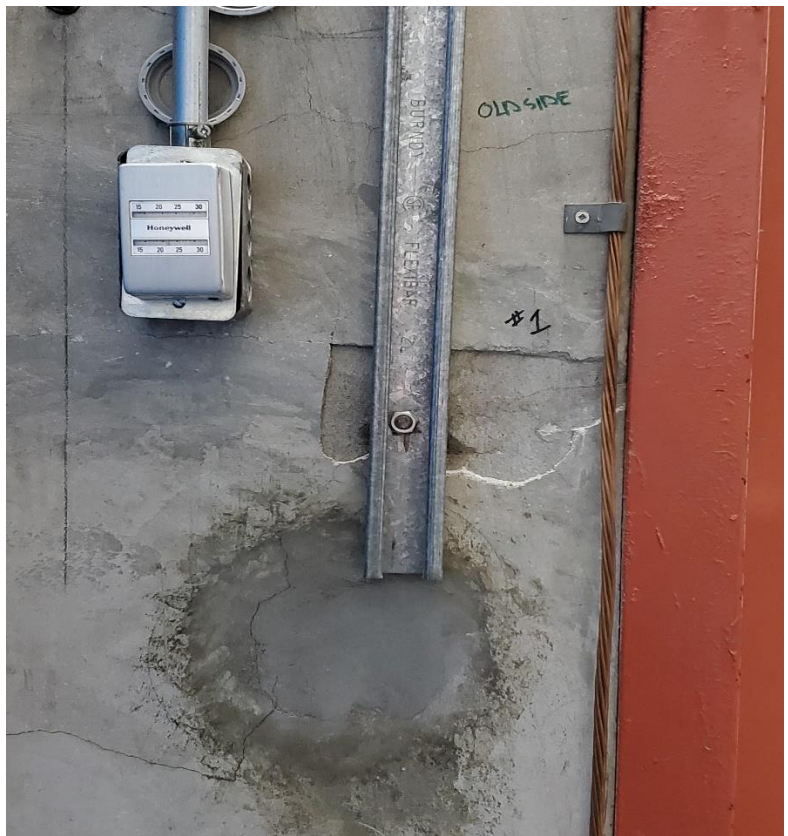
Sample Number 1**Description**

Grey Skim Coat in
Electrical Room adj. Boiler
Room – East Wall adj.
Entrance

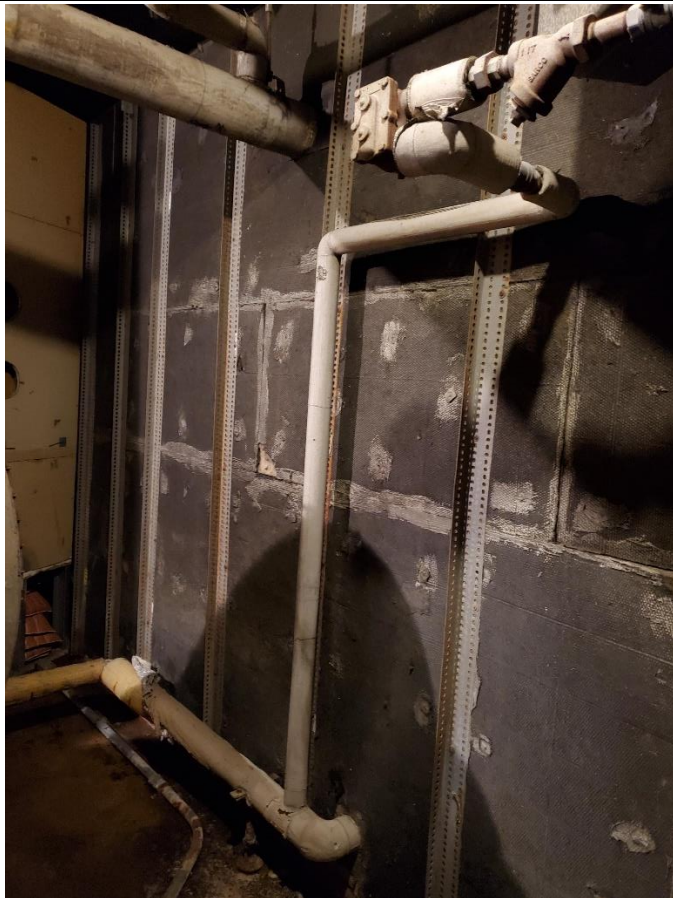
Sample Number 5**Description**

- c) The rigid insulation material within the air plenums was identified as containing 8% Chrysotile Asbestos in the black tar coating. The insulation itself is a fibre-glass composition. The black tar coating is also a non-friable material and poses no health-related concern in its present condition and location. The Chrysotile fibres are imbedded in a tar mixture that would require elimination of the tar for the fibres to become airborne. If removal of the rigid insulation is not necessary to accommodate the building improvements, it may remain in place until renovation/demolition activity warrants prior removal.

Black Tar Coating on
Rigid Fibre-glass in F17
Coil Room – North Wall

- d) Any removal of the rigid insulation with black tar coating will be completed as a Low Risk Asbestos Process. This will entail the isolation of any penetrations into the plenum to prevent any airflow through the work area. Isolations will be completed with poly-weave 6 mill sheeting and sealed with duct tape to ensure of an airtight seal. Any black tar coated insulation removed will be disposed of in 6 mil asbestos disposal bags and transported to an approved landfill. Workers involved in the removal activity will be equipped with P100 respirators and wear disposable coveralls. Upon completion of the removal activity all dust/debris from within the work area will be removed using HEPA vacuums. For any areas where the insulation requires removal Bersch Consulting Ltd. will complete inspection and air monitoring prior to deem the area suitable for access by other trades involved in the project and verify that all required work has been completed in accordance with all regulating authorities.
