**City Hall
Asbestos Survey Report**

January 2015

Prepared For: City of Saskatoon Infrastructure Services - Facilities Branch
3130 Laurier Drive, Saskatoon, SK.
Attn: Brent Anderson

Prepared By: Bersch & Associates Ltd.
Project No. : B67SRA14

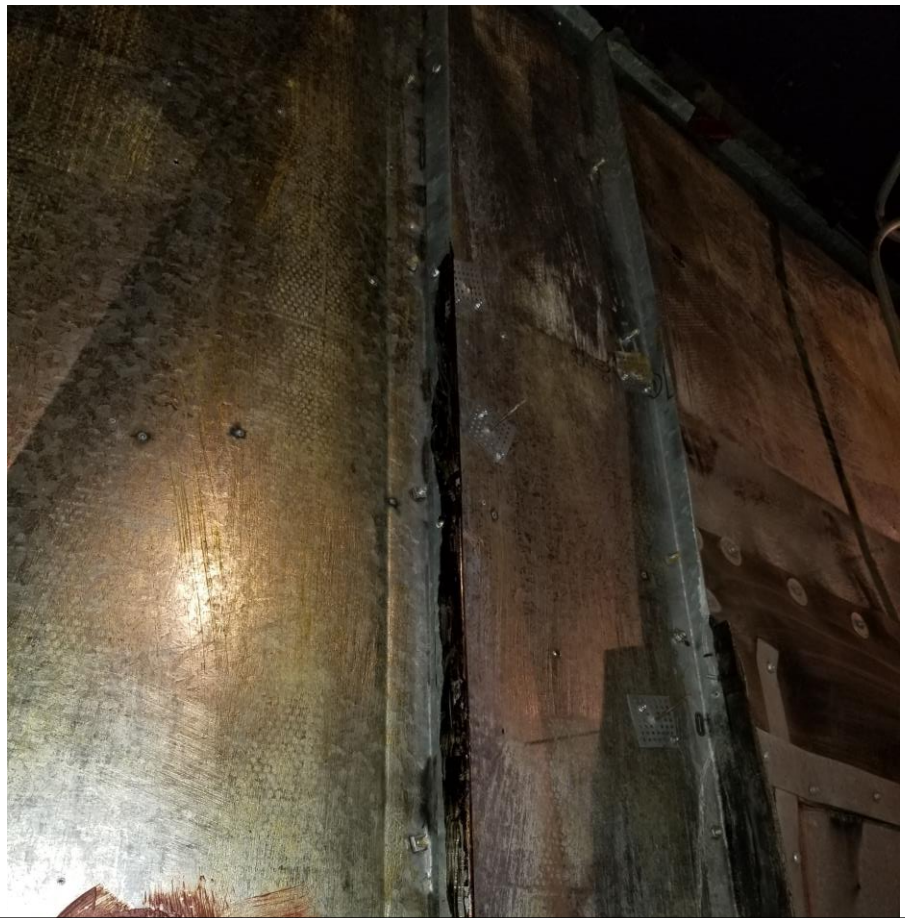
Tar on the Angle Iron.

Right side of doorway in F17
suction side of wall.

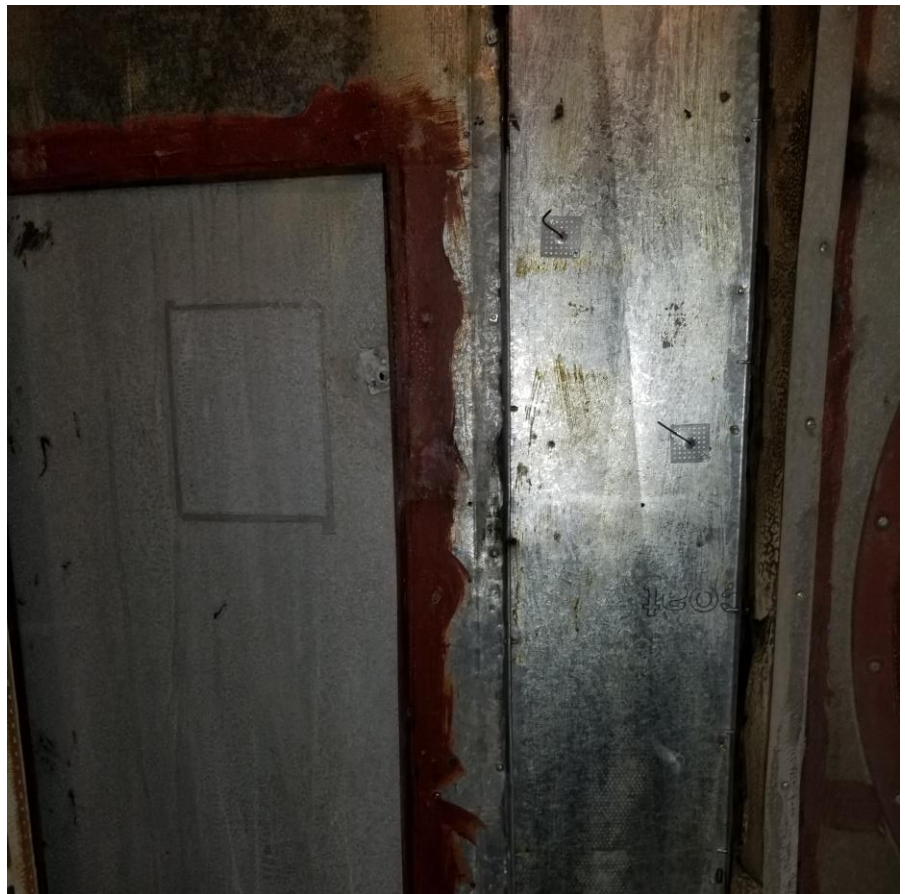
B67IRC28J - 002

Red Sealant on the doorway.

F17 suction side.

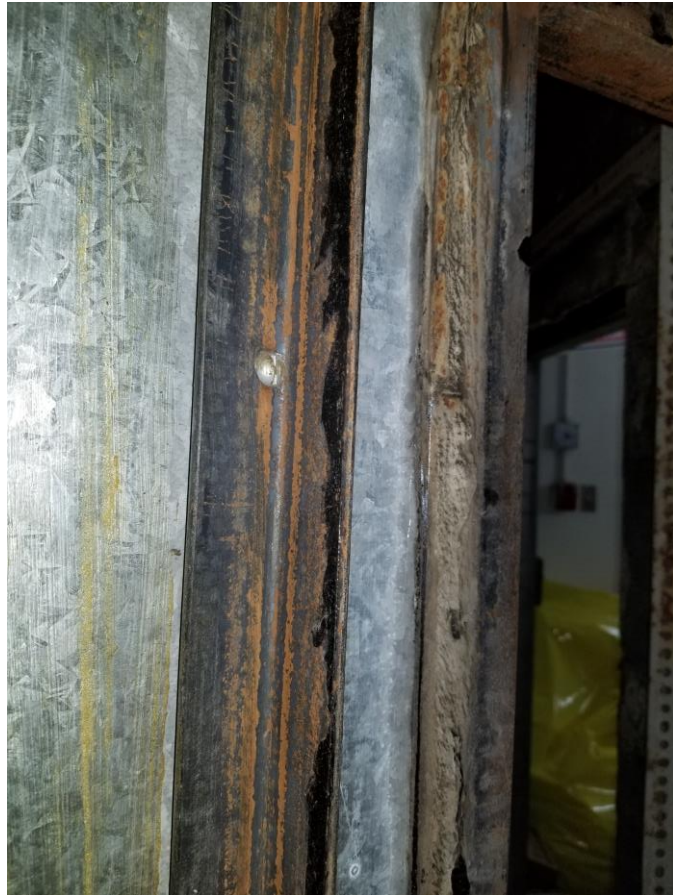
B67IRC28J - 003

Tar on the Angle Iron.

Left side of doorway in F17 coil or
discharge side of wall.

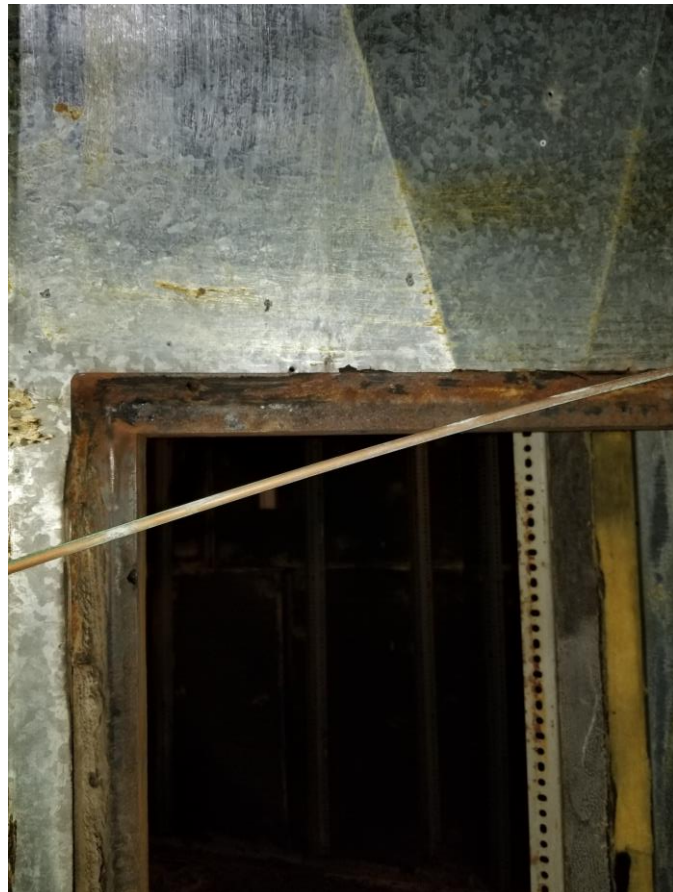
B67IRC28J - 004

Tar on the Angle Iron.

Above the doorway in F17 coil or
discharge side of wall.
