**City of Saskatoon
Civic Square East
202 4th Ave North, Saskatoon, Sk.**

**Asbestos Survey Report
November 2016**

**Prepared By: Bersch & Associates Ltd.
Project No.: B40SRH29F**

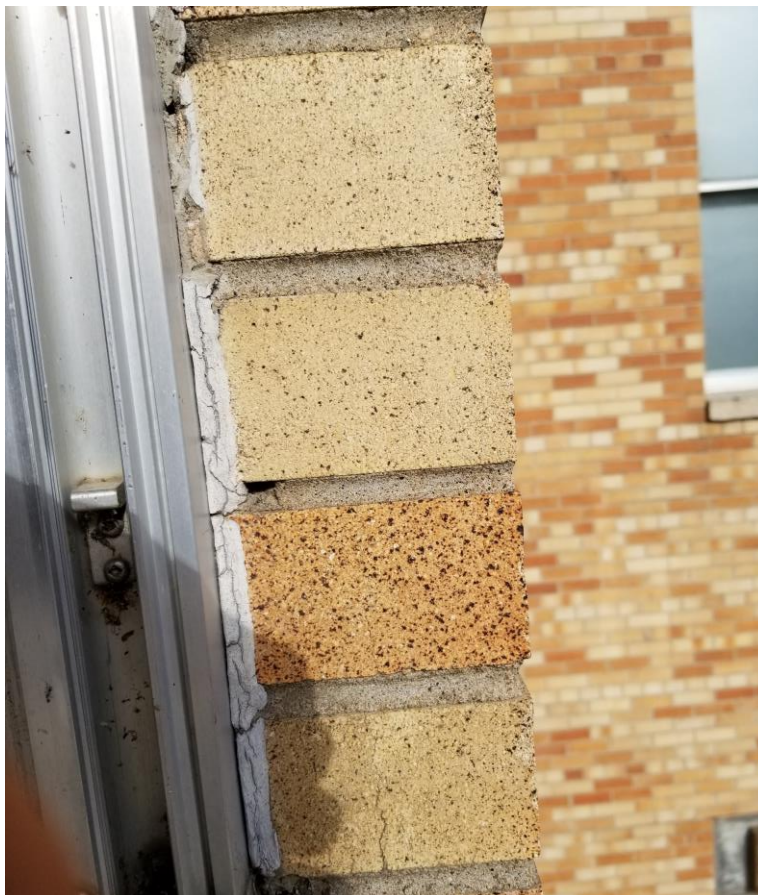
345 Staff Lounge Exterior

- a) **345 Staff Lounge** - The caulking between the window frame and the brick is deemed as containing asbestos. Refer to **Sample 1** of the Bulk Analysis in Appendix I.
- b) **316 Office Area** - The caulking between the window frame and the stone is deemed as containing asbestos. Refer to **Sample 3** of the Bulk Analysis in Appendix I.
- c) **Window Mullions** – The area behind a window mullion was observed and determined to be fiberglass insulation. This area does not contain asbestos material. Refer to **Photo 4** in **Appendix II Site Photos**.

Caulking Between Window
Frame and Brick.

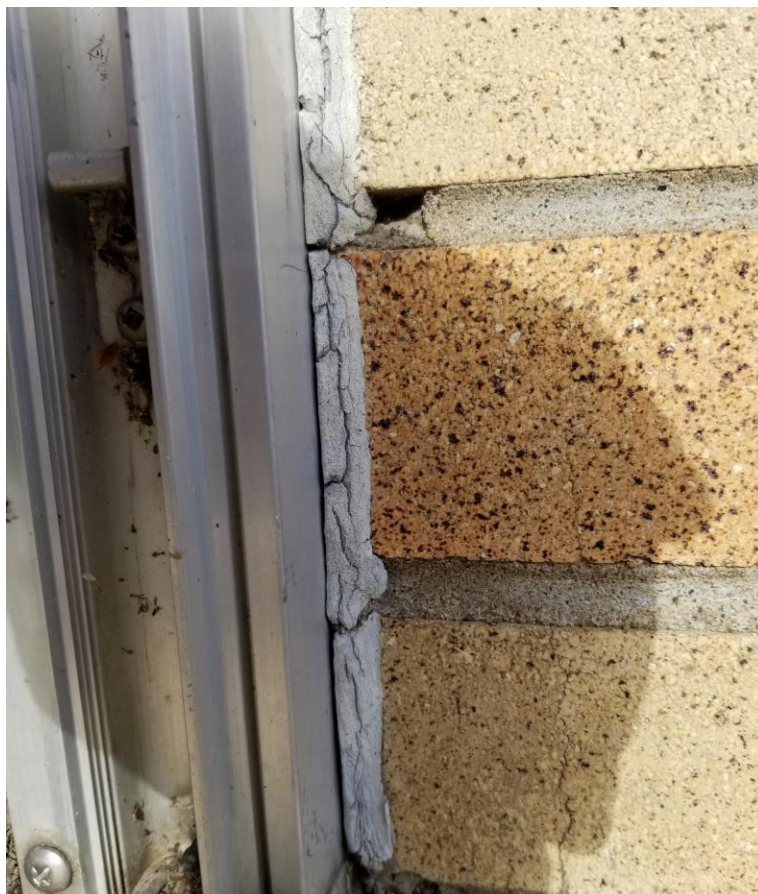
345 Staff Lounge Exterior

Exterior Brick Mortar.

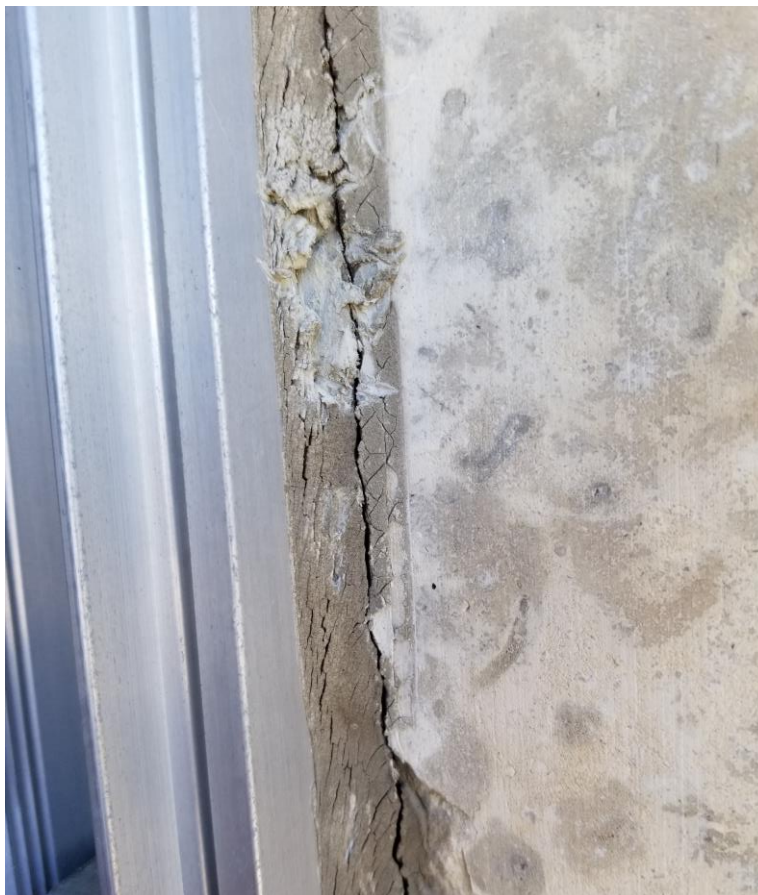
316 Office Area Exterior

Caulking Between Window
Frame and Stone.

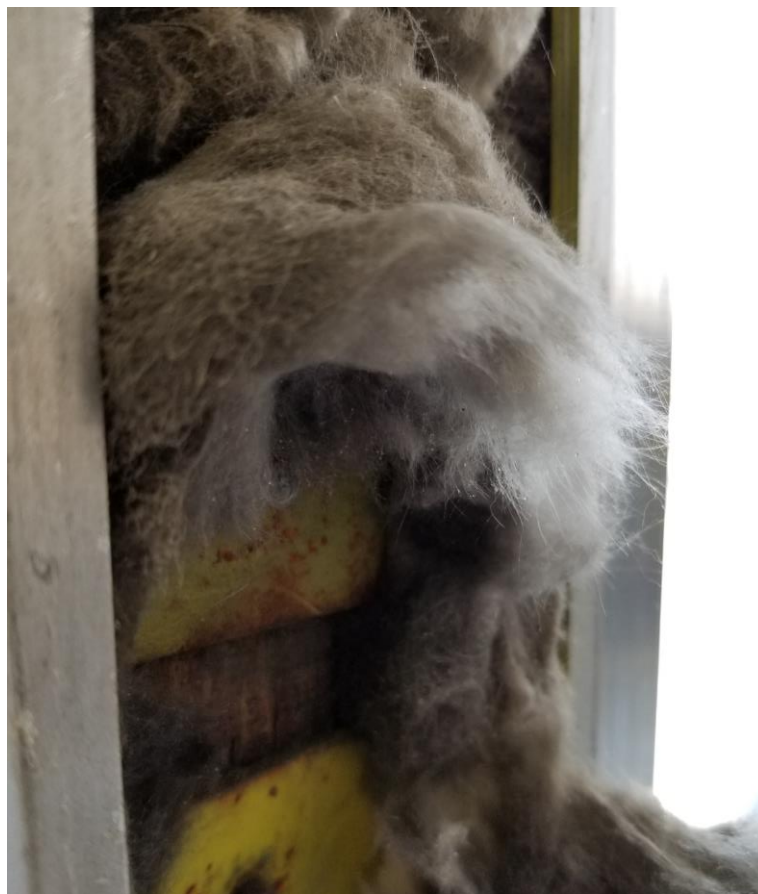
Insulation Behind the Window
Mullions.

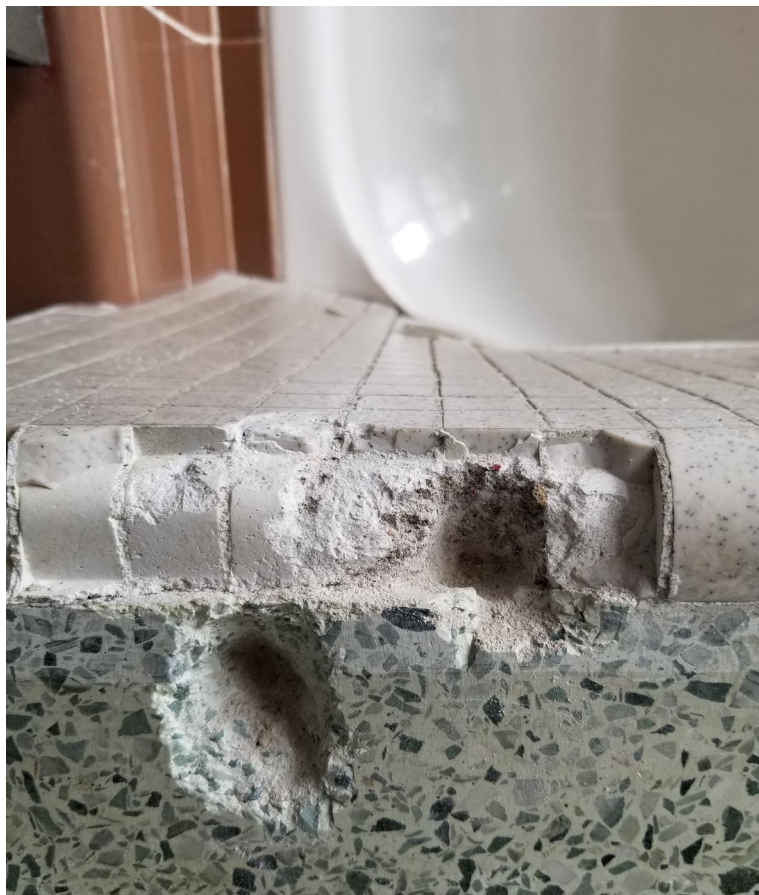
Room 430 – Men's Washroom

Terrazzo Floor and Concrete
Slab in Front of the Urinals.

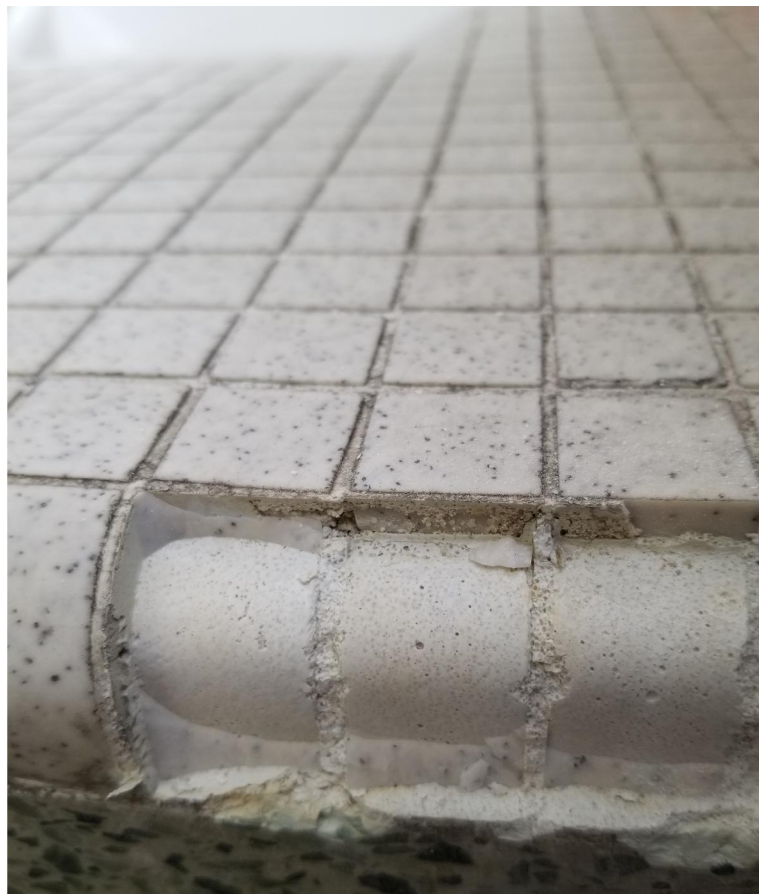
Room 430 – Men's Washroom

1" X 1" Ceramic Floor Tile White
Mortar at the base of the
Urinals.

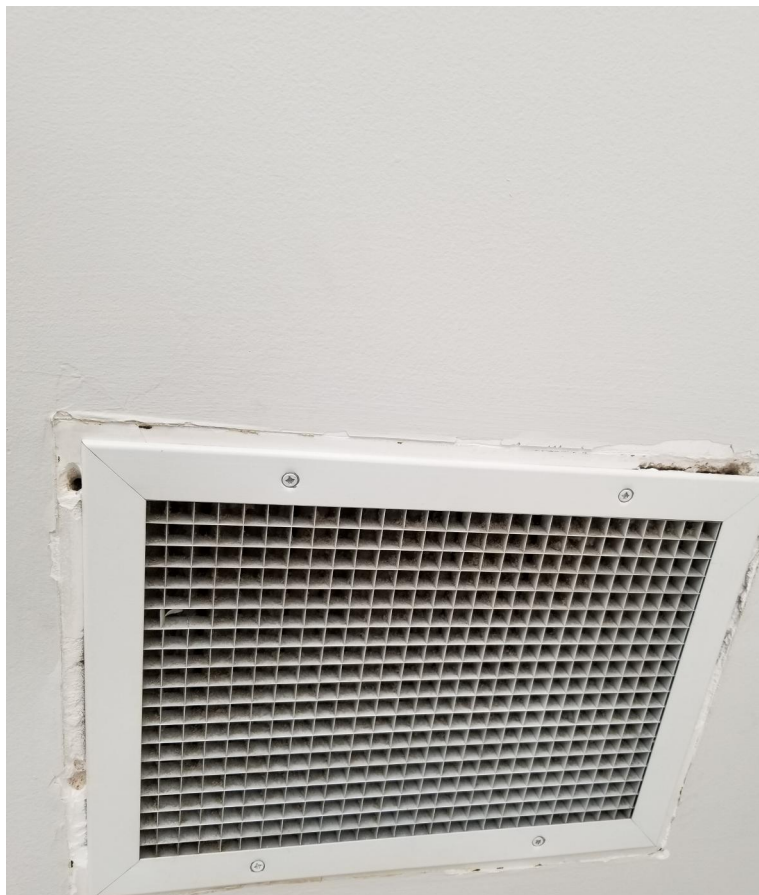
Room 430 – Men's Washroom

Ceiling Skim and Base Coat
Parging Around the Exhaust
Grille.

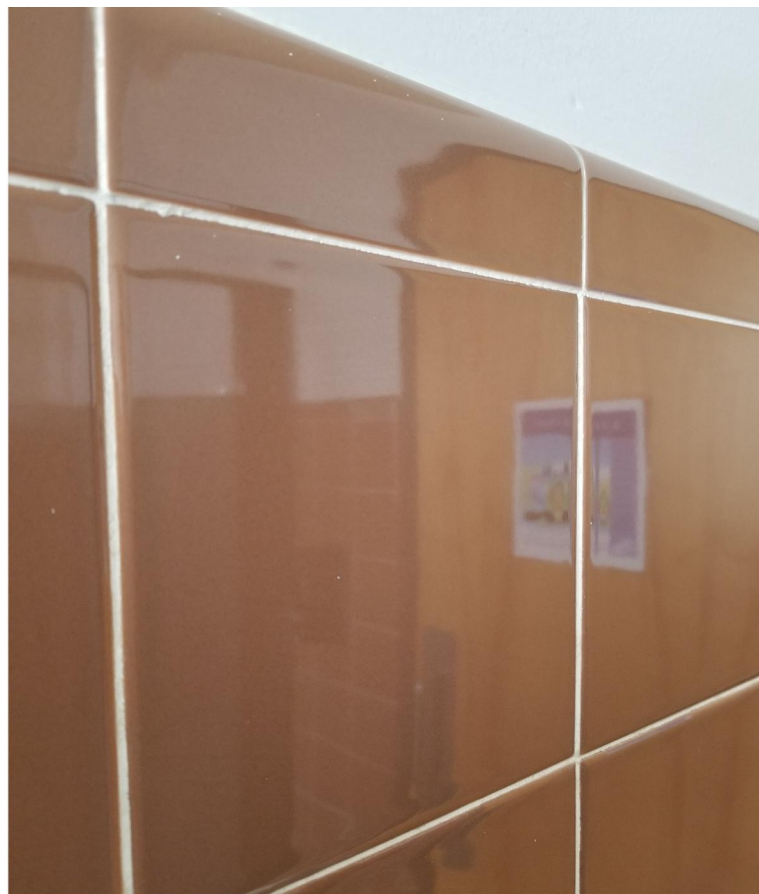
Room 430 – Men's Washroom

White Grout on Brown Ceramic
Wall Tiles.

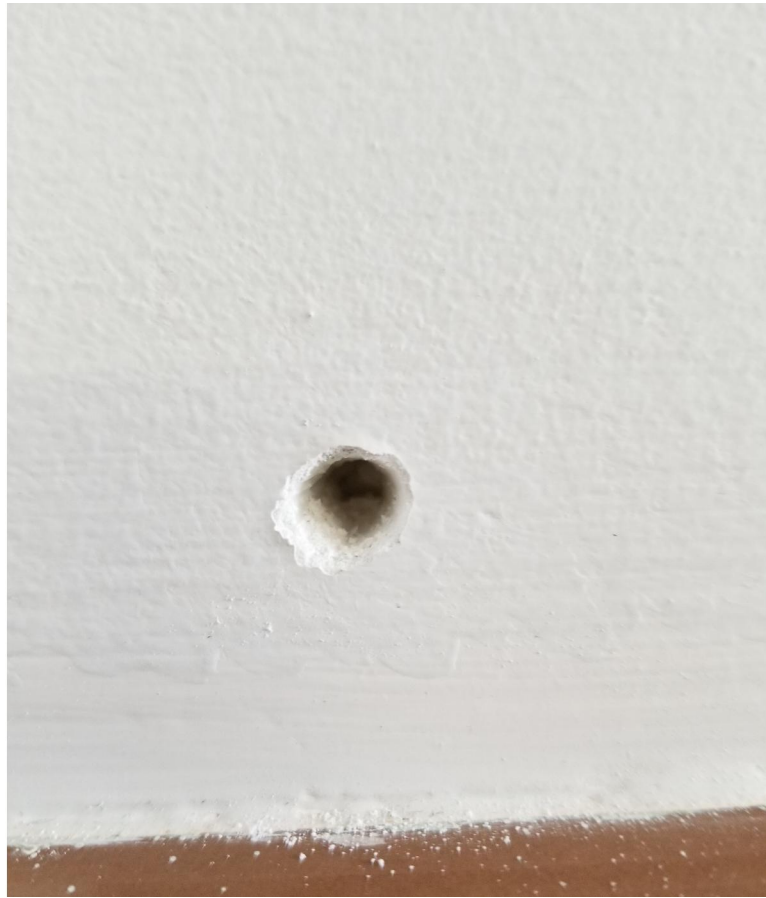
Room 430 – Men's Washroom.

Compilation of Wall Parging
