DERRICK CARROLL ASBESTOS SURVEY REPORT

March 2014

Prepared By: Bersch & Associates Ltd.
Project No. : B67SRC06

Subject: Pre-Renovation Assessment – Derrick Carroll Building

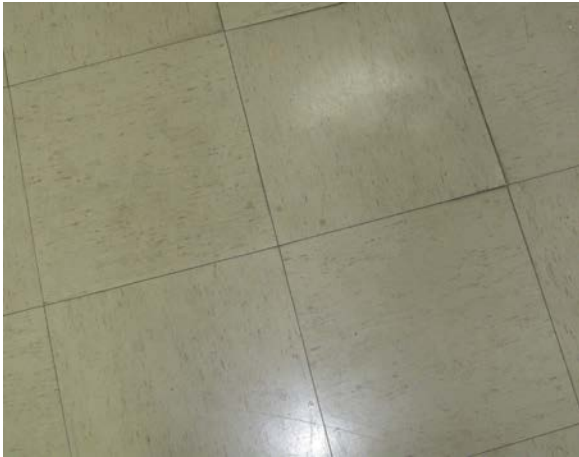
#4) Floor Tile

In total, fifteen (15) bulk samples of suspect asbestos-containing materials were collected within the Derrick Carroll Building. As a result Chrysotile asbestos was detected within the #4 floor tile sample. Refer to Appendix I for a copy of the Bulk Sample Analysis Report. All bulk samples collected were analyzed by Bersch & Associates Ltd. laboratory in accordance with the current U.S. 40 CFR Part 763, Vol. 52, No.210 for the analysis of asbestos in building materials using polarized light microscopy and dispersion staining techniques. The detection limit of this method is listed as less than 1%.

Vinyl Asbestos Floor Tile is located within the room. This material is considered a non-friable material and will not produce an elevated airborne fibre release unless mechanically disturbed. Recommendation is for the management of this material until renovations warrant removal.

PRIORITY:	THREE
CONDITION:	GOOD
POTENTIAL FOR DISTURBANCE:	LOW
ACTION:	MANAGE

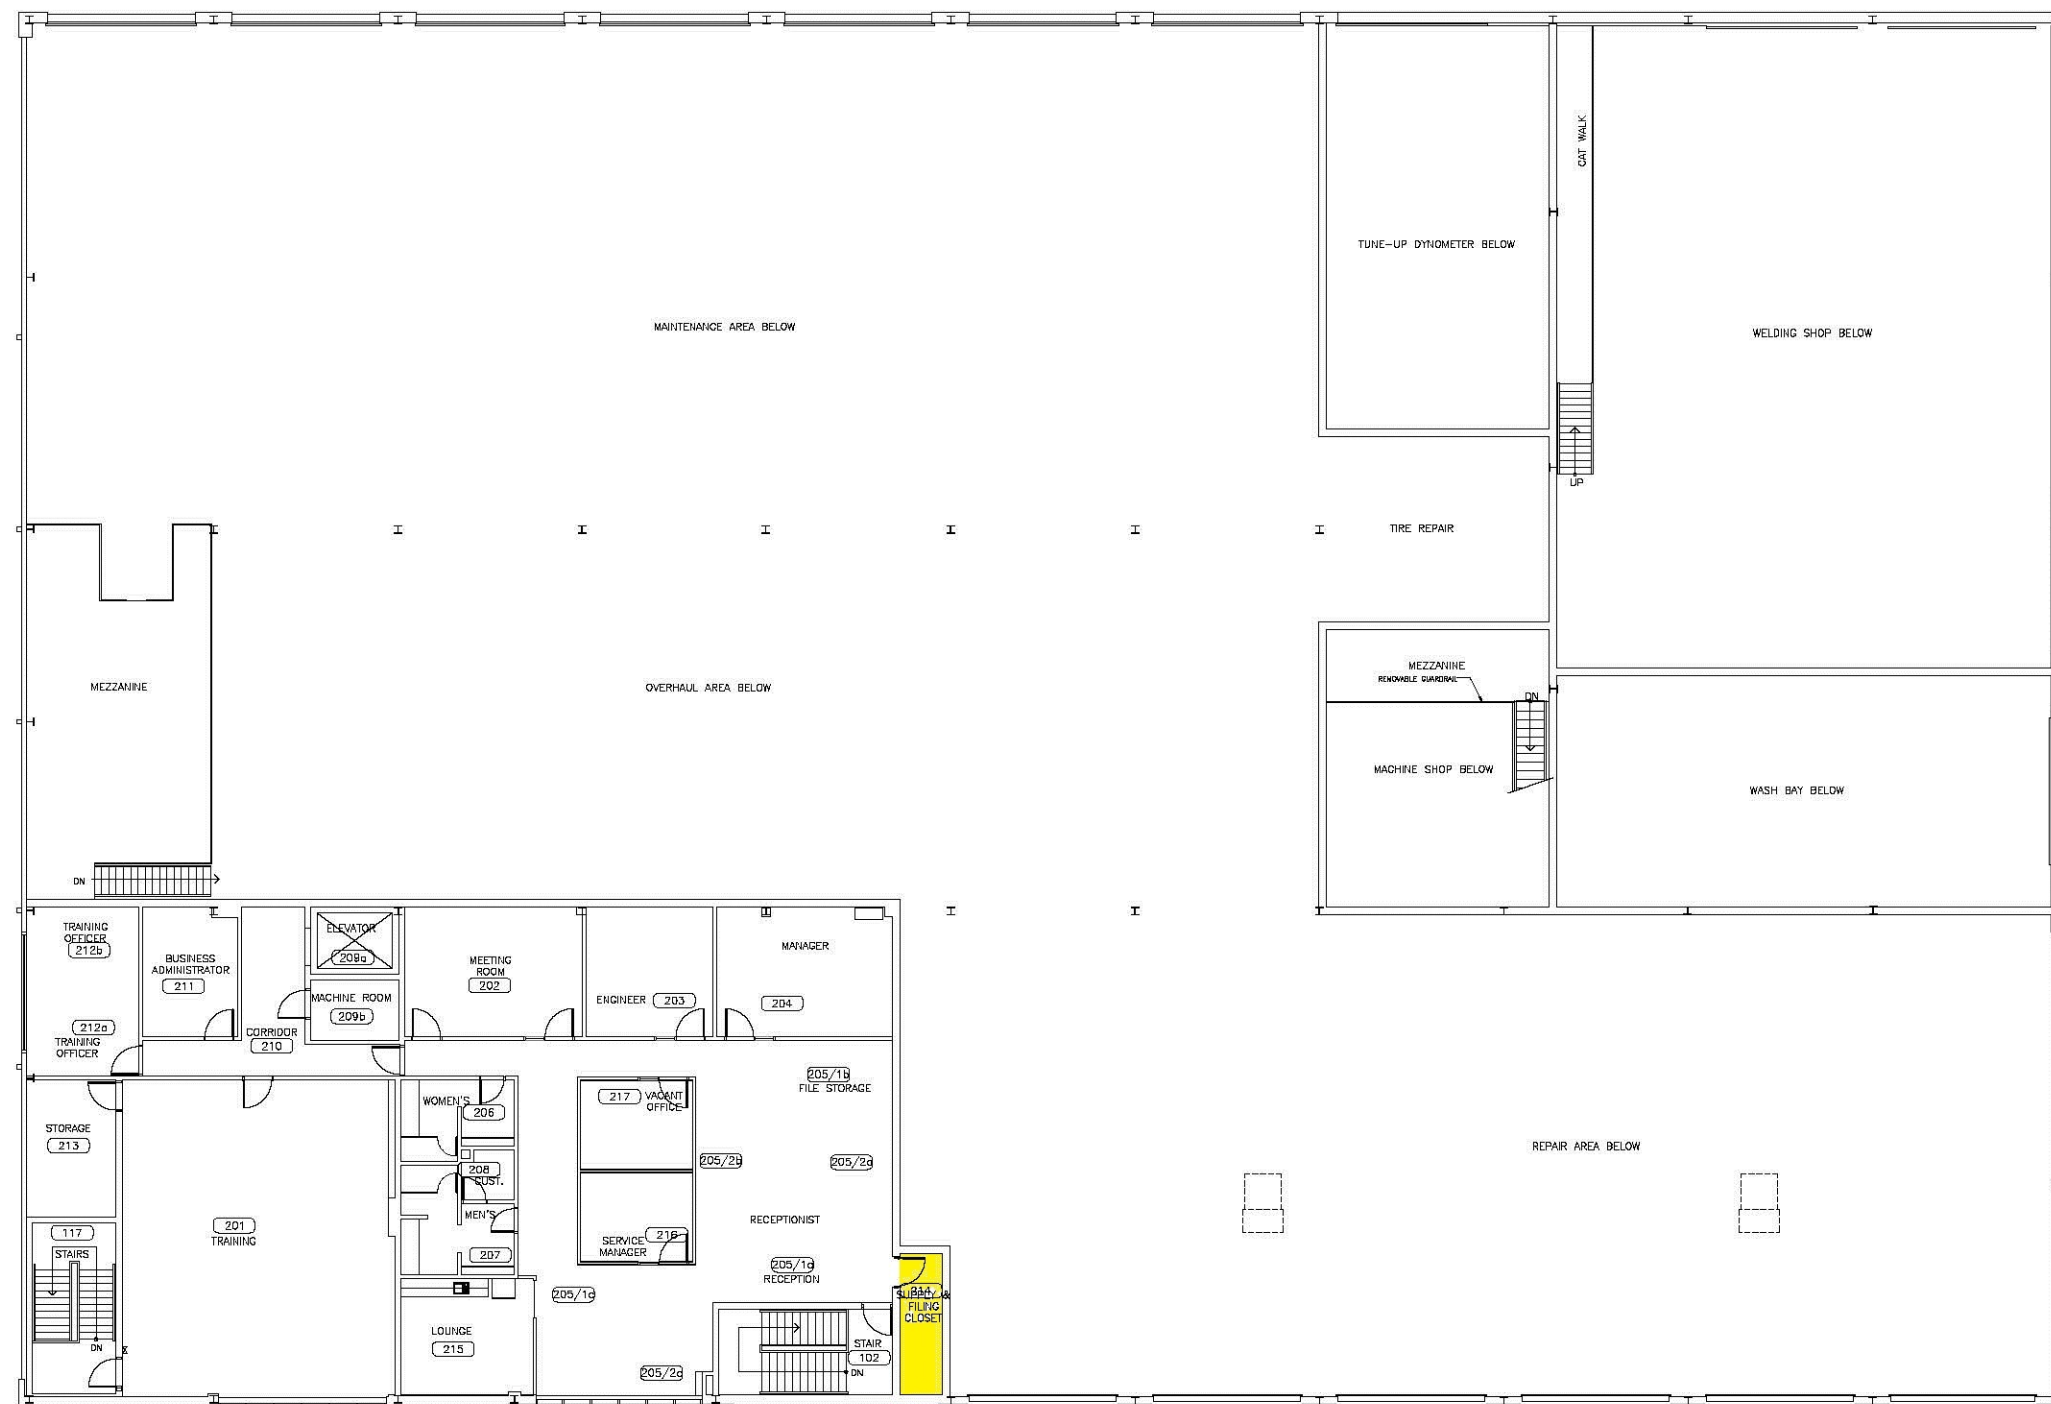
**Second Floor
Base Plan**

- **Vinyl Asbestos Floor Tile** is located within 214 Supply & Filing Closet.
- **Although it is unlikely due to sample results, any material located within ceilings, wall cavities, pipe chases or other inaccessible areas or areas of limited access shall be considered asbestos-containing until testing of the material can determine the presence or absence of asbestos.**

214 - Supply & Filing Closet

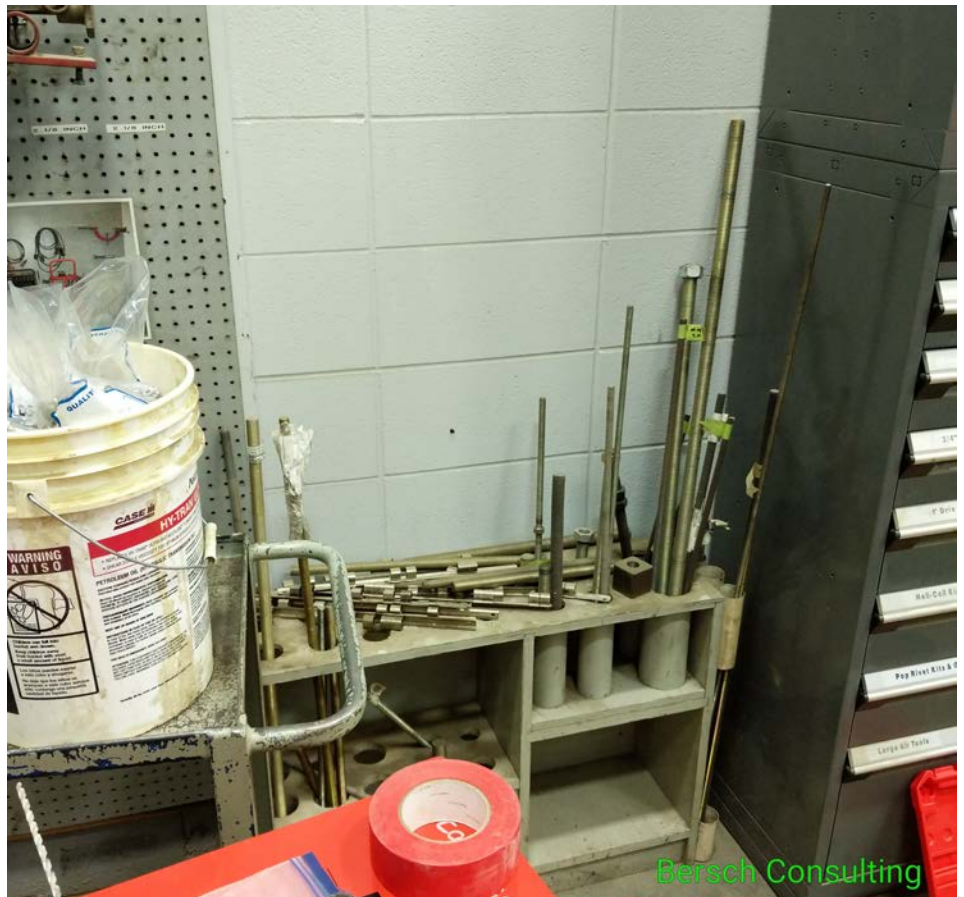
B67PRH19I - 001

Interior cinderblock wall.

Room 121/122 adjacent the
Welding Shop.

Vermiculite was not present
within the wall.

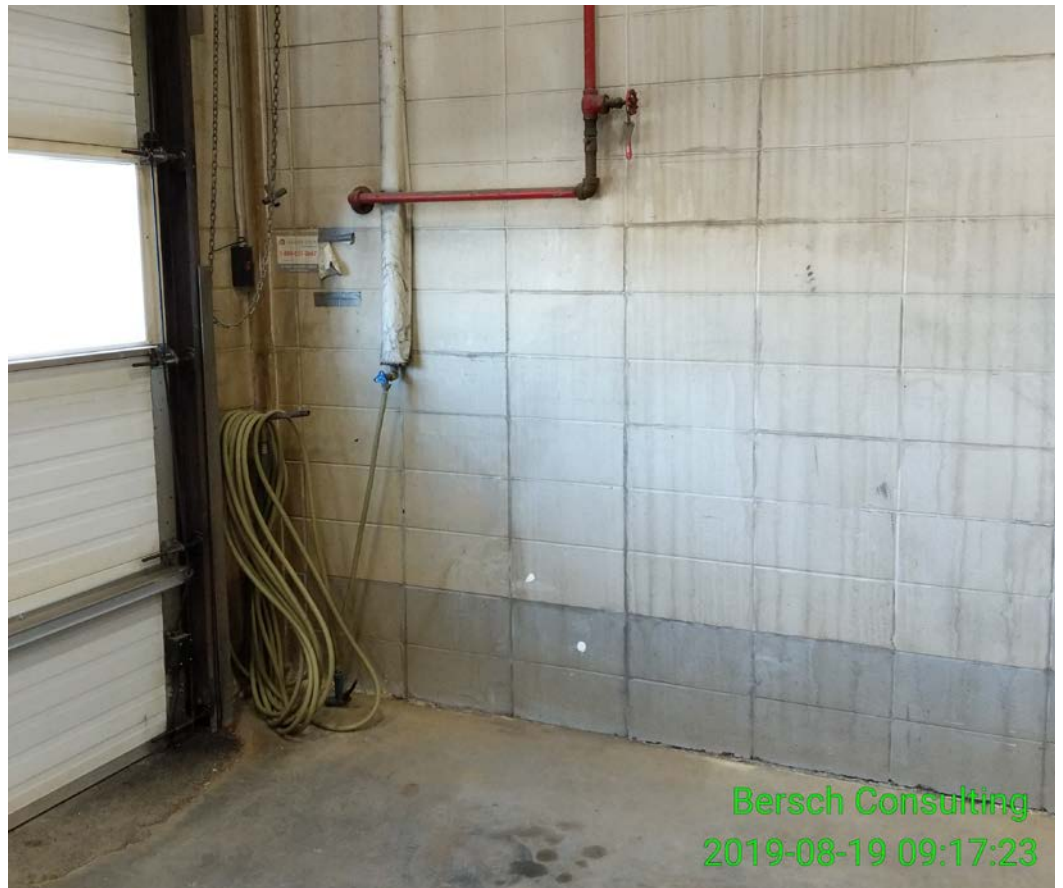
B67PRH19I - 002

Exterior cinderblock wall.

Northwest building wall.

Vermiculite was not present
within the wall.

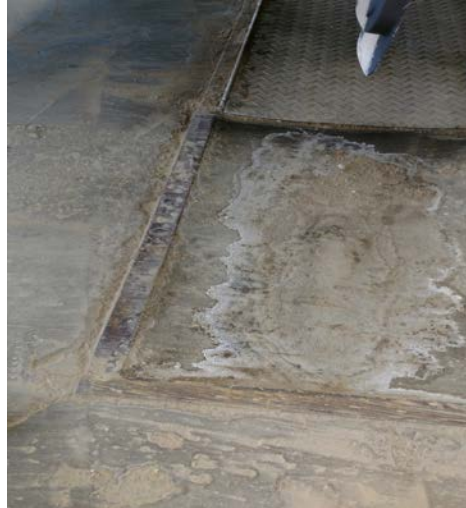
PHOTO 1 – MAIN SHOP AREA – IN-FLOOR HOIST

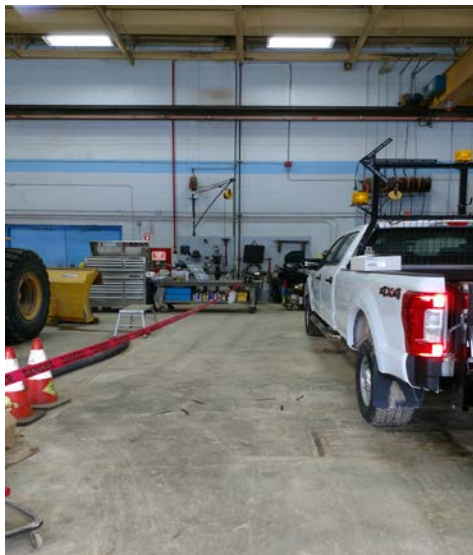
NO.	DATE	SAMPLE INFORMATION	ASBESTOS	%	ANALYST
1	7-Mar-17	Main Shop Area - Concrete Flooring	No Asbestos Detected		WB

PHOTO 2 – MAIN FLOOR AREA – CONCRETE FLOOR

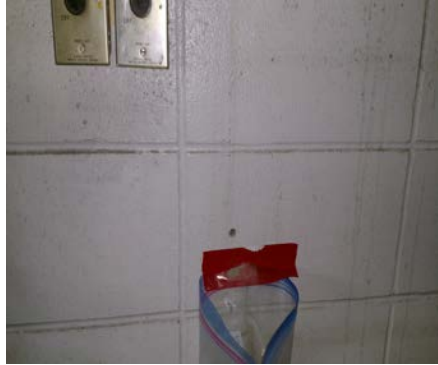
PHOTO 1 – 124 (BAY #10) – NORTH BLOCK WALL

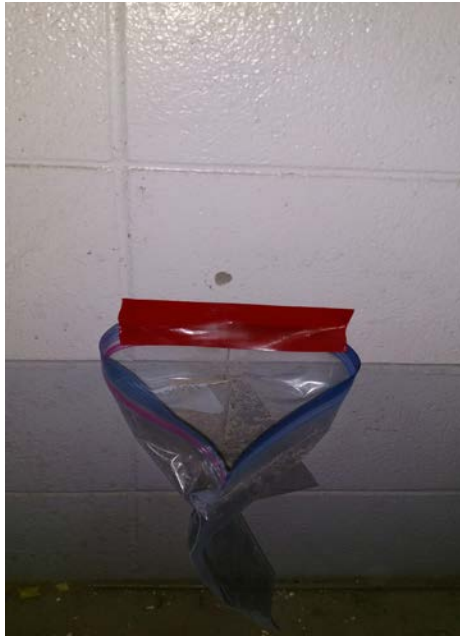
PHOTO 2 – 124 (BAY #10) - EAST BLOCK WALL

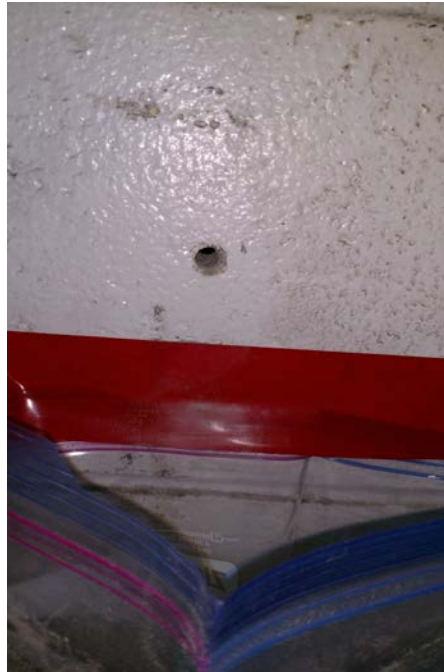
PHOTO 3 – 124 (BAY #10) - SOUTH BLOCK WALL
