October 4, 2017

## CITY OF SASKATOON AND GENERAL MANAGEMENT SERVICES

# Asbestos-Containing Building Materials Assessment Report - Essex Plaza

**Report Number: 1779656**

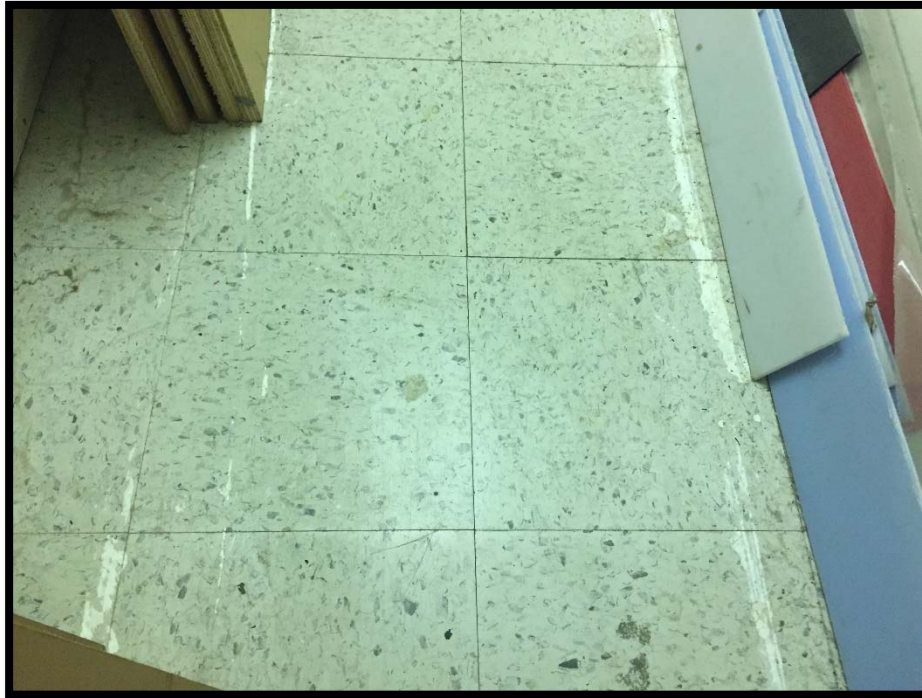
Two (2) samples of 12"x12" off-white floor tile with black flecks were collected during the assessment. Both of the samples collected were found to contain trace to 1.8% Chrysotile asbestos. Asbestos-containing 12"x12" off-white floor tile with black flecks (see Photograph 1 in Appendix B) was observed in the following locations:

**Photograph 1: Asbestos-Containing 12"x12" Off-White Floor Tile with Black Flecks.**

If scheduled for impact, asbestos-containing 12"x12" off-white floor tile with black flecks should be abated following low-risk abatement work procedures as outlined in the *Saskatchewan Asbestos Abatement Manual* (2017). Alternatively, as the 12"x12" off-white floor tile with black flecks was observed in good condition, and with a priority rating of 5 (please see the room by room spreadsheet provided in Appendix C for a description of the priority ratings), it can be managed in place if not scheduled for impact.

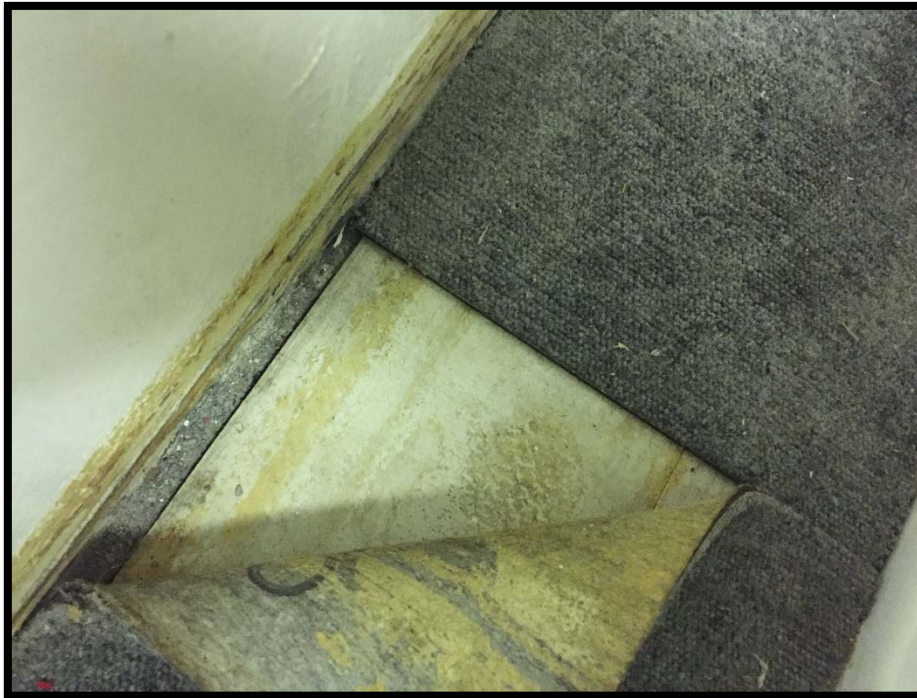
One (1) sample of 12"x12" floor tile with an indistinguishable pattern (due to carpet glue) was collected during the assessment. The sample collected was found to contain trace Chrysotile asbestos. Asbestos-containing floor tile (see Photograph 2 in Appendix B) was observed in the following location:

**Photograph 2: Asbestos-Containing 12"x12" Floor Tile (Indistinguishable Pattern).**

If scheduled for impact, asbestos-containing floor tile (indistinguishable pattern) should be abated following low-risk abatement work procedures as outlined in the *Saskatchewan Asbestos Abatement Manual* (2017). Alternatively, as the floor tile (indistinguishable pattern) was observed in good condition, and with a priority rating of 5 (please see the room by room spreadsheet provided in Appendix C for a description of the priority ratings), it can be managed in place if not scheduled for impact.

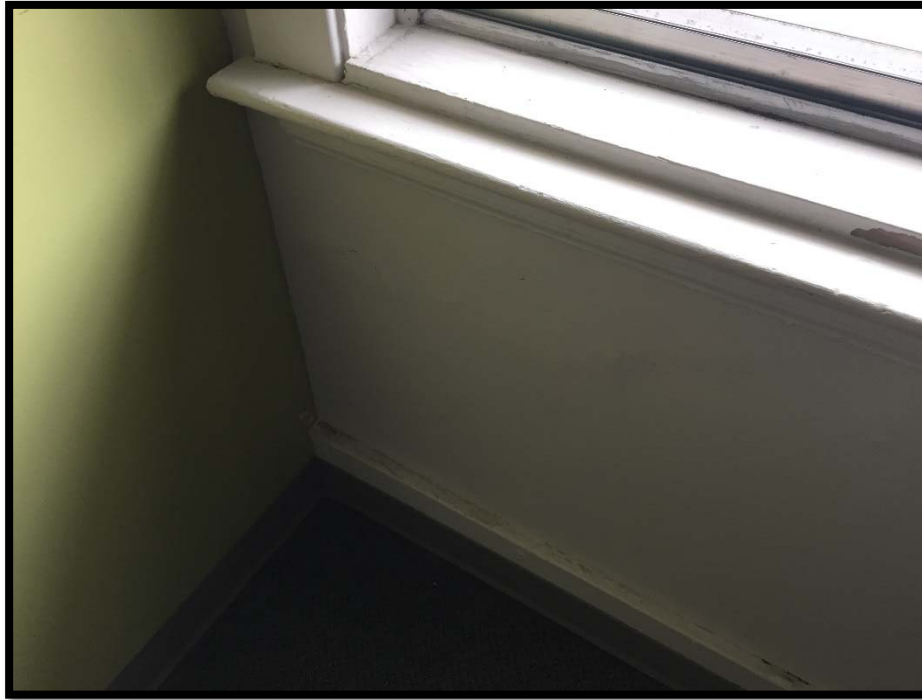
Five (5) samples of plaster were collected during the assessment. Two of the samples collected were found to contain 0.25% to 2.4% Chrysotile asbestos. Asbestos-containing plaster (see Photograph 5 in Appendix B) was observed in the following locations:

Based upon our observations during the assessment, the majority of the walls throughout the Site were observed to be drywall. It is suspected that additional plaster is located in concealed locations (behind solid walls, suspended and solid ceilings, shafts, etc.) throughout the Site.

**Photograph 5: Asbestos-Containing Plaster.**

If scheduled for impact, asbestos-containing plaster should be abated following high-risk abatement work procedures as outlined in the *Saskatchewan Asbestos Abatement Manual* (2017). Alternatively, as the plaster was observed in good condition, and with a priority rating of 5 (please see the room by room spreadsheet provided in Appendix C for a description of the priority ratings), it can be managed in place if not scheduled for impact.

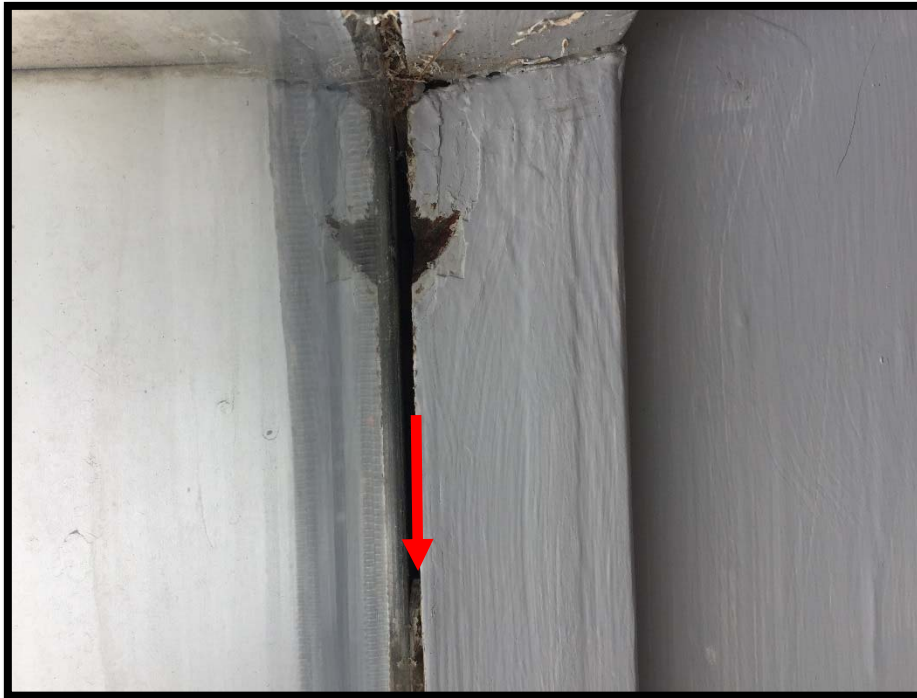
One (1) sample of white window caulking was collected during the assessment. The sample collected was found to contain 20% Chrysotile asbestos. Asbestos-containing white window caulking (see Photograph 6 in Appendix B) was observed in the following location:

**Photograph 6: Asbestos-Containing White Window Caulking.**

If scheduled for impact, asbestos-containing white window caulking should be abated following low-risk abatement work procedures as outlined in the *Saskatchewan Asbestos Abatement Manual* (2017). Alternatively, as the white window caulking was observed in good condition, and with a priority rating of 5 (please see the room by room spreadsheet provided in Appendix C for a description of the priority ratings), it can be managed in place if not scheduled for impact.

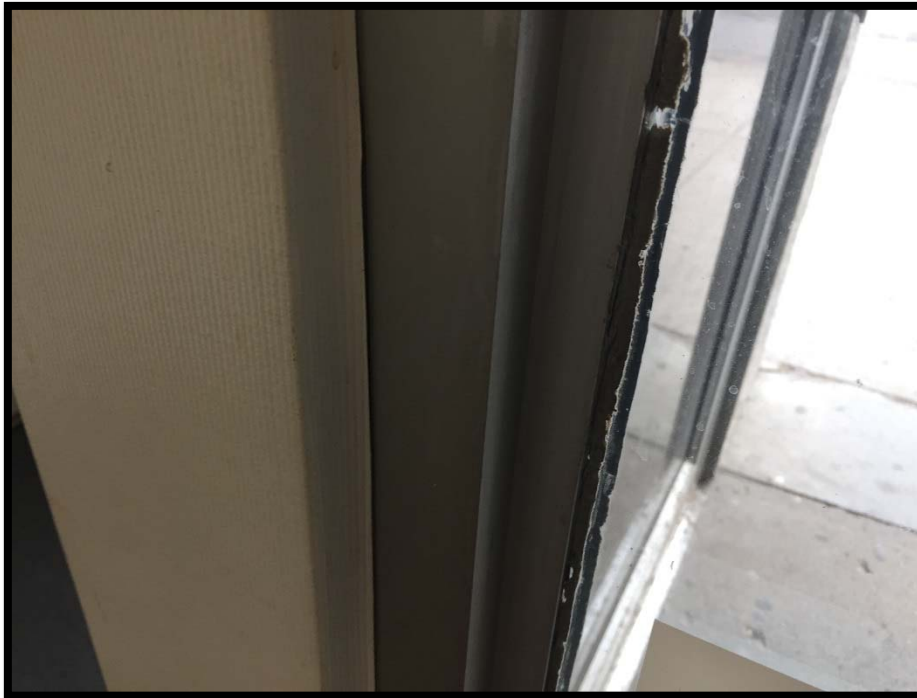
One (1) sample of grey window caulking was collected during the assessment. The sample collected was found to contain 2.1% Chrysotile asbestos. Asbestos-containing grey window caulking (see Photograph 8 in Appendix B) was observed in the following location:

**Photograph 8: Asbestos-Containing Grey Window Caulking.**

If scheduled for impact, asbestos-containing grey window caulking should be abated following low-risk abatement work procedures as outlined in the *Saskatchewan Asbestos Abatement Manual* (2017). Alternatively, as the grey window caulking was observed in good condition, and with a priority rating of 5 (please see the room by room spreadsheet provided in Appendix C for a description of the priority ratings), it can be managed in place if not scheduled for impact.

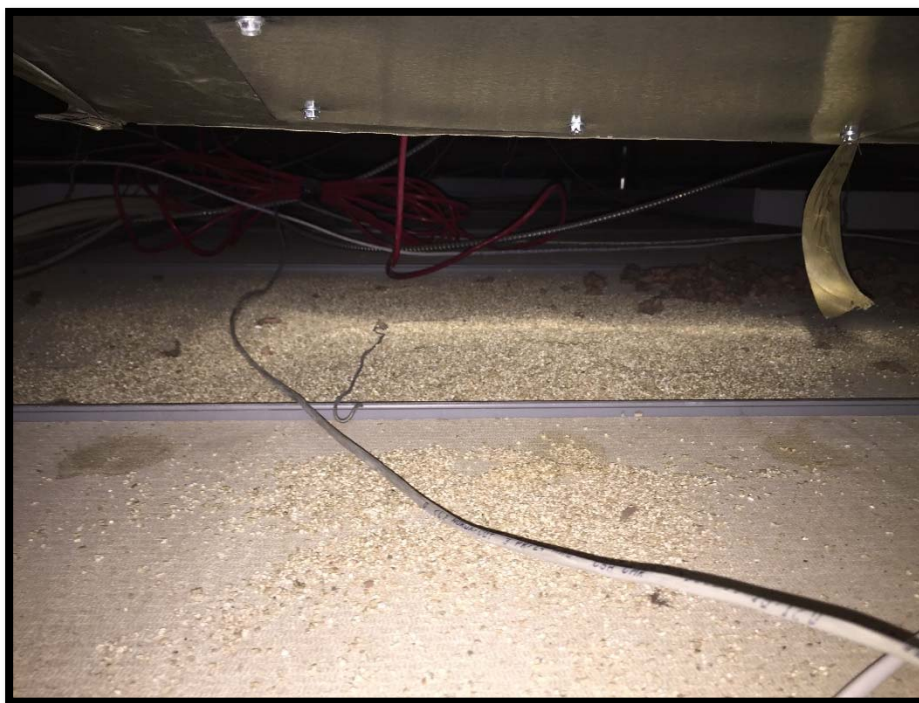
One (1) sample of loose vermiculite insulation on top of a suspended ceiling tile (see Photograph 9 in Appendix B) was collected during the assessment. The sample collected was found to not contain asbestos, however due to the inability to collect a thorough representative sample of the vermiculite insulation with an adequate volume, the material should be treated as a suspect asbestos-containing materials until further sampling can be conducted. Based upon the observations on Site, suspect asbestos-containing vermiculite is suspected to be located above the solid ceilings throughout the Site. Additionally, sporadic spills of the suspect vermiculite insulation are suspected on the various ceilings throughout the Site.

**Photograph 10: Suspect Asbestos-Containing Vermiculite Insulation.**

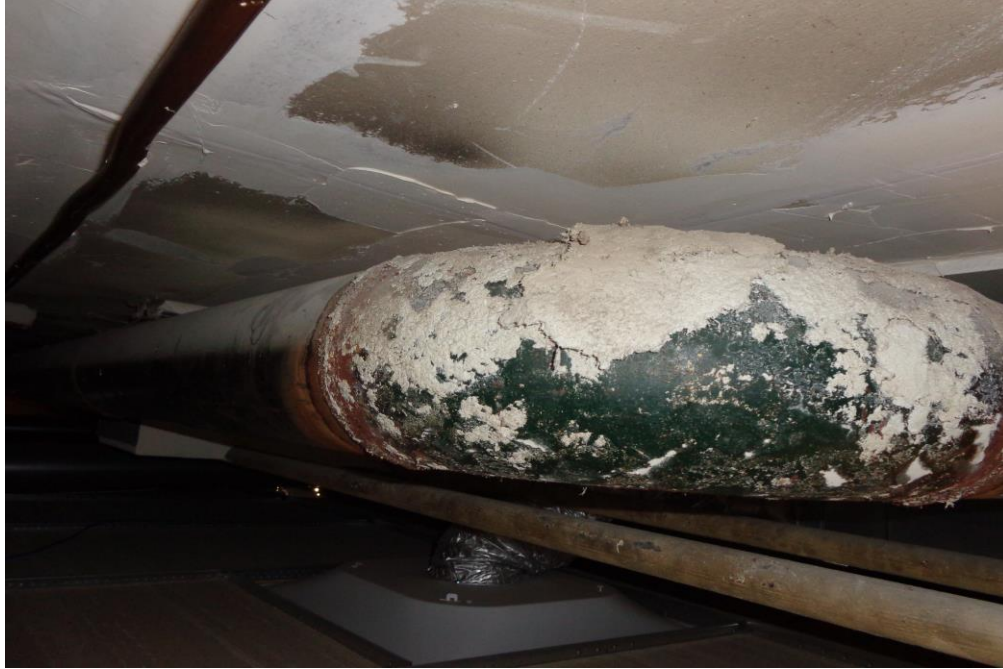
- 1) The ceiling space within the area “Potential to Raise Entire Ceiling” currently poses no issue for accessing the ceiling space or removing the suspended ceiling. The drywall ceiling surface above the suspended ceiling has been fire-taped and sealed from the space above the drywall. It is suspected the vermiculite identified in other areas of the building is present above the drywall. Refrain from puncturing through the drywall. If any activity is performed that will require penetrating the drywall, special precautions are recommended. See photo 1 on page 3 of this report to view the ceiling throughout the space.

- 2) Two large pipeline fittings were observed and sampled within the ceiling space. The mud compound was removed leaving remnants on the pipeline fittings. The glovebag removal is recommended to remove the material from the pipeline surface prior to removing the ceiling tile throughout the area. See photo 1.

**PHOTO 1 – Fire-tape on Drywall Ceiling and Remnants of Asbestos Mud Compound on Pipeline Fitting.**

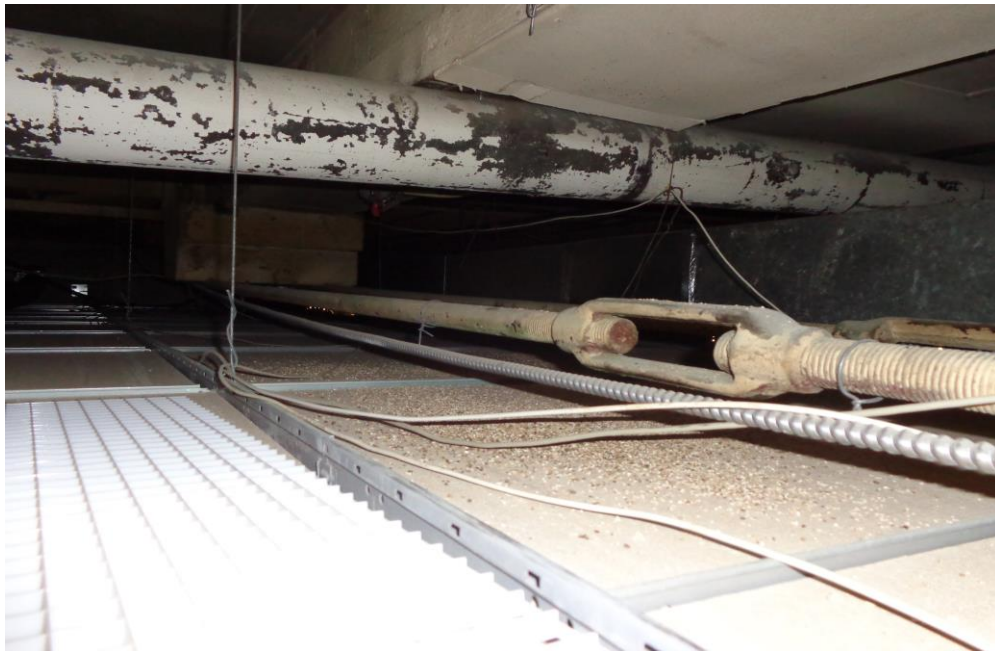
- 4) The ceiling space directly to the north of the meter readers area and east of the area mentioned above, reveals vermiculite insulation within the ceiling space above the drywall as well as debris throughout the ceiling grid and on the ceiling tile surfaces. We recommend a thorough HEPA vacuuming of the suspended ceiling system throughout this area either in conjunction with this renovation or in future planning. The seams / penetrations in the drywall ceiling above the suspended ceiling systems should be sealed with caulking to prevent the vermiculite from falling on the surfaces below the drywall. See photo 2.

**PHOTO 2 – Vermiculite Debris Within the Ceiling Space North of Meter Readers Area.**
