## Pre- Renovation Assessment

**File Number: B67PRL10H- Old Bunkhouse**

**Project: Forestry Farm – Old Bunkhouse – Investigation of Main Floor Living Room**

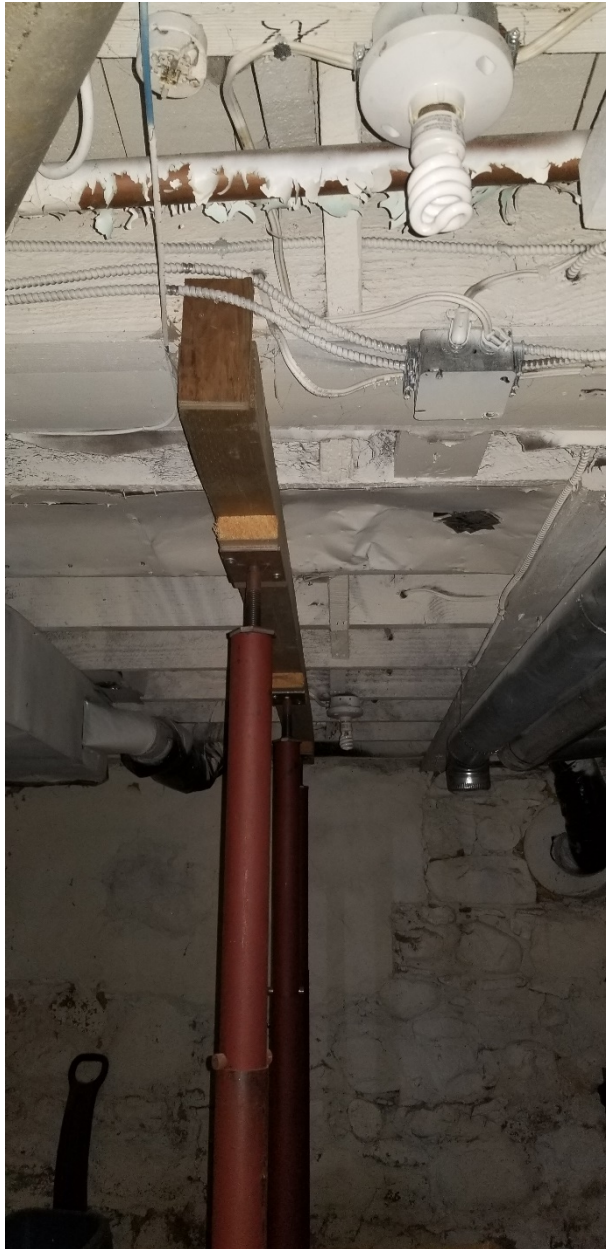
**Photo 003- The basement below the main floor living room. No insulation or asbestos containing materials were identified within the truss spaces.**

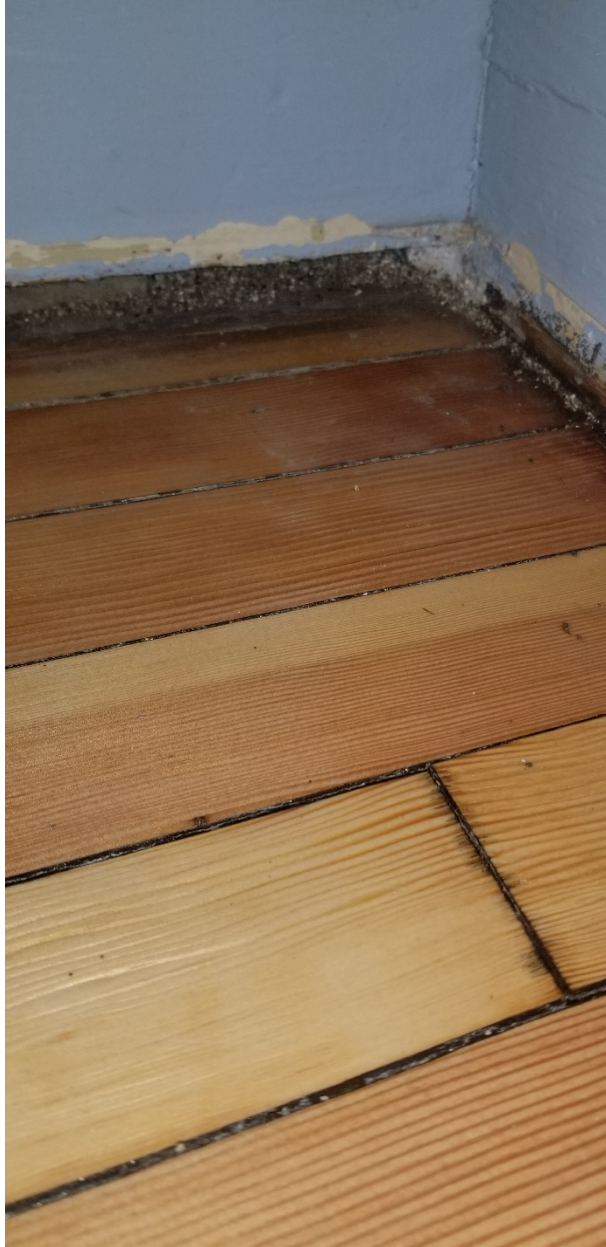
The second area of investigation was on the second floor, southeast bedroom. While the floor was being refinished, workers complained about a small amount of debris draining from a corner. The material was identified as vermiculite insulation and one sample was collected for analysis. Asbestos **was** detected within the sample. This vermiculite was present in an interior wall; like the vermiculite on the main floor this vermiculite is likely a result of attic insulation settling into wall cavities through penetrations. This insulation may be present sporadically and unpredictably throughout wall spaces and ceiling space.

**Photo 006- Vermiculite draining from wall in upstairs bedroom.**

While performing work that involves drilling into walls or ceilings, behind which is a cavity, workers should be made aware of the possibility of vermiculite insulation and be equipped with the proper PPE, such as Niosh approved half-mask respirator.
